The Garvin House: A Preservation & Interpretation Plan For An 1870 Freedman's Home

Prepared for the Town of Bluffton, South Carolina
By

July 15, 2009

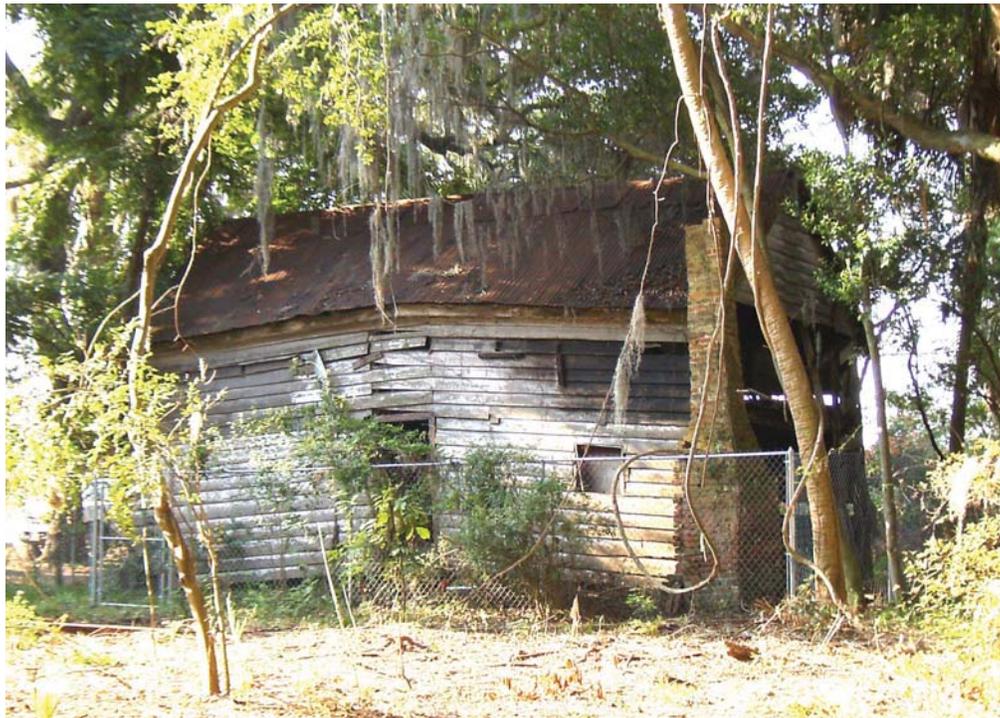
Figure 1: Exterior view, North Elevation; 2008. Note the deterioration of the floor system from the middle of the building to the ends.

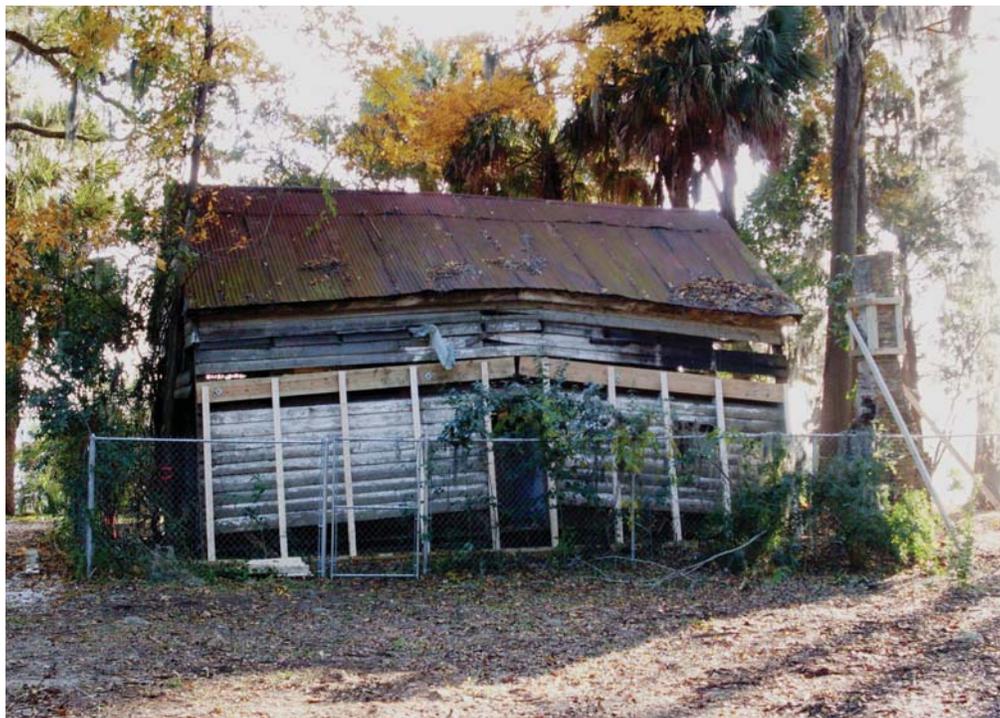
Figure 2: North Elevation. View during Phase 1 – Stabilization, December 2008. Note the exterior attachment board (2x10) to the North Elevation (second floor joist) to help level the entire structure before the W 16 steel beam is lifted into place.

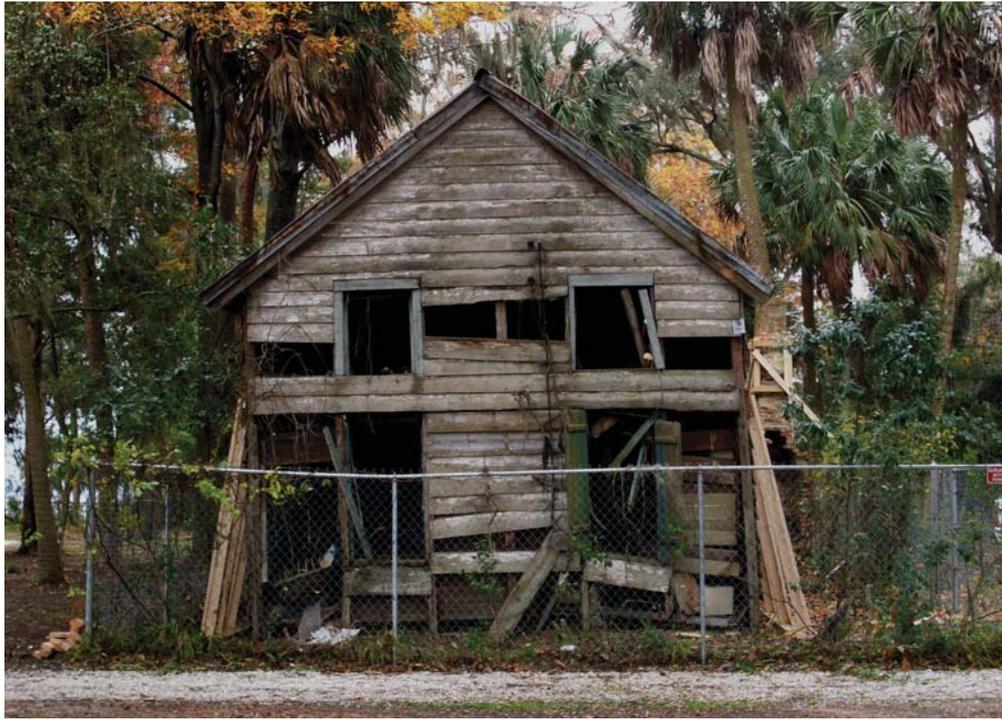
Figure 3: Exterior view; East Elevation; 2008. Note size and location of first and second floor windows, offering both symmetry and simplicity. Three existing shutters—exhibiting basic board and batten construction—on first floor windows (34"x60") appear to be original to the structure.

Some building materials may have been salvaged from nearby buildings [Figures 48 & 49]. Traditional framing techniques, use of cut nails, and a combination of hand hewn and sawn wood are found throughout the house. Existing shutters from the first floor windows demonstrate traditional board and batten construction [Figures 4 & 63].

be replicated on the west elevation [Figures 3 & 4]. There are a total of seven windows on the first floor. The only window opening along the north elevation should be covered over to show the original 1870 exterior view of the house.

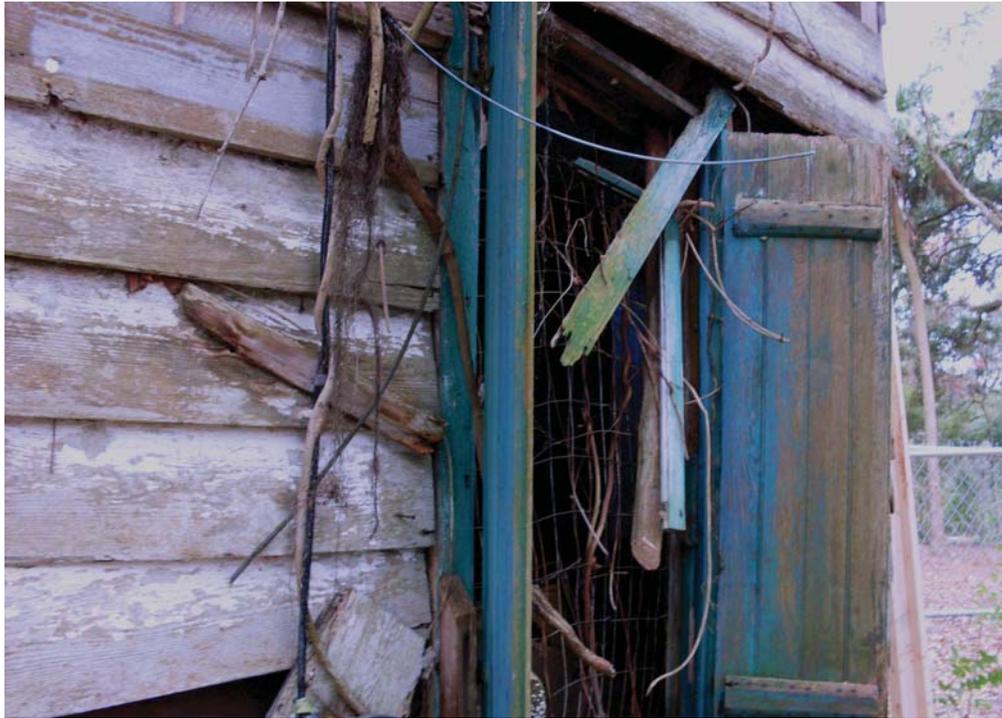
Figure 4: Exterior view of the first floor window (NE corner). Note the deterioration of the window opening trim and shutters. The window trim color reflects an indigo blue and medium shade of green over the last 140 years.

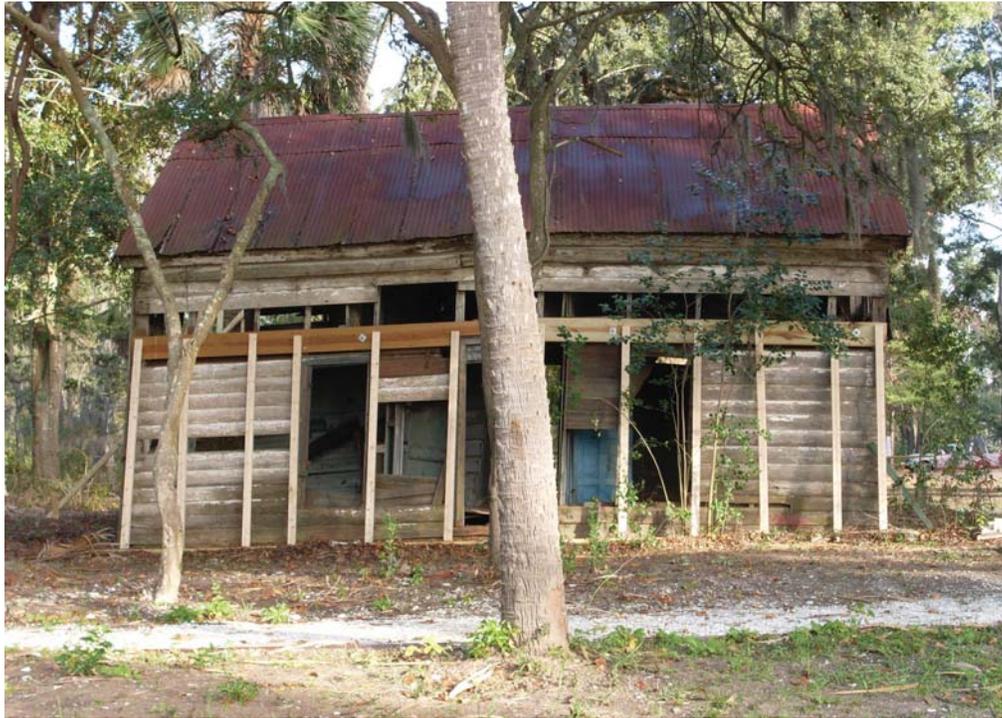
Figure 5: Exterior view; South Elevation; December 2008. Note location of the doorway and two windows. Door entrance is centered and the two window openings are equal distances from each end of the building. This architectural style is common among Freedman buildings during the Reconstruction period in the South.

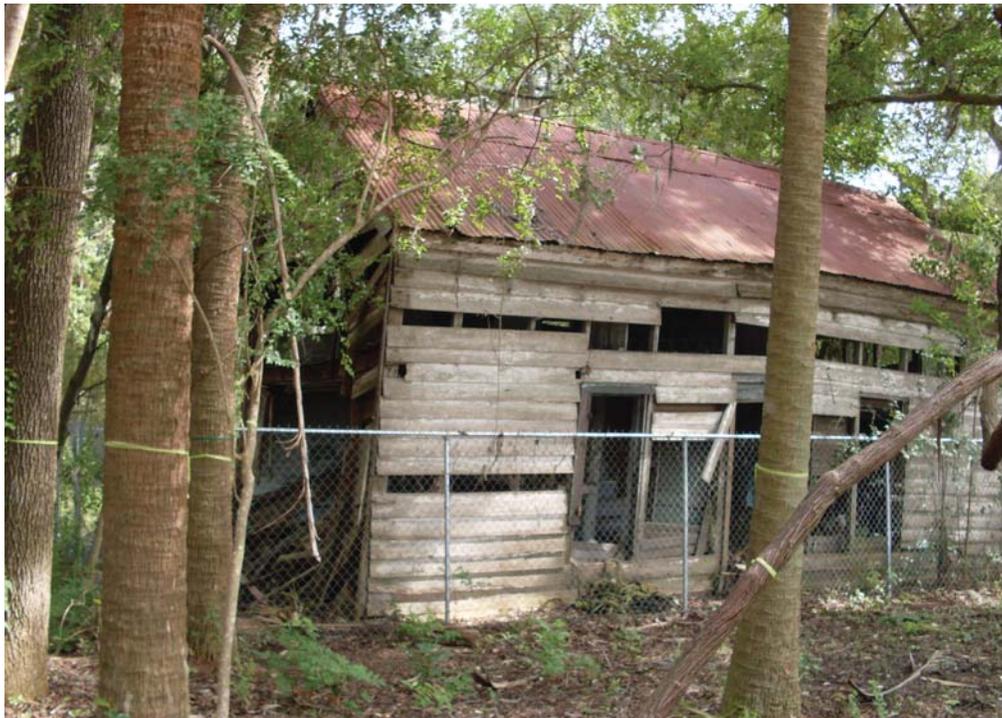
Figure 6: Exterior view; Southwest Corner; 2008. Note that approximately 30% of weatherboarding is missing on this elevation. Previous observation notes state that the siding was painted white and that window and door trim was blue. An exterior color analysis from a local paint company (e.g. Sherwin Williams) can help to verify the colors.

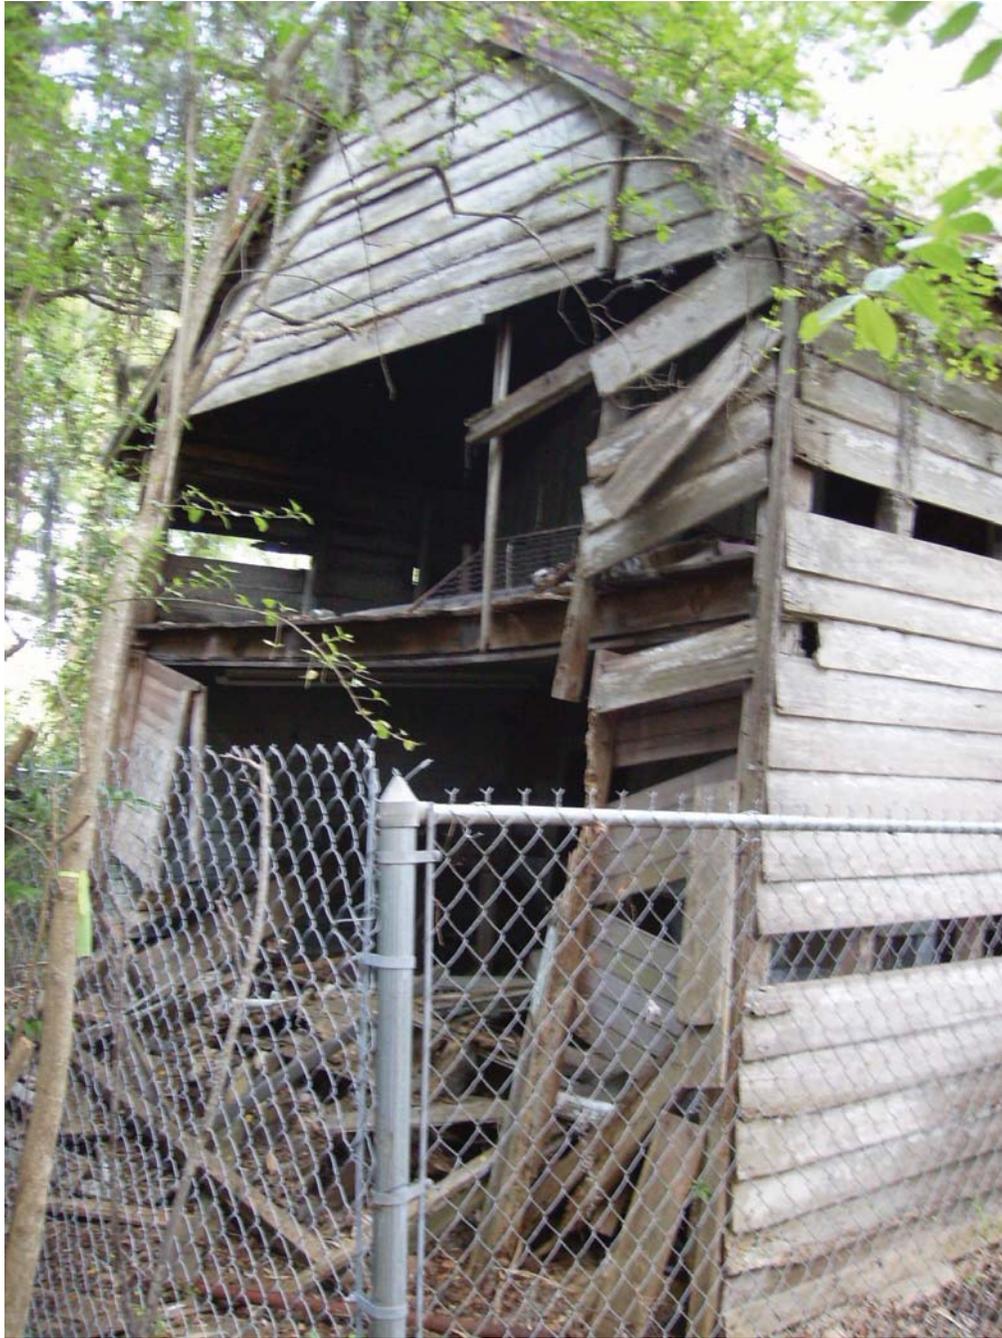
Figure 7: Exterior view; West Elevation; December 2008. Note debris on the first floor and open space where the chimney once stood.

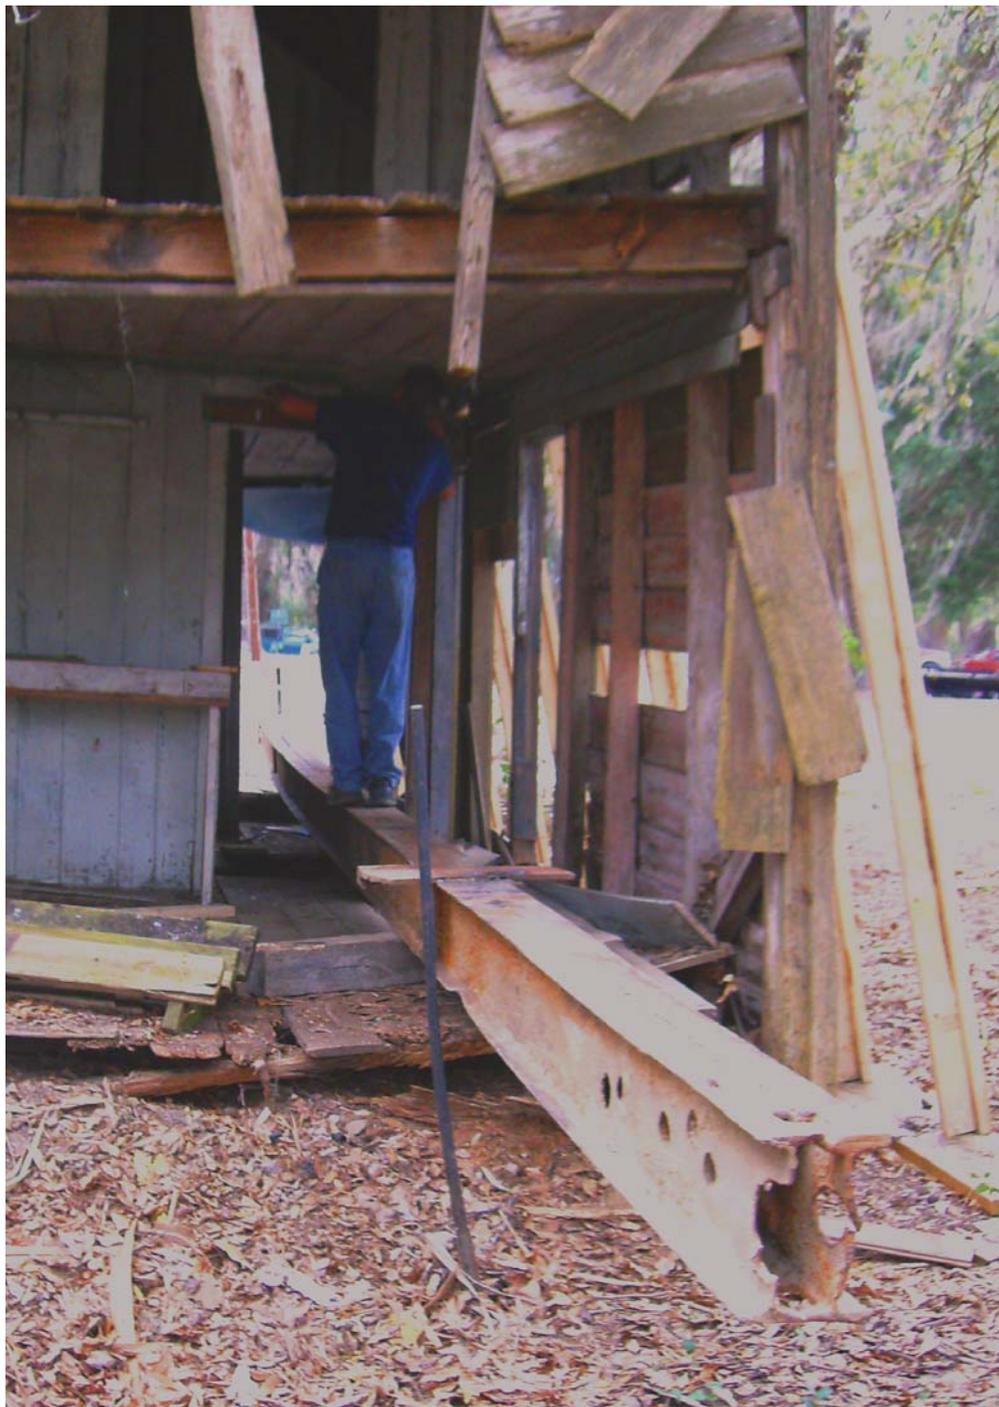
Figure 8: Exterior view; West Elevation; December 2008. The chain link fence and debris from the first floor wall shown in Figure 7 have been removed. Support steel is being inserted to help stabilize the second floor and level/square the building to reflect its original rectangular shape.

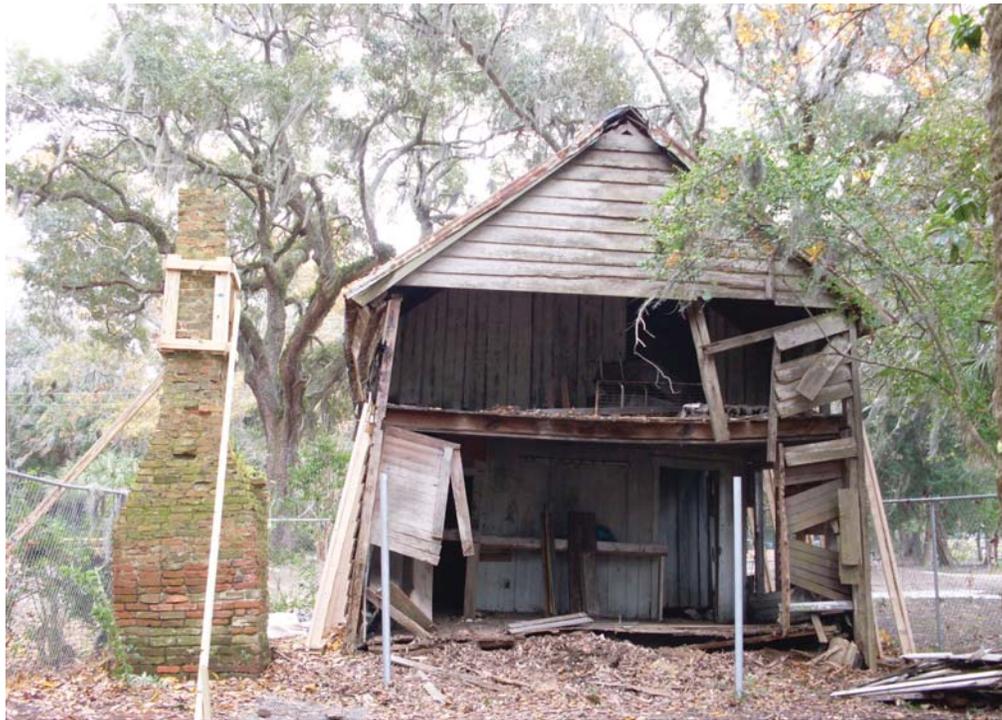
Figure 9: Exterior view; West Elevation. Note that original main chimney has been removed. The remaining chimney was part of the back room addition made during a 1920s-1930s renovation. Several original Slave-Freedman structures in the South show modifications after Reconstruction in the period leading up to 1900, including the construction of additional back rooms to the family tenant home (e.g., Hobcaw-Friendfield Plantation in Georgetown).

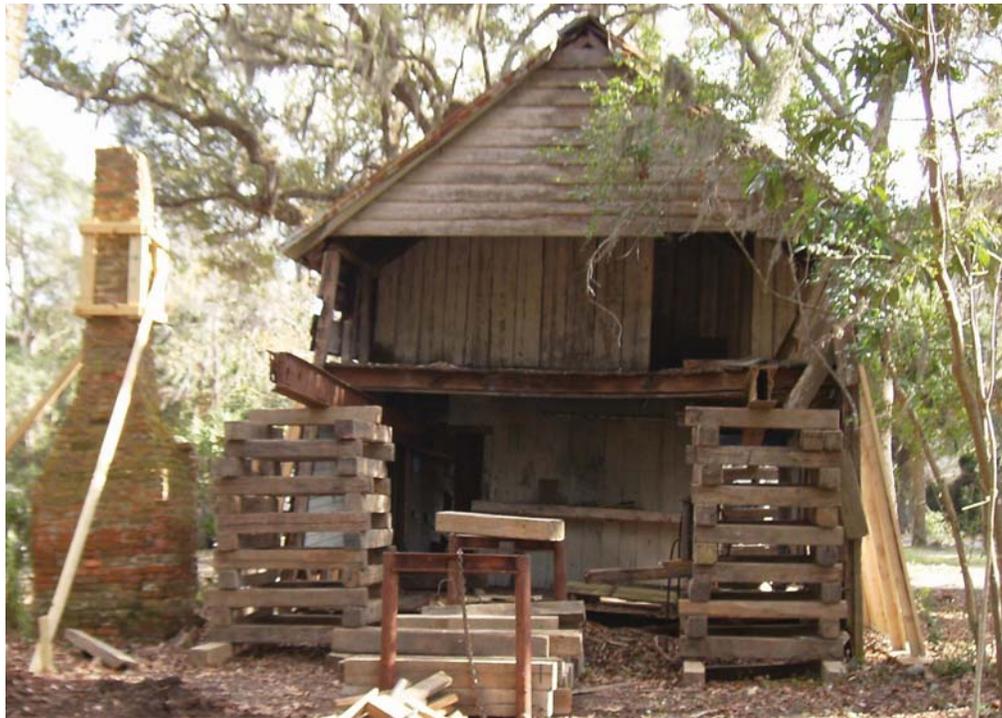
Figure 10: Exterior view; West Elevation; Phase 1 – Stabilization; December 2008. Note the cribbing and support steel needed to level out the second floor and wall systems. The second floor gable weatherboarding is in good shape. Upon repairing the whole first floor system (new sills and center support beam), several wall studs will need to be repaired (Example: Dutchman repair – 8 to 12 inches).

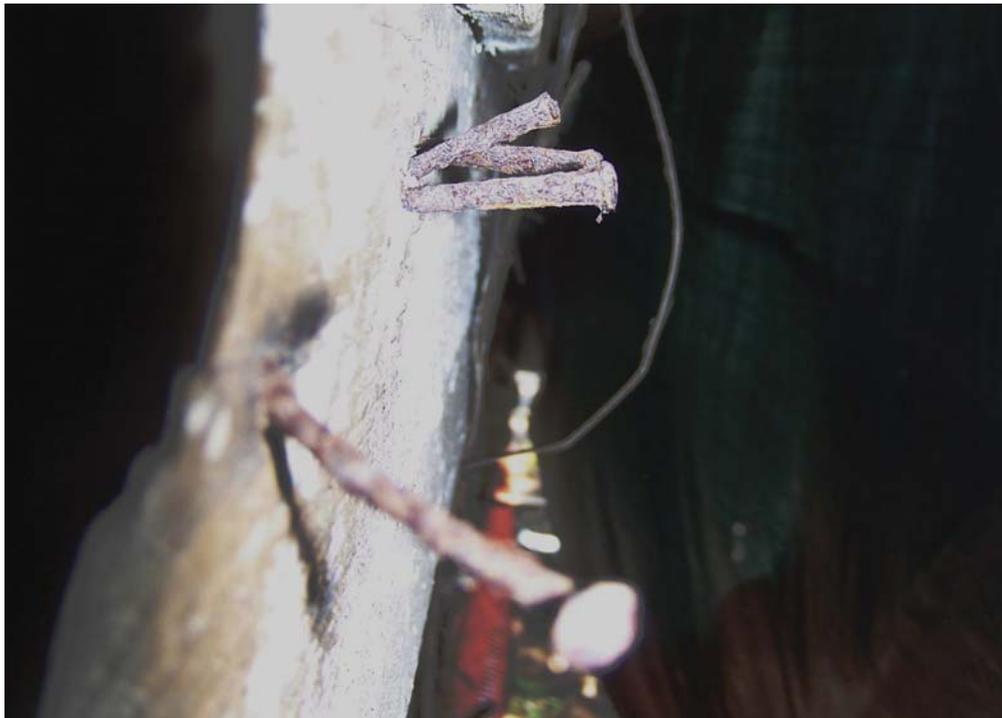
Figure 12: Exterior view, South elevation; April 2009. Close-up view of the nail fasteners used to attach the missing roof rafters to the south porch elevation. Note how all three cut nails were toe nailed to the siding-second floor wall stud every 24 to 28 inches above one foot below the soffit- roof line.

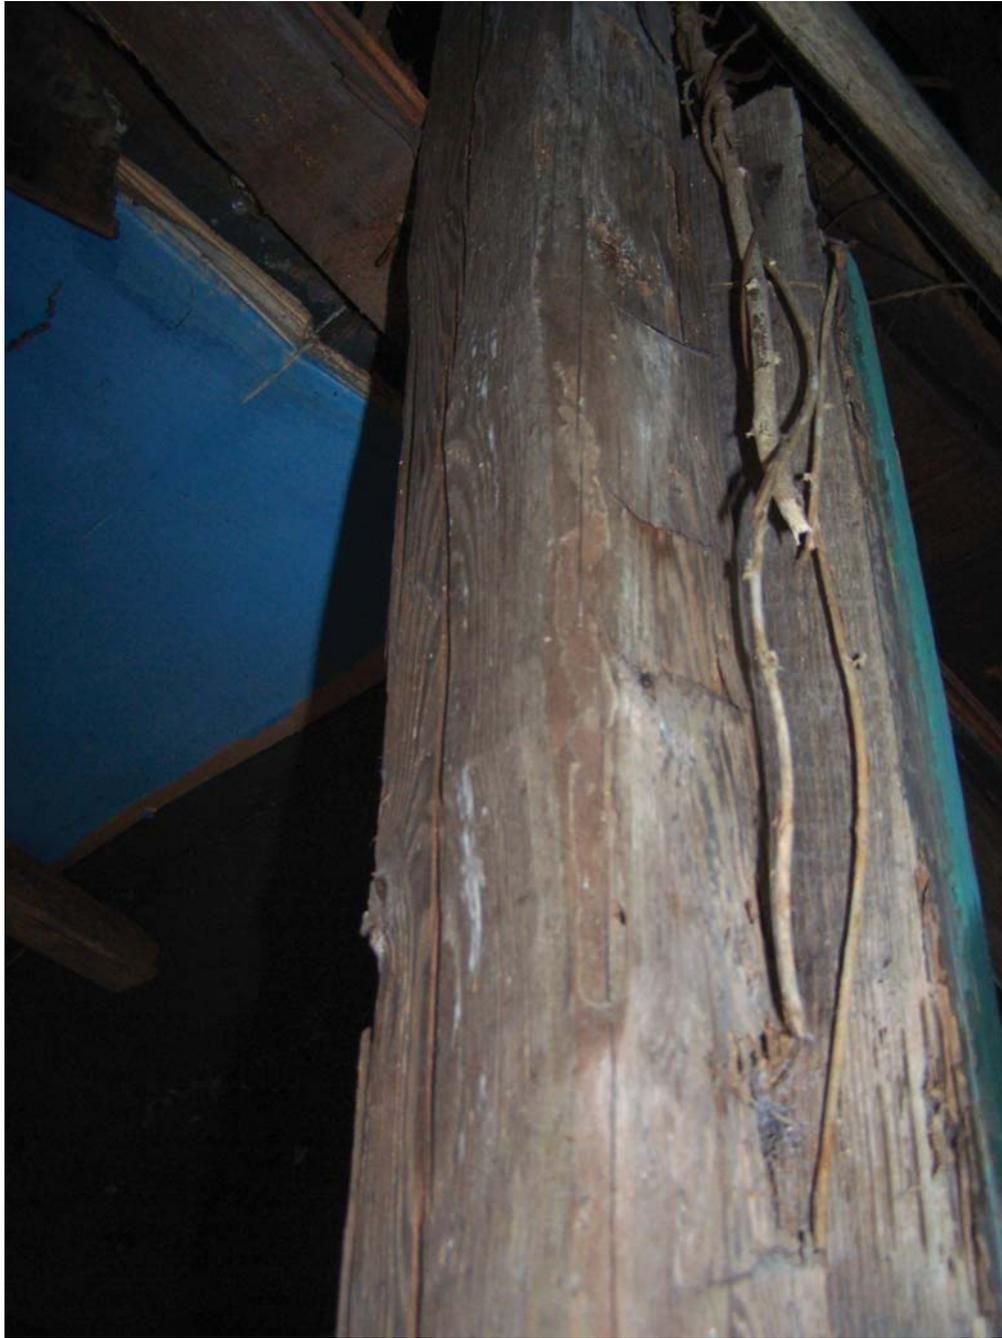
Figure 13: Interior view, South Elevation, June 2009. Note the timber 4x4 wall stud is hand hewn and the window framing is sawn cut. It appears that every other wall stud is 50% sawn cut and the corner and midway thicker wall studs are hand hewn. Every wall stud shows signs of termite/insect damage, so each wall stud on the first floor elevation will need to have Dutchman repairs from the floor sill up 18" to reinforce each wall stud – all elevations.

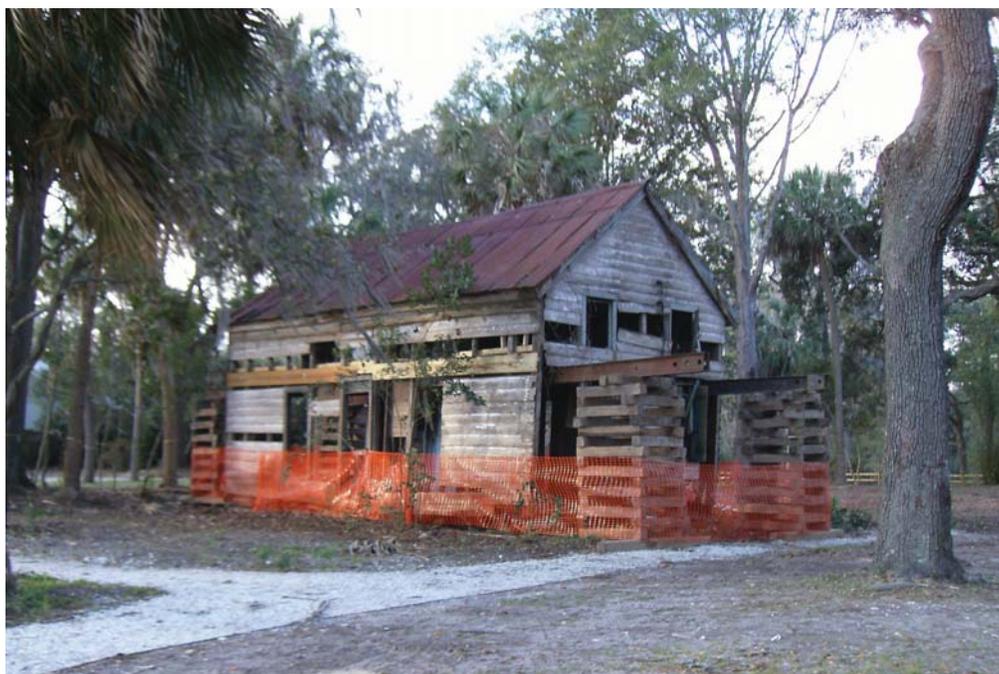
Figure 14: Exterior view; Southeast Elevation; December 2008. Note the missing weatherboarding just above the window and door locations on the South Elevation. Older photos of the Garvin House reveal a rafter ghost line with three cut nails positioned together at 12 feet above the first floor location, indicating a front porch was attached to this elevation. Some of the nail fasteners used to connect the missing rafters are cut nails from the mid to late 1880s. This evidence raises the question of whether the front porch was constructed at the original 1870 date or a few years after the main house was erected.

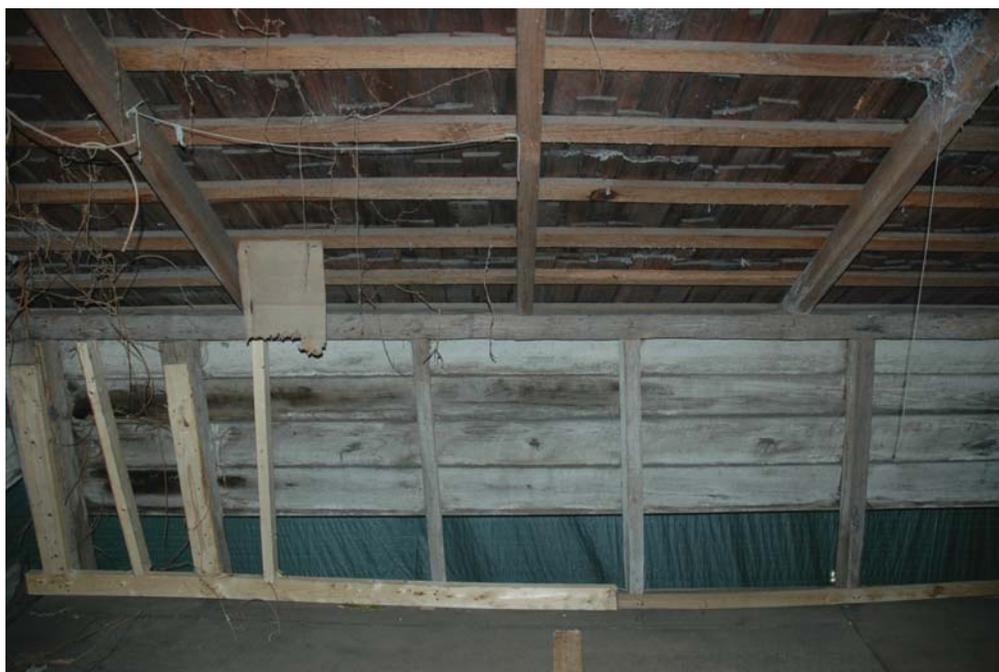
Figure 15: Interior view; Second floor space along the South Elevation wall. Note the old whitewash on the interior wall studs. It will need to be determined in the interpretation plan if the front porch was original to the 1870 construction of the Garvin House (Reference Preservation-Interpretation plan).

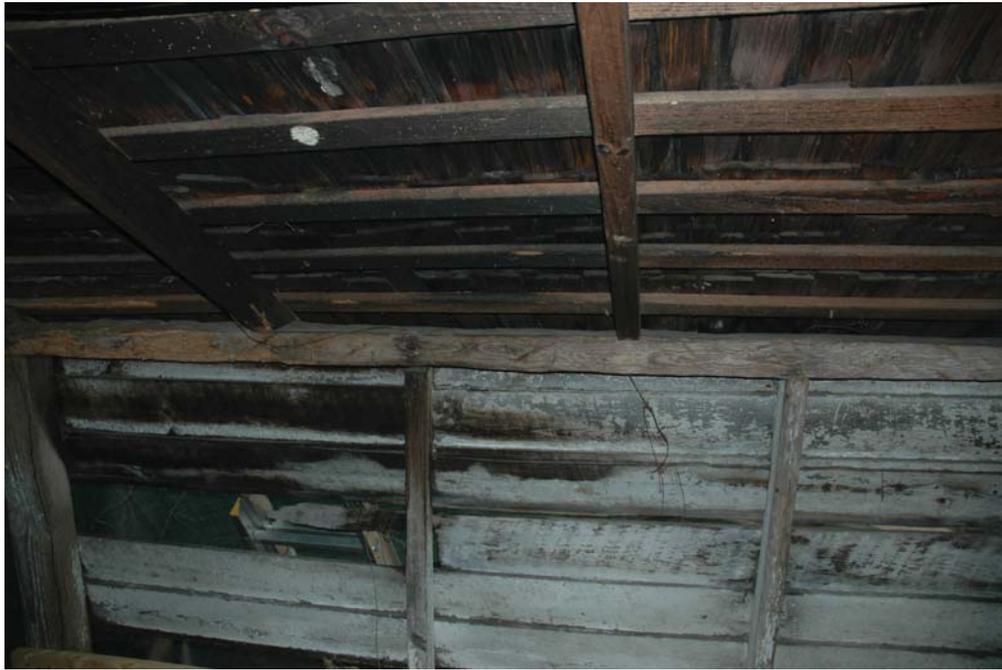
Figure 16: Interior view; Second floor space along the North Elevation. Note the continuous 4x4 top timber plate and rafter connections. Each existing 5x3 timber rafter is spaced 40" apart with 1x4 thick purlins (12" o.c.) to construct the roof system. This building style is very common in slave and Freedman structures throughout the South in the 19th century (e.g., slave cabins at Magnolia, Friendfield and McLeod Plantations; all Lowcountry cabins from 1840s to 1870s).

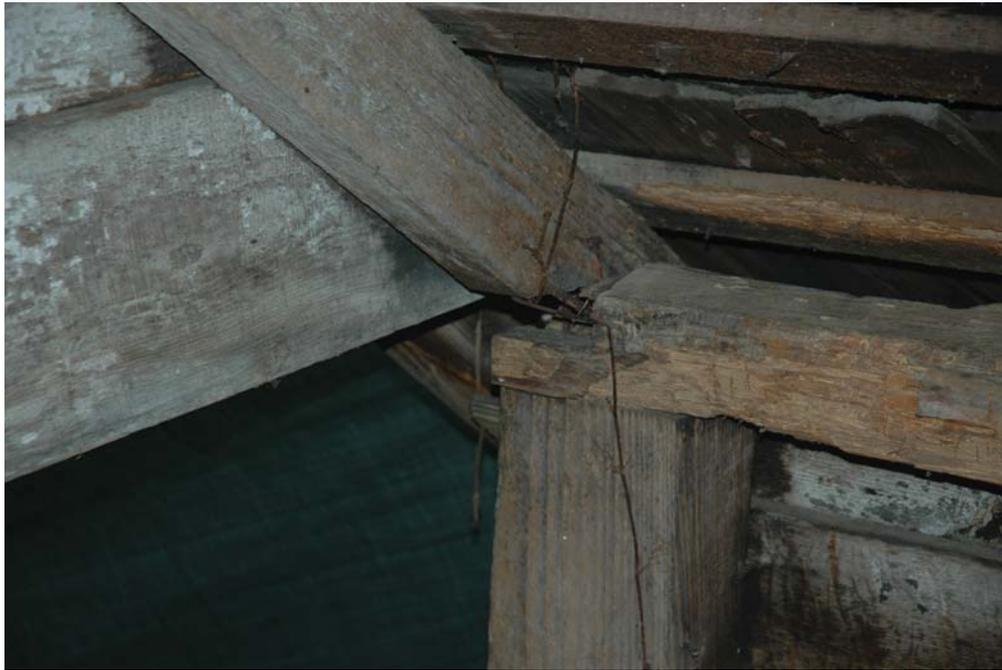
Figure 17: Interior view; Second floor wall-rafter connection at the NW corner; April 2009. The 5x3 timber rafter has a "bird mouth" cut to rest upon the wall plate (4x4 timber) and is attached with 3 1/2" cut nails on both sides of the rafter-plate connection. The 4x6 corner post is a mortise and tenon joint atop the 4x4 timber plate.

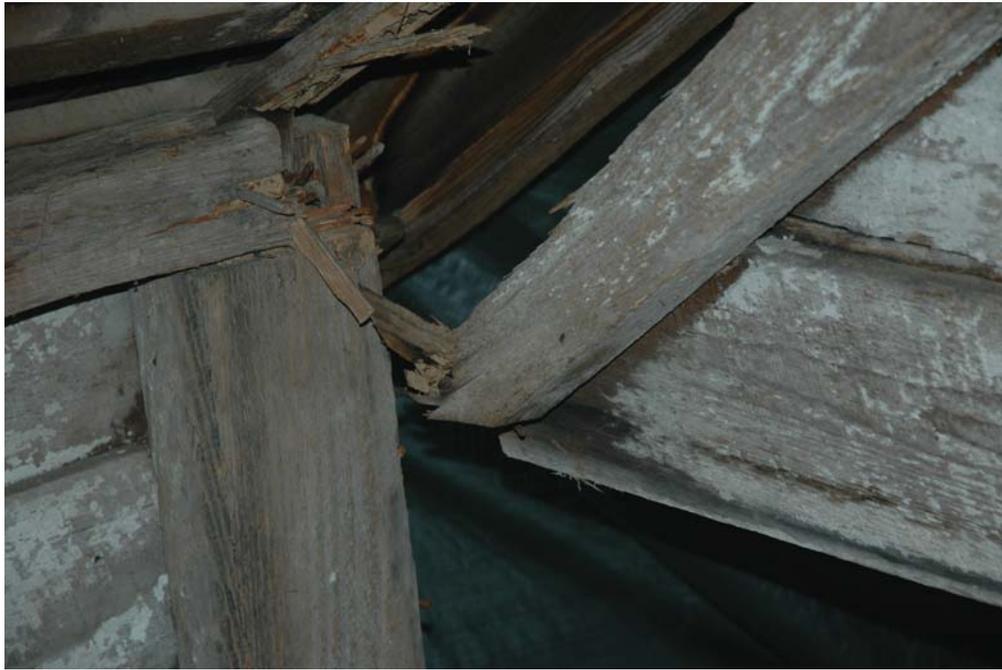
Figure 18: Interior view; Corner post-rafter connection in the SW corner; April 2009. Note the separation of the deteriorated rafter from the corner post connection. The remaining tail end of the damaged rafter is still spliced on top of the wall plate and extends 10' on the exterior side of the box cornice. This original roof member will need to be replicated and reattached to repair the end gable section of the roof system in the restoration/preservation phase of the project.

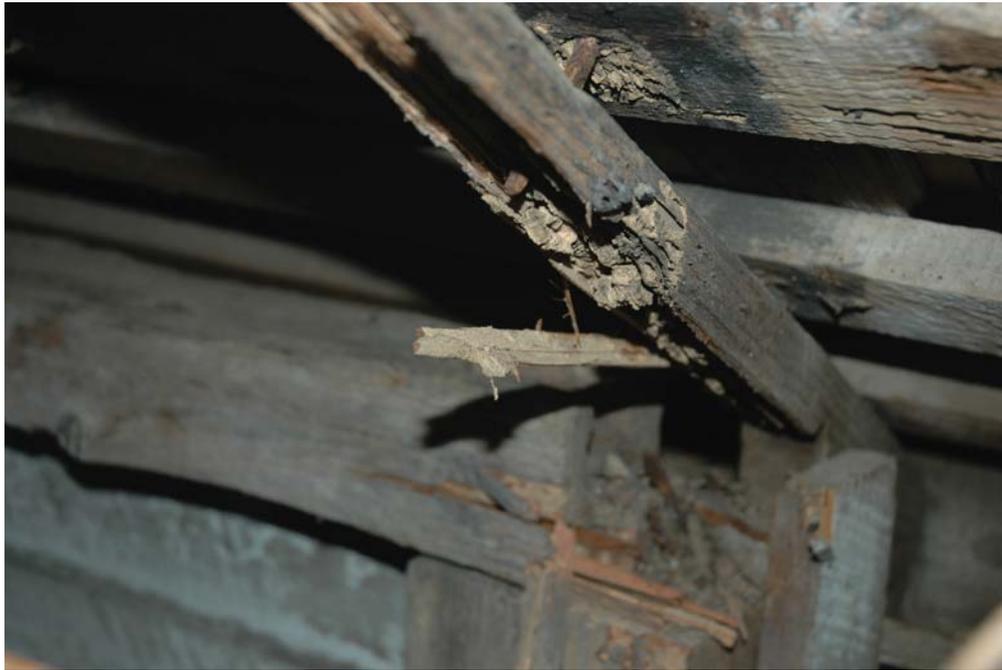
Figure 19: Interior view; Opposite side of the gable roof rafter at SW corner of the second floor (Reference Figure 16). Note the water and termite damage on this section of the gable end rafter. Notice the missing timber member (4x4) that was mortised and hewn to the SW corner. The entire first floor West Elevation wall will have to be replicated to repair this side of the building.

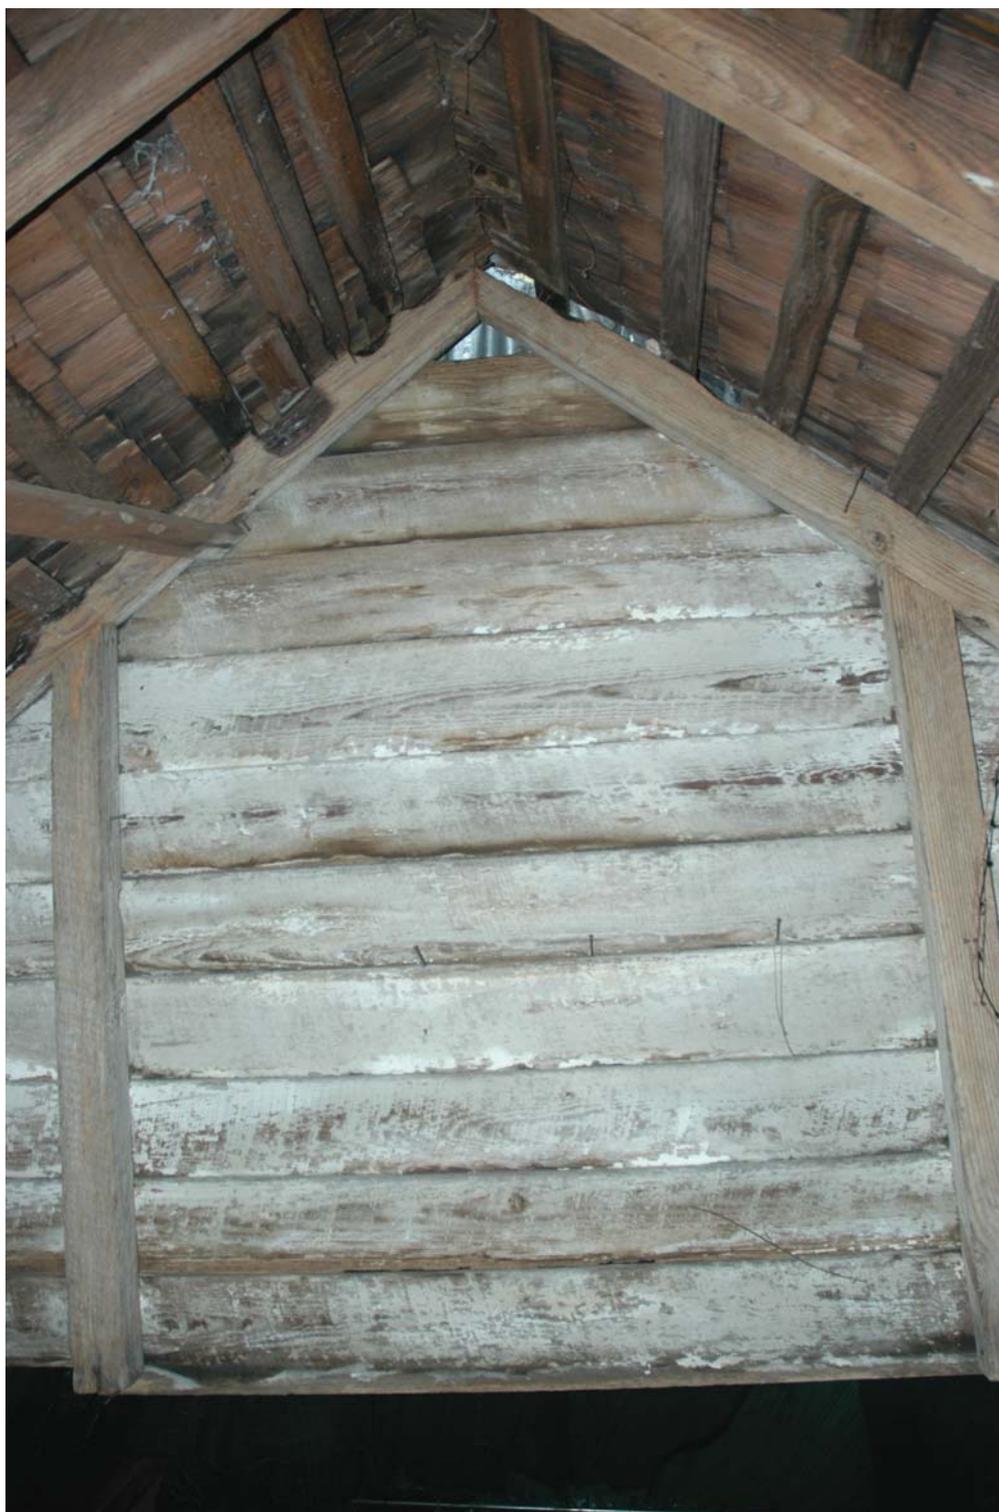
Figure 20: Interior view; Second floor, West gable end. Note the gable end 5x3 timber rafters, 4x4 timber wall studs and interior whitewash siding. Each 1x8 weatherboard shows the original saw mark impressions through the whitewash. Normally, a wall stud is positioned in the center of the gable end from the roof ridge to the next floor level in building construction (1800s time period). It is not uncommon for a Slave-Freedman building to exclude a wall stud from this section of the gable wall. (Reference: Magnolia Plantation slave cabin, Charleston; Friendfield Freedman cabin, Georgetown; Eliza Freedman House, Middleton Gardens.)

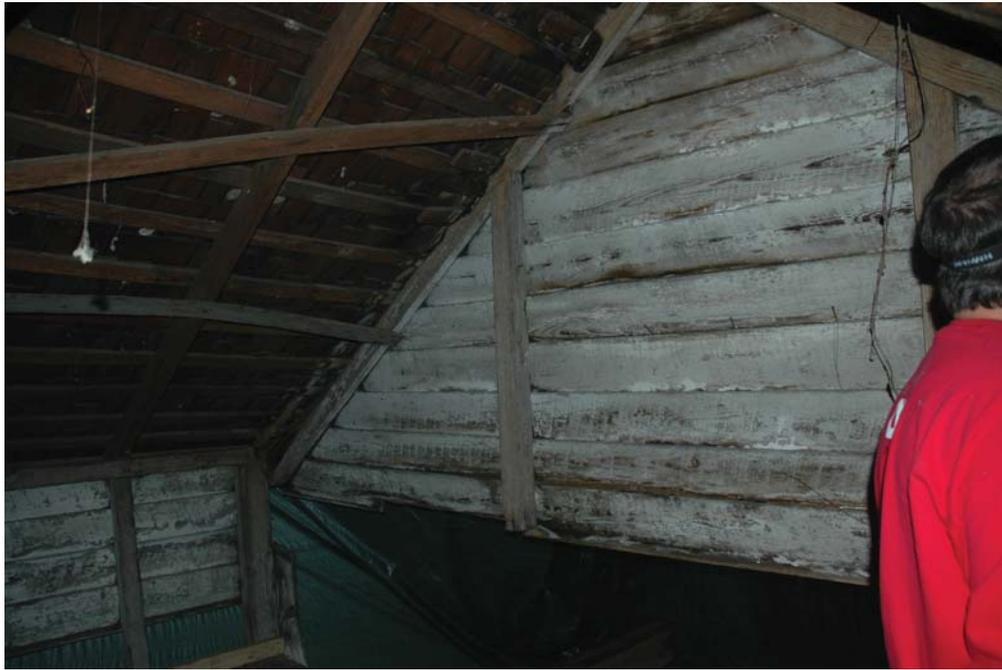
Figure 21: Interior view; SW corner of the second floor space; April 2009. Note the use of only two 4x4 wall studs to construct the gable end of the house. Another interesting construction element in this house is the 1x5 timber cross brace attached to the gable end and middle section of the South Wall Elevation. The cross brace is used to stabilize the gable end across the roof slope against wind uplift and maintain an equilibrium pull from the lateral force on each end of the house.

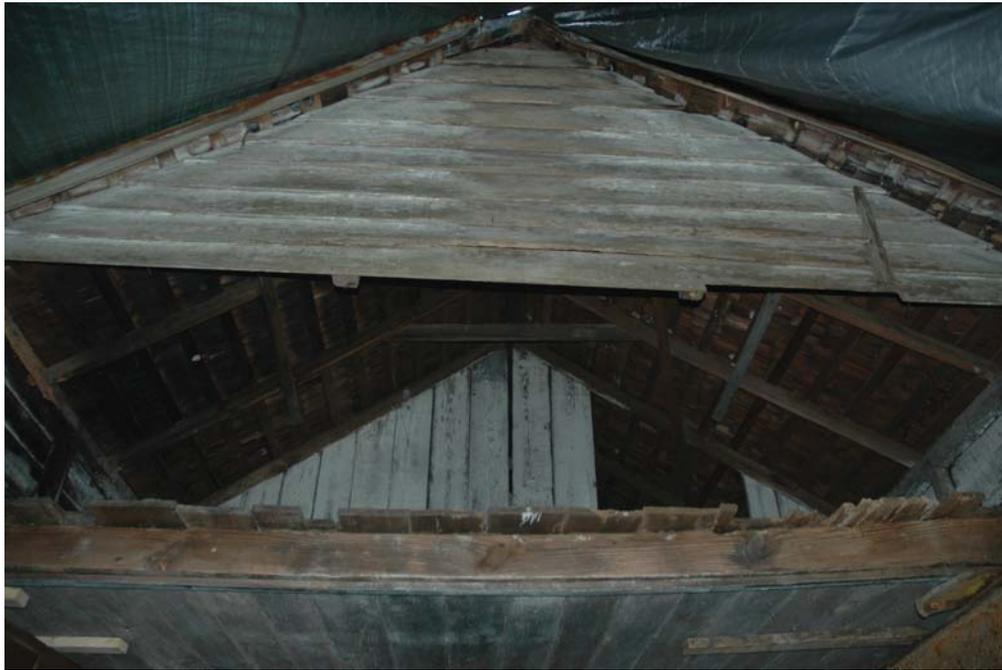
Figure 22: Exterior view; Missing West Elevation wall from the first to second floor. Sometime in the last 20 years, the west end chimney was dismantled and removed from the Garvin House site. The missing wall studs from the first and second floor suggest that two upper and lower windows were similar in size and location to the East Elevation. Holes and ghost lines in the first and second floor show the locations of the missing wall members and match the spacing of the existing wall studs on the East Elevation.

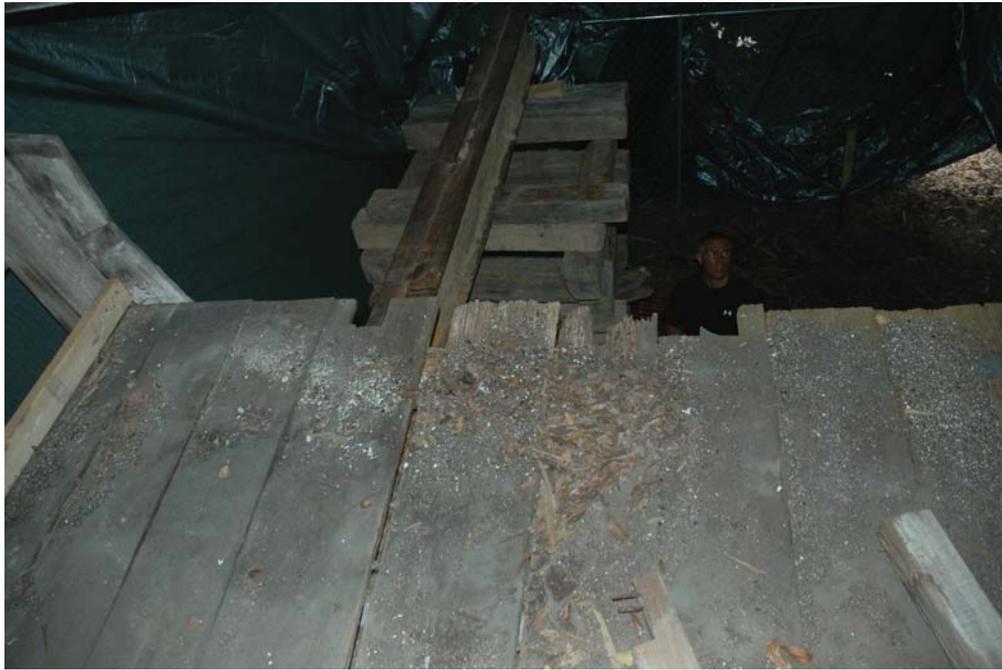
Figure 23: Interior view; Second floor boards along the missing West Elevation wall. Note the 2x4 and 6x4 cut out shapes at the edge of the second floor boards. This evidence indicates that a continuous wall stud was attached to the first floor sill to the top of the second floor wall-gable timber plate (4x4). Only the two gable wall studs and weatherboarding remains

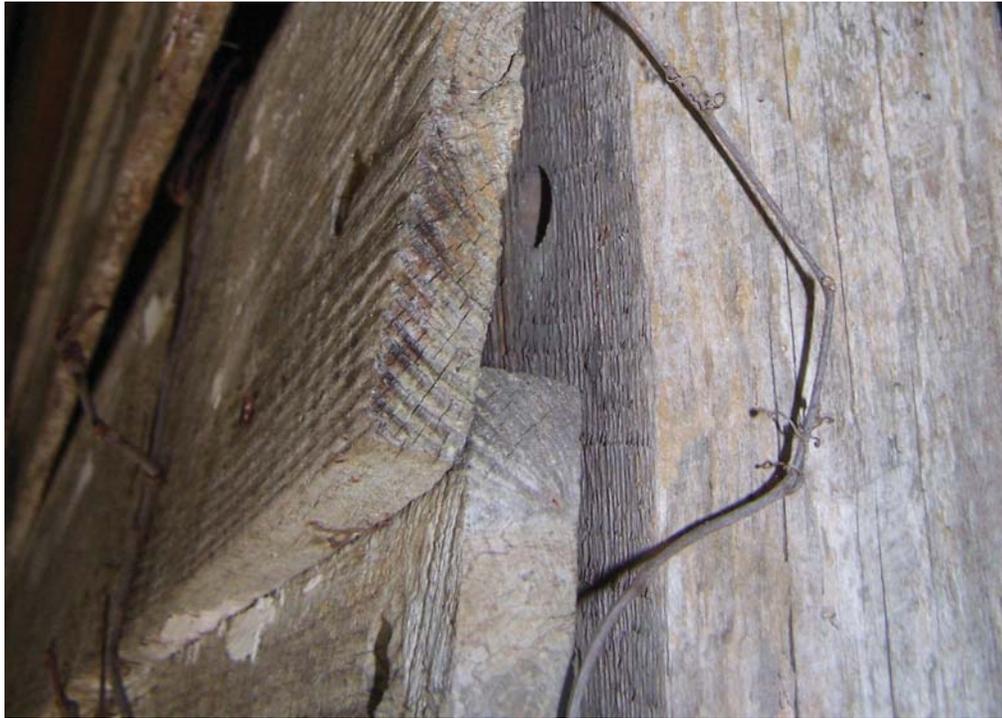
Figure 24: Exterior view, upper southeast corner, June 2009. Weatherboarding (1x8) attached to wall studs with cut nails fastened at the top and bottom average one inch over and in with a one-inch overlay on each board.

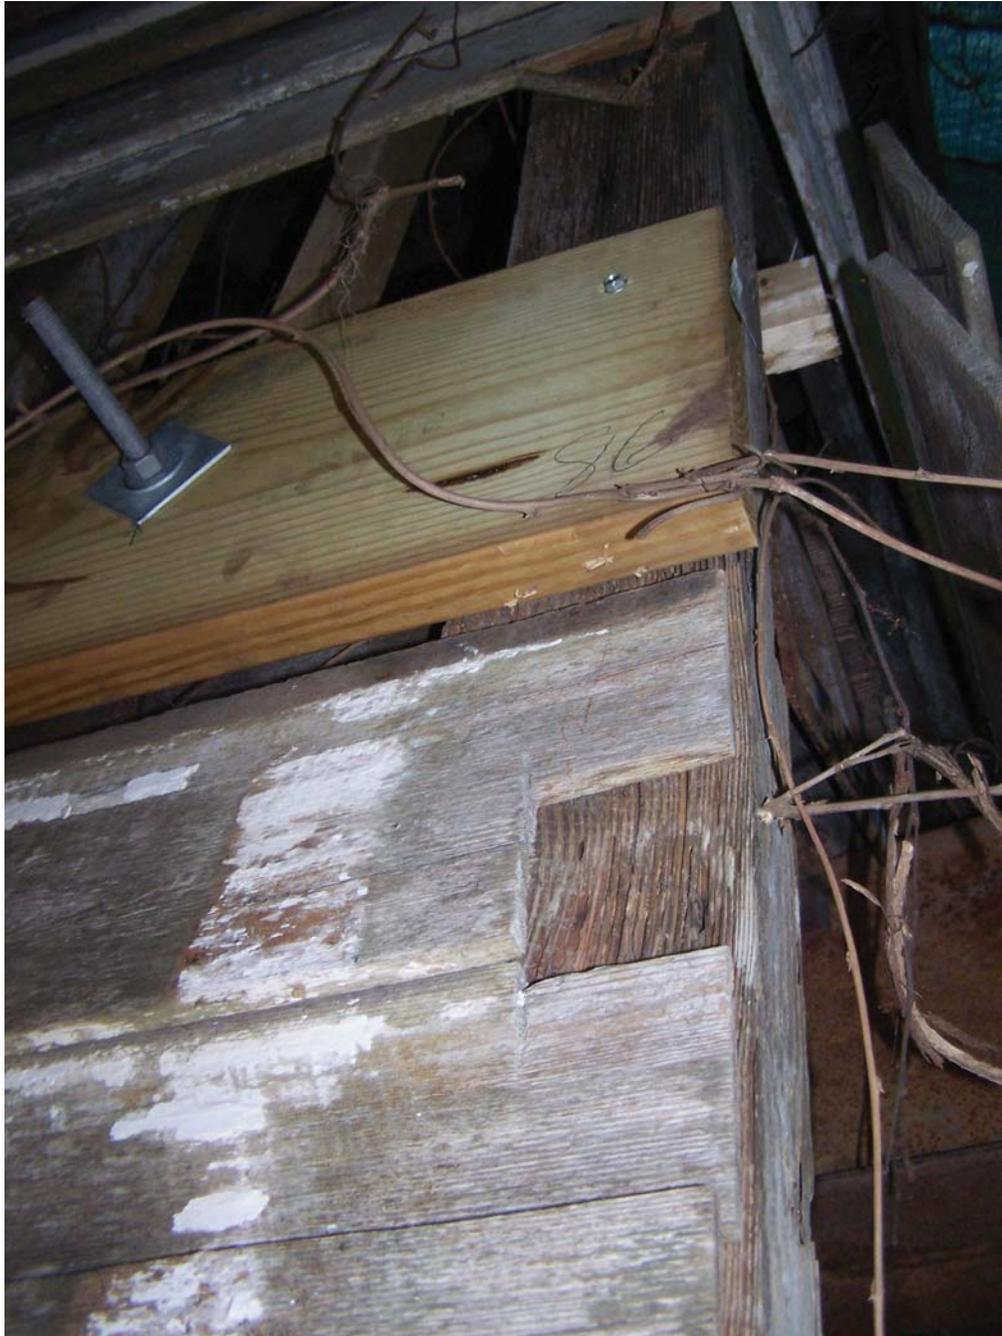
Figure 25: Exterior view, Southeast corner, June 2009. Note the attached 2x10 reinforcement lumber to square the building. Just below this board is a 4x4 cut section of siding on the corner. This represents the original missing cross support timber to the south porch elevation (located 4 feet below the roof soffit).
