The Garvin House: A Preservation & Interpretation Plan For An 1870 Freedman's Home

Prepared for the Town of Bluffton, South Carolina
By

July 15, 2009

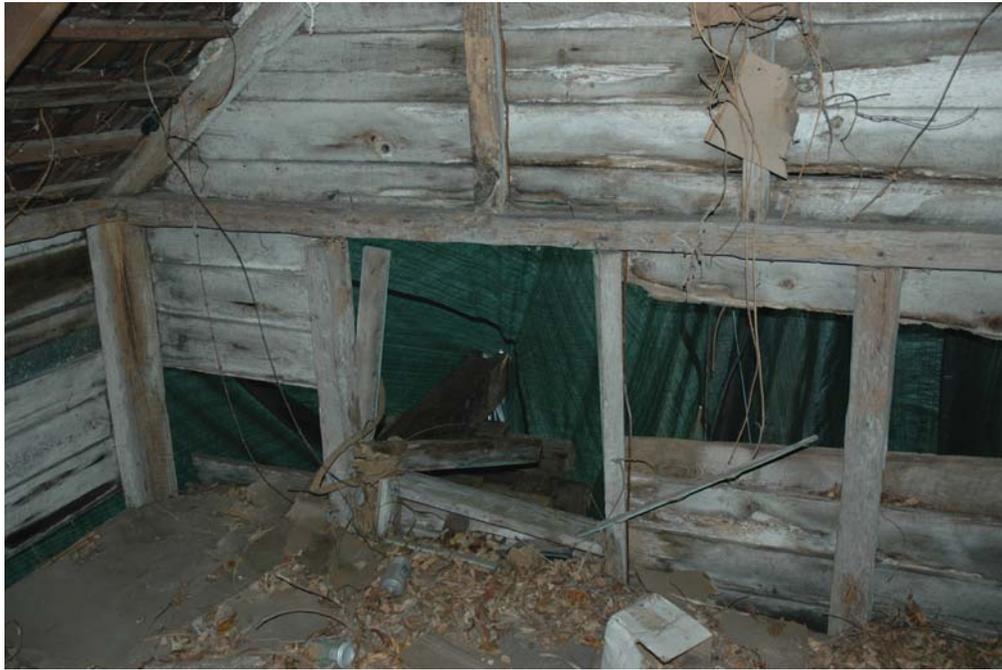
Figure 26: Interior view; Window opening on the second floor space along the East Elevation. Note the location of the windowsill about 4 inches above the second floor (unique to the SC Lowcountry Freedman's house).

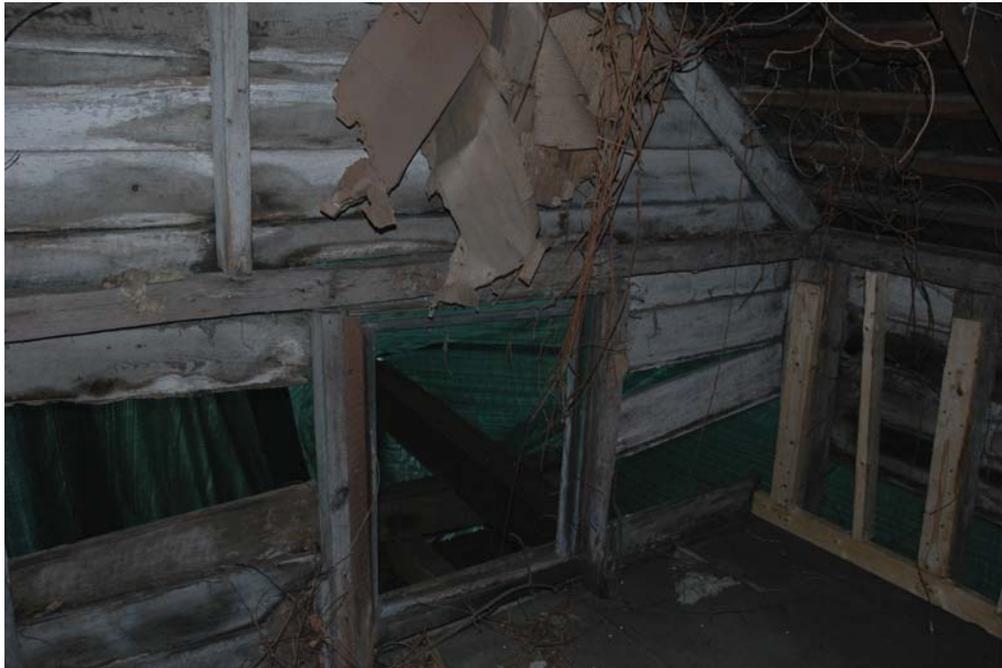
Figure 27: Interior view; Second floor area along the Southeast corner. Note how intact the upper window opening is compared to the window in Figure 22. Most of the original sill, framing, and trim (both interior and exterior) are extant. This window location will become the primary example for replicating all the second floor window trim and features.

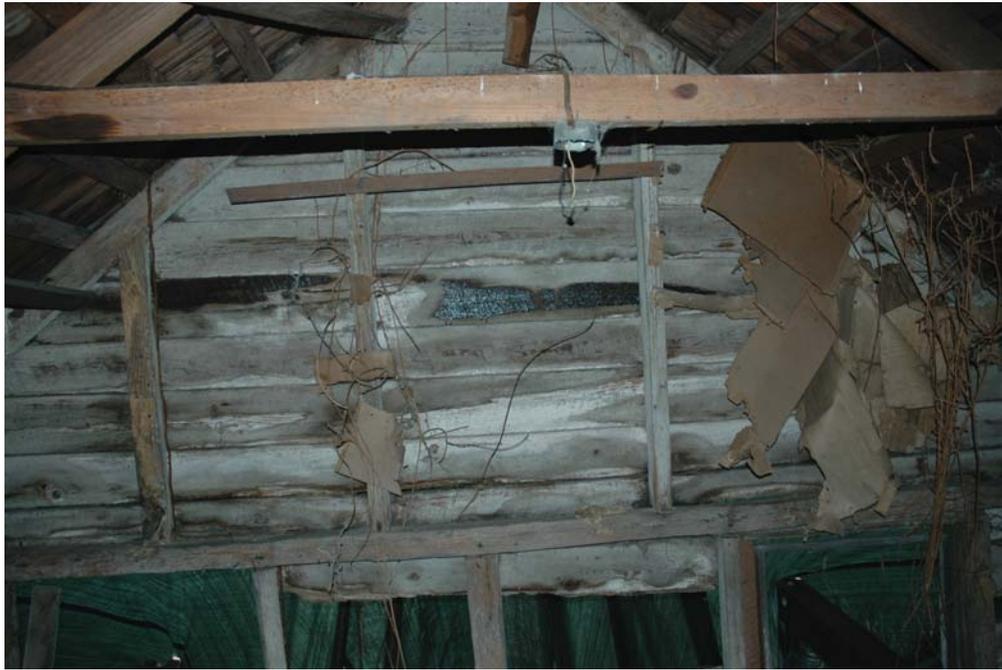
Figure 28: Interior view; Second floor gable end along East Elevation. Note the original interior whitewash from top to bottom area around the window. The cardboard appears to have been attached to the walls as insulation and/or wallpaper around the 1940s-1950s when the metal corrugated roof was installed over the wood shingles.

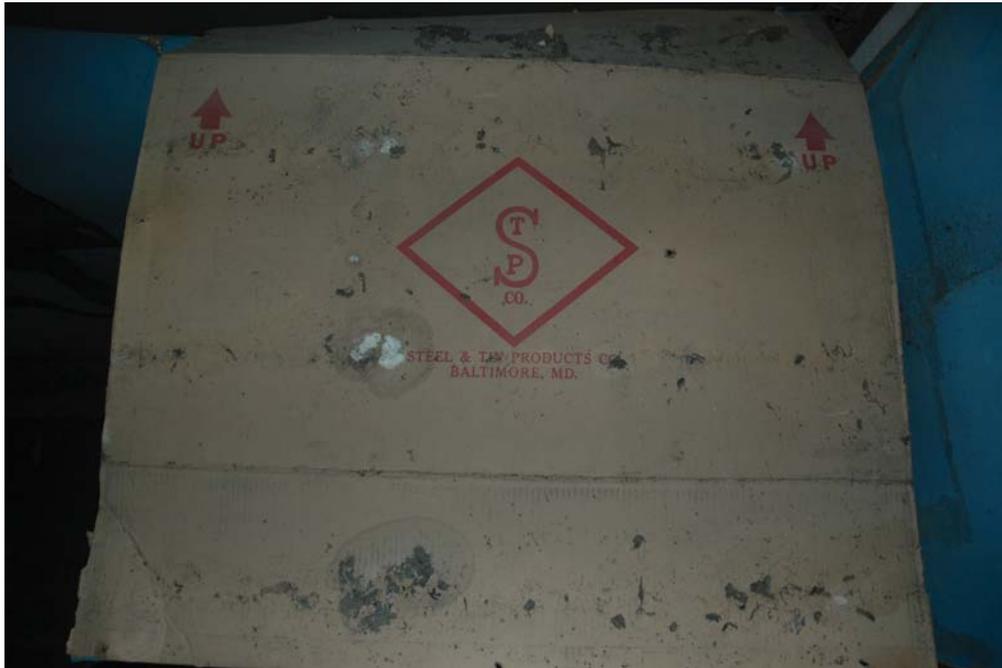
Figure 29: Interior view of old cardboard on the first floor area along the East Elevation; April 2009. Note the Steel & Tin product symbol on the cardboard box. Many different paper materials were used as insulation or wallpaper in the early to mid 1900s (Ex: Magnolia Plantation slave cabin B, Friendfield Freedman Cabin, or McLeod slave cabins, Charleston).

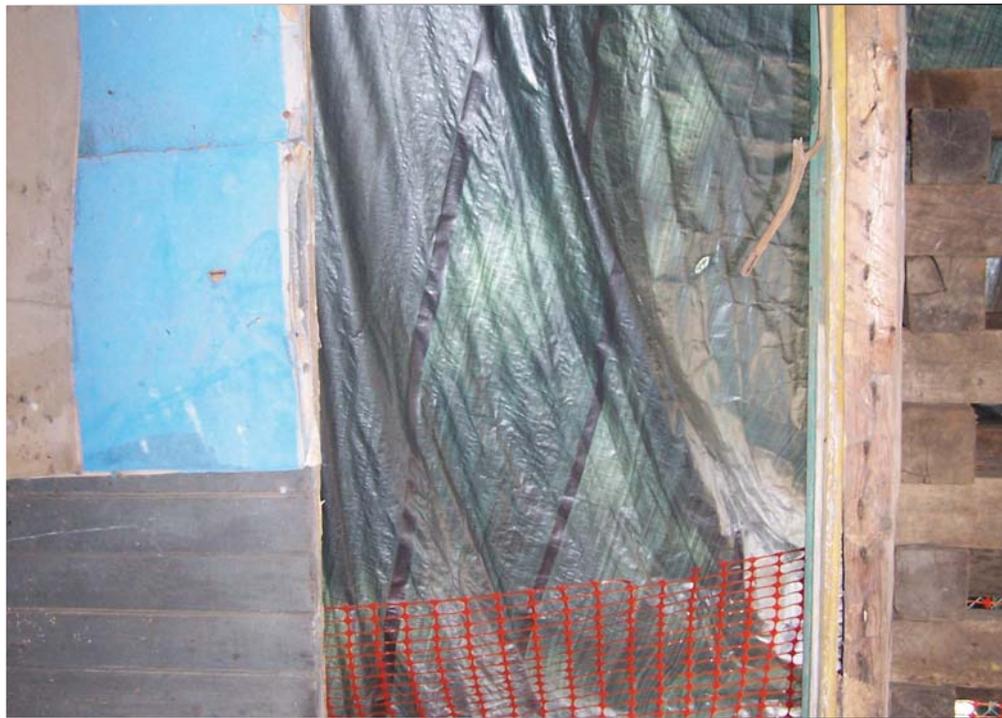
Figure 31: Interior view, first floor east window elevation, June 2009. Note how the horizontal wall boards have been covered over with two layers of cardboard insulation and painted blue (attached 1950s).

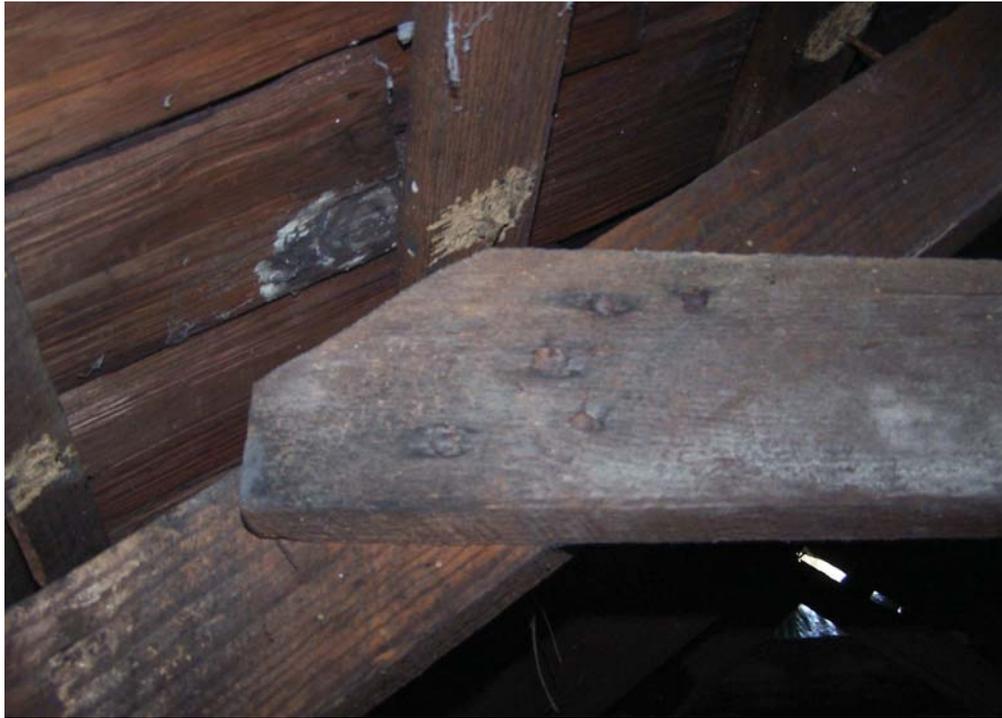
Figure 32: Interior view, second floor roof area, June 2009. Every 3rd roof rafter is secured with a cross tie (2x6) timber member – average 5 to 6 cut nail fasteners per connection.

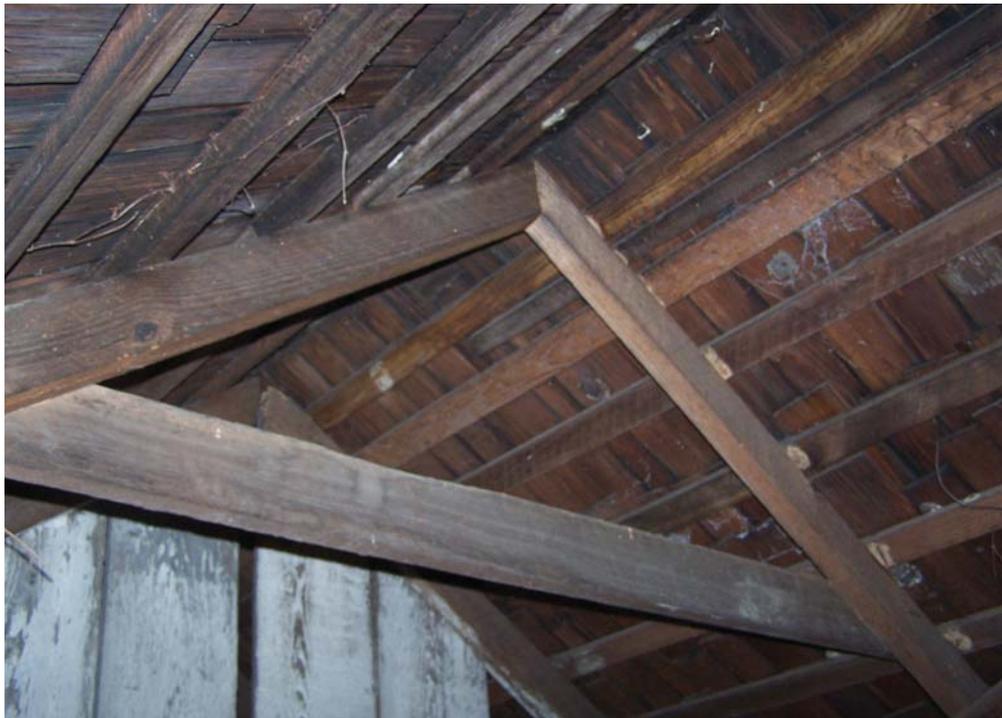
Figures 33: Interior view, second floor roof area, June 2009. Each roof purlin (runner) is a 2x4 sawn cut board spaced one foot apart on average.

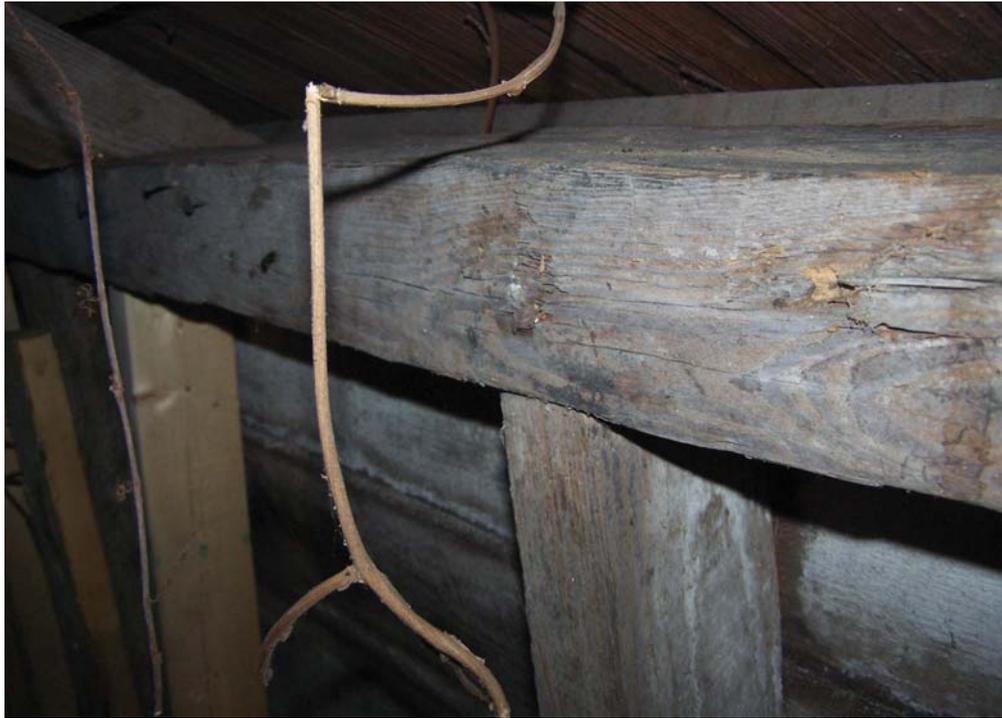
Figure 34: Interior view, second floor area, June 2009. Note the continuous top wall plate (4x6 hand hewn timber) and how each wall stud is attached with a mortise and tenon connection. A large 6" spike fastener is driven at the top of the wall member and another 4" wrought iron spike is fastened on other second floor wall studs at the top connection.

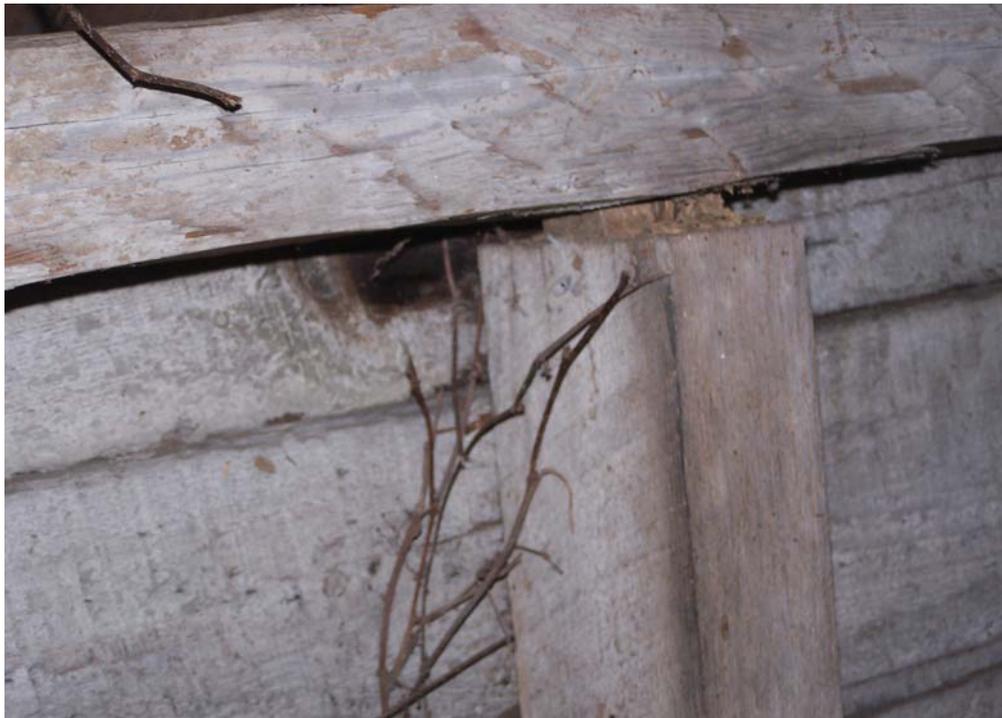
Figure 35: Interior view, second floor area, June 2009. Detail view of the mortise and tenon connection.

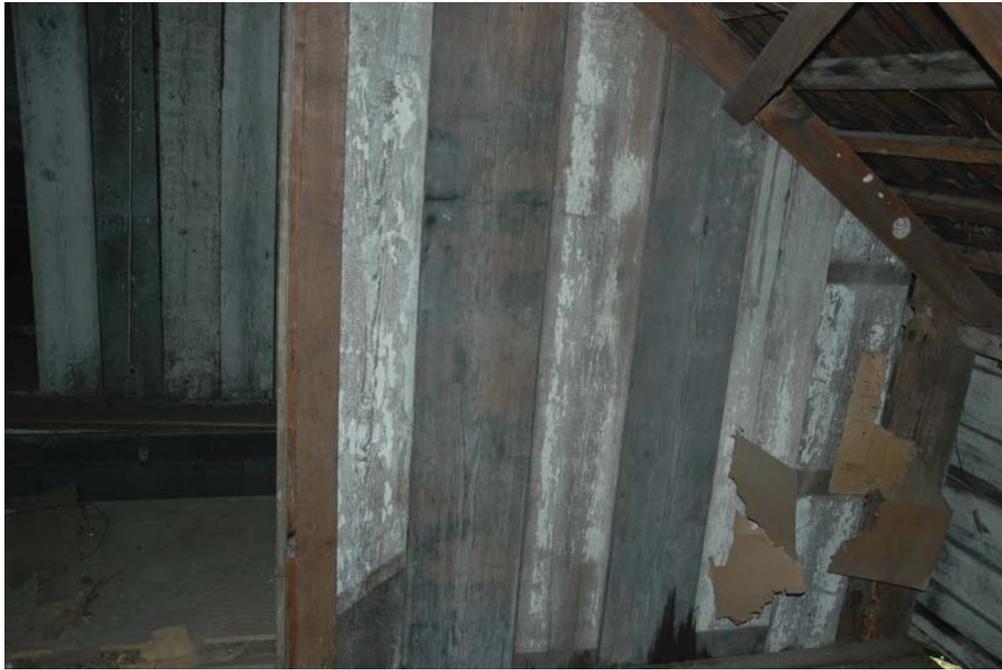
Figure 36: Interior view; Second floor partition wall between the stair access and west end bedroom. Note the width and thickness of each wall board (matches the existing first floor ceiling and floor boards – 8 to 10 inches wide). Some of the original mid-1900s cardboard is still attached to the wall surface. In the Interpretation plan, the second floor will be stabilized and preserved to help visitors understand what it was like for the Garvin family to live in an un-insulated house with no electricity or running water.

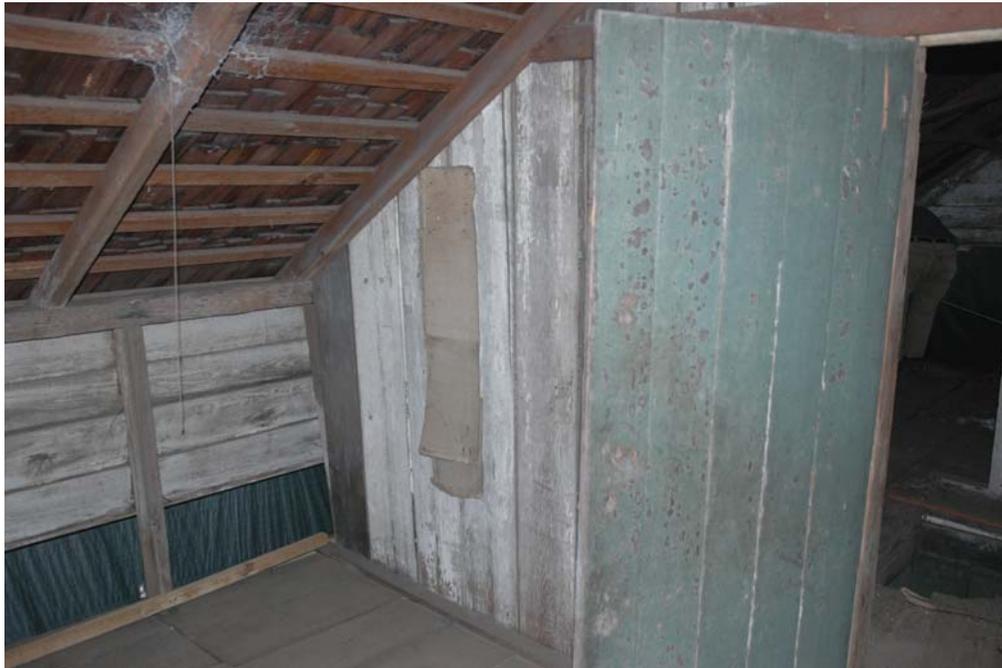
Figure 37: Interior view; Second floor partition wall and door opposite of the stair access in the east end bedroom. Note the original board and batten door painted an off-greenish blue color. The hardware currently on the door appears to have been installed around the 1920s. The original hinges to this style of door would have been strap or pin hinge (Reference Hardware Notes).

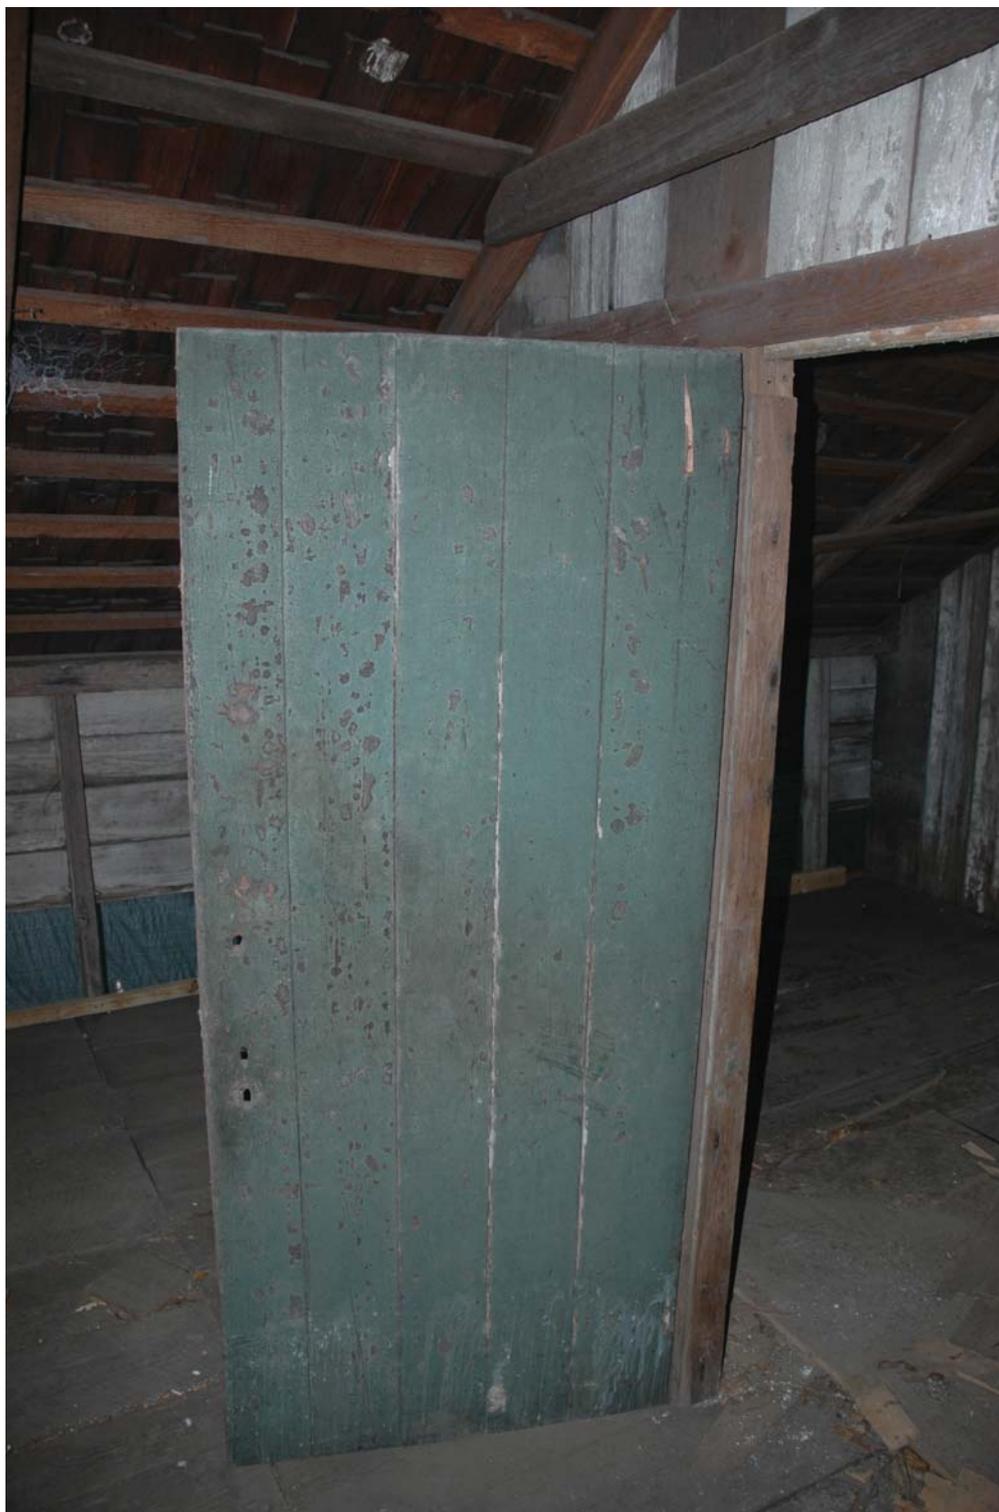
Figure 38: Interior view; Second floor door from the staircase to the east bedroom. This board and batten door may or may not be original to the 1870 construction date. Note the missing door handle hardware. The three holes left on the door might indicate an old wrought iron handle-door latch. This style of hardware was commonly used throughout the mid to late 1800s (Reference Hardware notes).

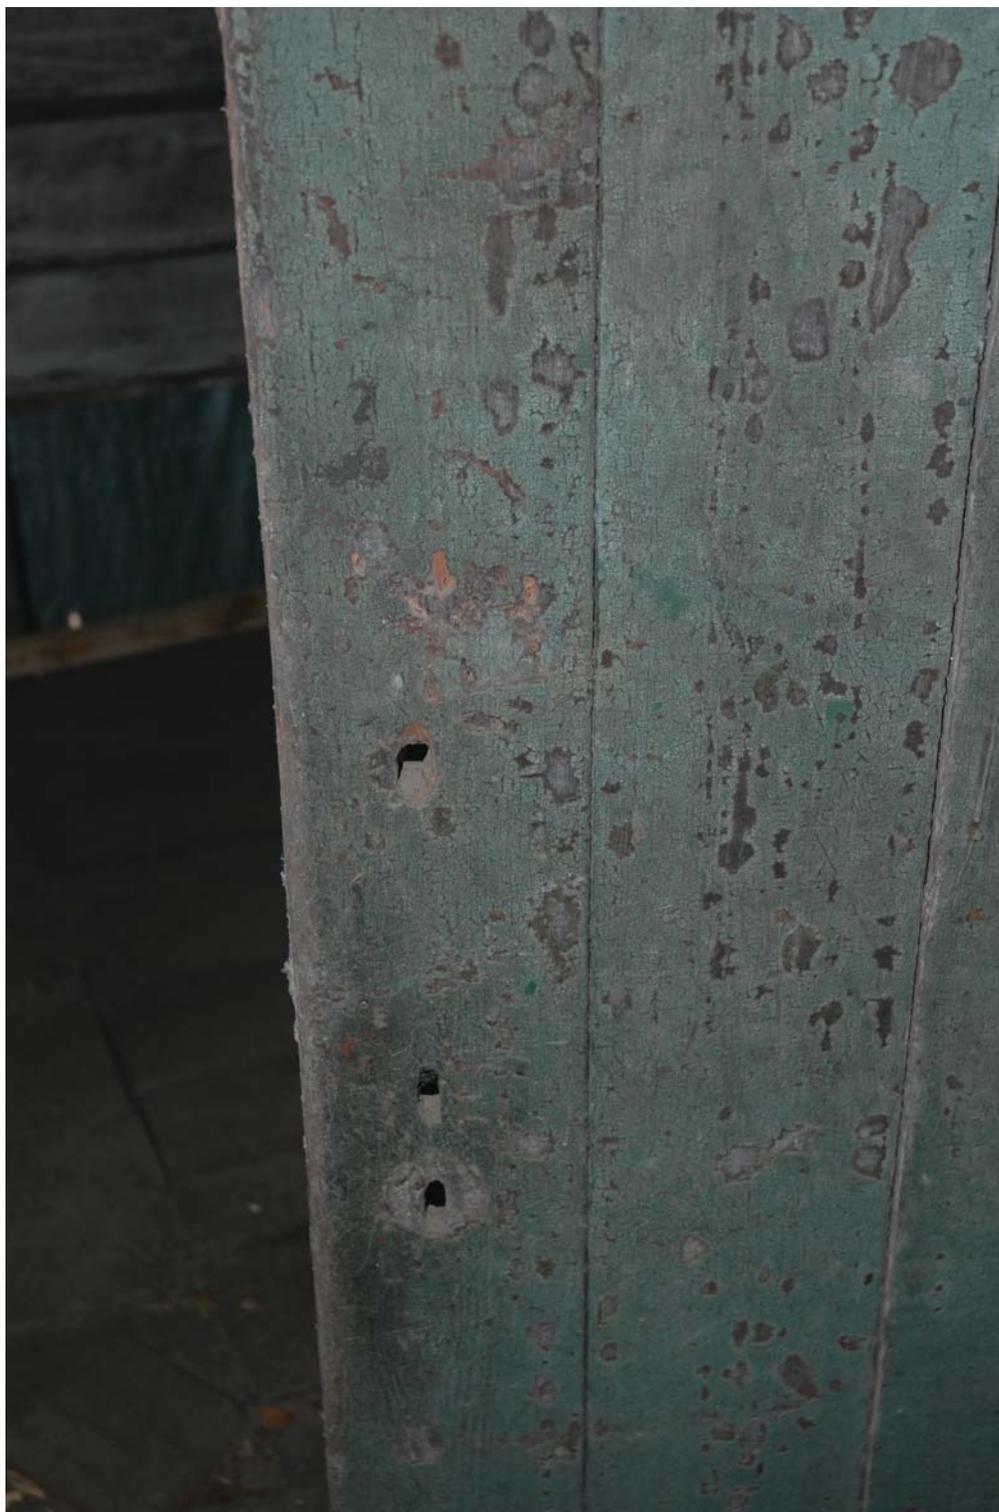
Figure 39: Interior view; Second floor door from the staircase to the east bedroom. Detail view of the door where the missing hardware was located.

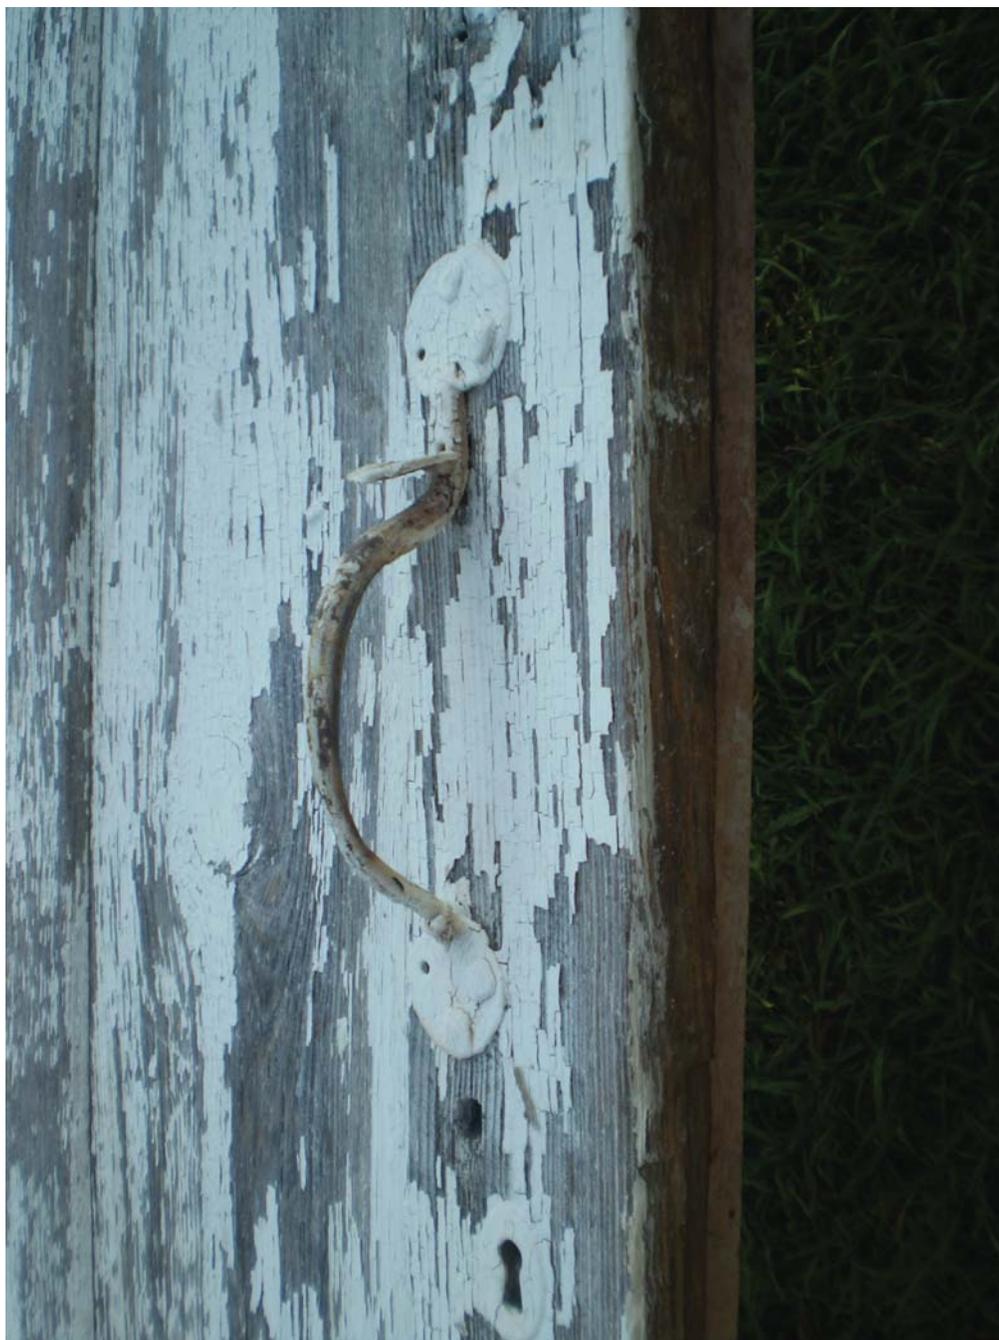
Figure 40: Example photo of old wrought iron handle-door latch from a slave kitchen in York County. This handle would have had two holes in the door about the same distance like the second floor door at the Garvin house and the third hole would have been for a keyhole for a lock box on the interior side of the door.

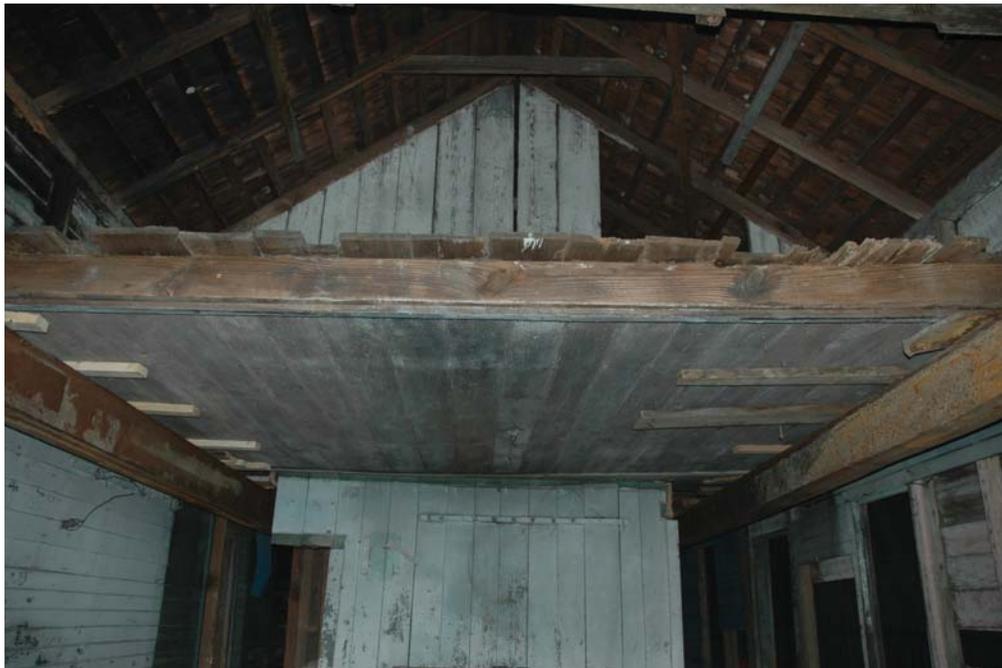
Figure 42: Exterior view of the 1 ½ story structure from the West Elevation looking inside. During stabilization planning, the remaining first floor wall and siding were removed. The west elevation chimney had been dismantled and removed from the site some years ago (1990s). Note the different building components of the house. Wood shingles attached to the 1x5 purlins upon 3x6 timber rafters resting on a 4x4 wall plate with 4x4 and 2x4 wood studs stretching from the first to second floor. The second floor system is made up of 1x8 floorboards upon 2x6 floor joists and also has 1x8 ceiling boards attached to the underside of the joist. The remaining sections of the interior are the partition wall (1x8 vertical boards) and first floor system (1x8 floor boards and 2x6 floor joist – spanning 16 ft).

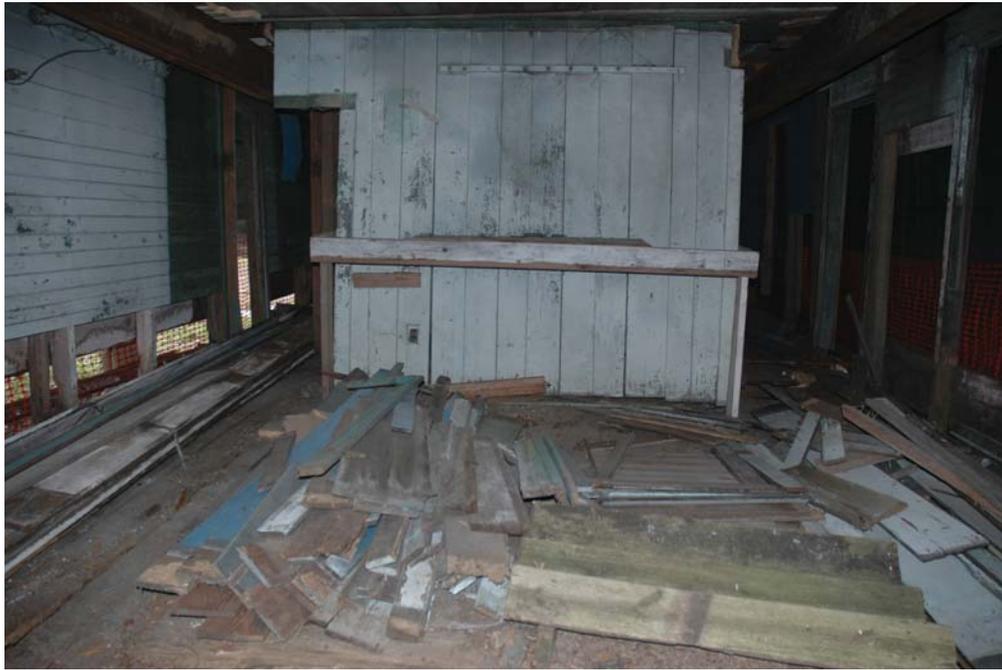
Figure 43: Interior view; Original kitchen space, first floor; April 2009. Note the stack of wood on the floor from the exterior wall elevation. The interior wall boards appear to be installed from a later date since the wall studs and interior side of the weatherboards are whitewashed like the vertical partition walls that separate the hallway and parlor space.

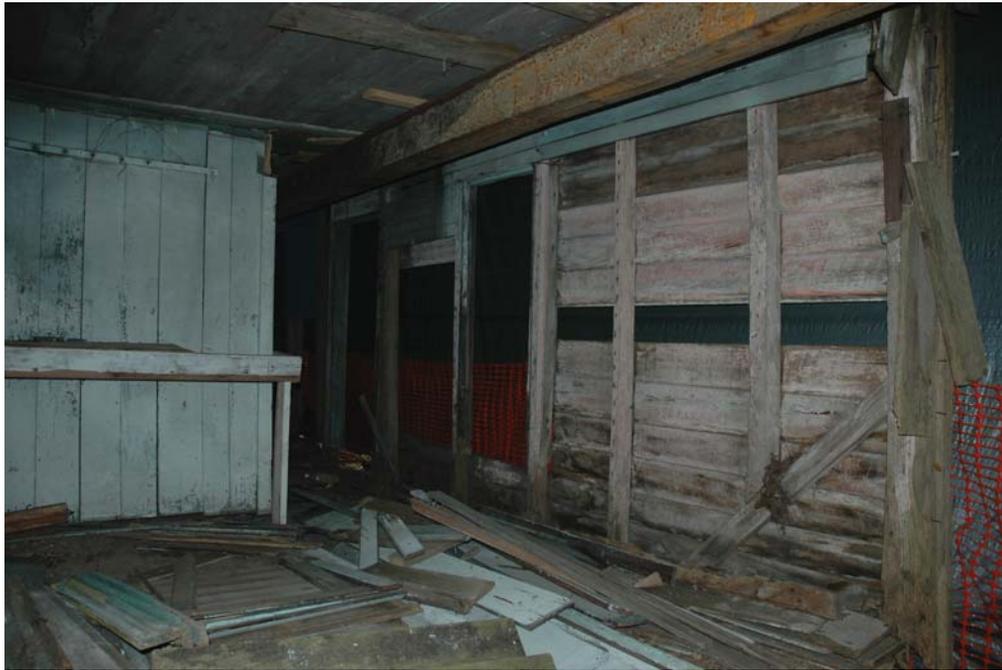
Figure 44: Interior view; First floor wall along the South Elevation. Note the interior horizontal wall boards have been removed to expose the original whitewash on the wall studs and weatherboarding. The feature is noted on all interior wall surfaces. The horizontal wall boards appear to have been installed around the late 1890s. Evidence of 2 ½" cut nails is present on the wall studs on the first floor.

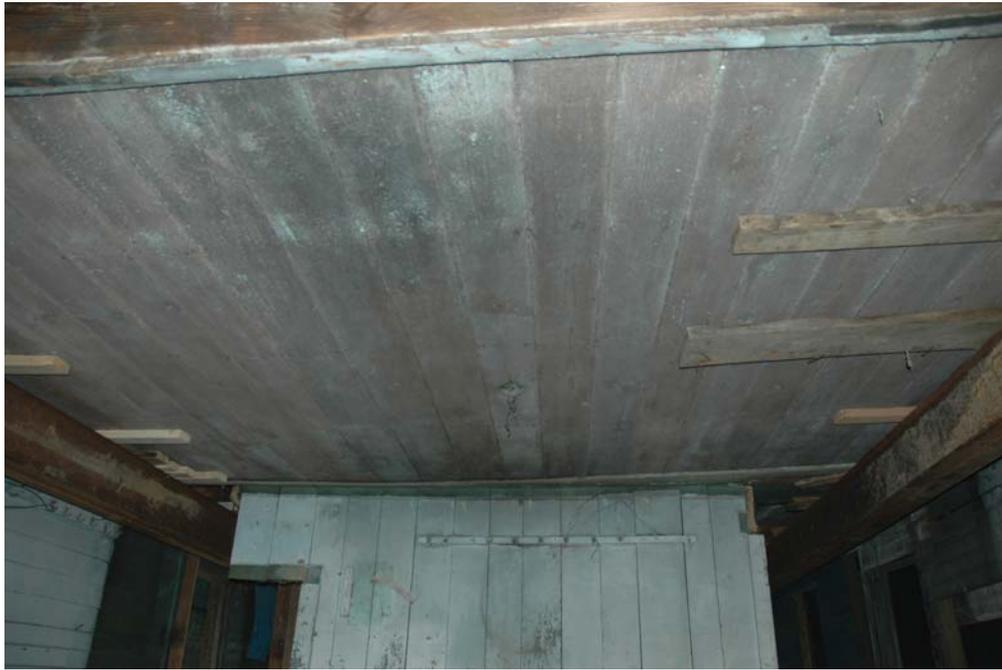
Figure 45: Interior view; First floor kitchen board ceiling; April 2009. By removing a small board from the kitchen ceiling, the original whitewash stains can be seen on the ceiling joist. This proves that the existing ceiling boards were installed at a later date probably around the 1890's to 1900. Many Freedman homes were modified and renovated as building materials became more available and affordable in the south at the end of the 19th century.

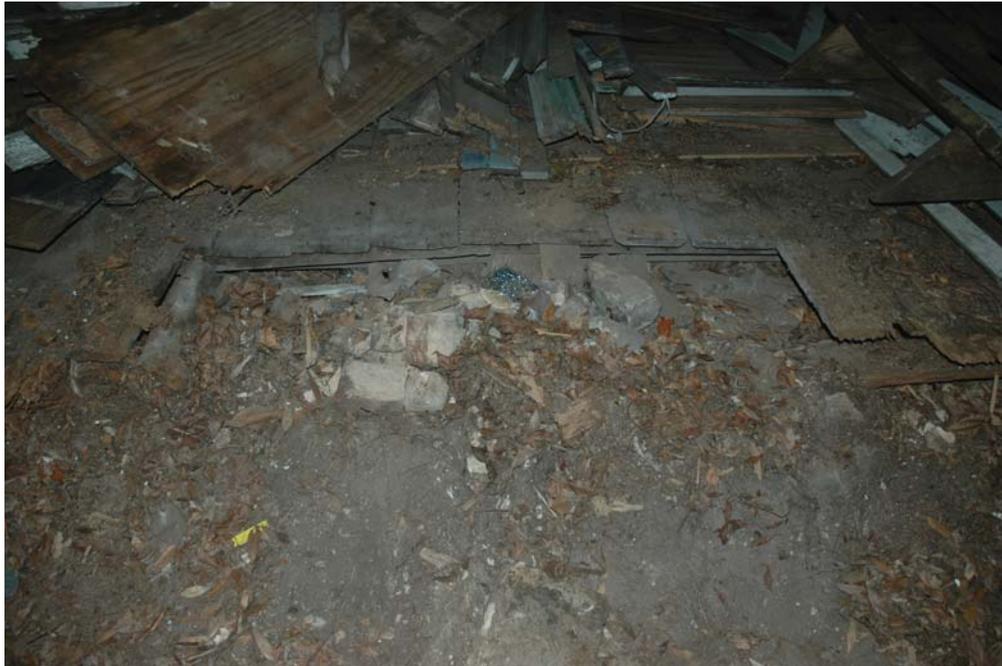
Figure 46: Exterior view of the missing chimney hearth and foundation along the West Elevation. Note that only a few bricks remain in the 5ft x 3ft outline of the old chimney hearth. Normally an earthwork of soil and bricks would be compacted around this section of the building to form the hearth, firebox and exterior brick foundation of the chimney. The floorboards would be positioned up to the brick line hearth and all the cooking would be done at this end of the house. The kitchen in a Freedman's house would have served as the dining room, gathering room and heat source during the winter months (Reference Interpretation plan – everyday life from slavery to Freedman).

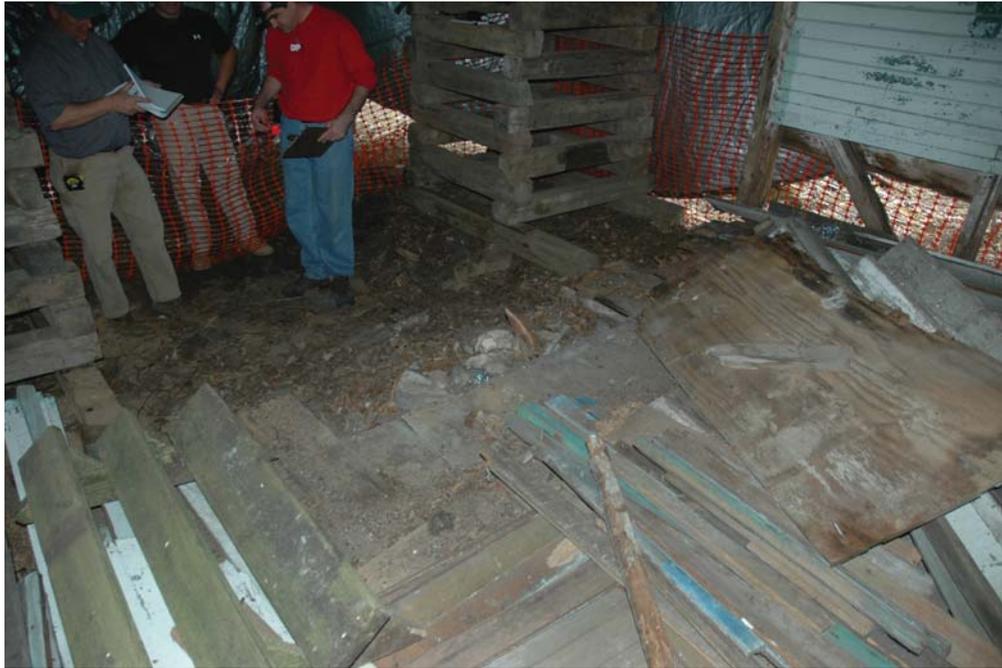
Figure 47: Interior view; Missing chimney hearth from inside the old kitchen room; West Elevation. Note all the missing wall sections on the kitchen floor from the first floor wall system – west elevation. To stabilize and preserve this section of the Garvin House, the existing floor system will be repaired and lifted back up to a 16 to 18 inch crawlspace height above the ground. The whole first and second floor wall system on the west elevation will need to be reconstructed with original and new replicated wall timber. The chimney foundation and hearth will then be reconstructed to close up this side of the building. Having the steel beams in place, the constructor can lift the existing building another 3 feet to start the foundation work around the perimeter of the building and install concrete footings to rest the new sill and floor system upon.

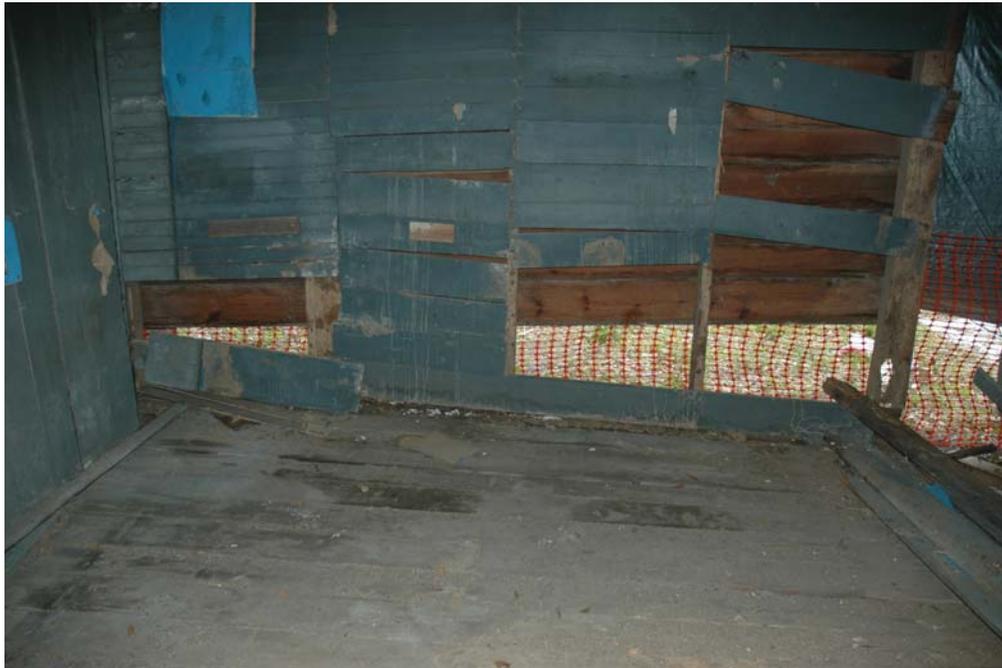
Figure 48 Interior view; Parlor room facing the NE corner; April 2009. Note no whitewash on the exposed interior side of the weatherboarding. This indicates that the interior horizontal wallboards are original to the 1870 construction. The 1x8 horizontal boards match the profile of the floorboards on the first and second floors. The windows located on the first floor are 2 feet taller than the second floor windows. It is interesting that the horizontal boards on the first floor wall span only the distance between each wall stud. This might indicate that interior boards were recycled from a shipping warehouse for crating and boxing up goods in the Bluffton-Hilton Head settlements.

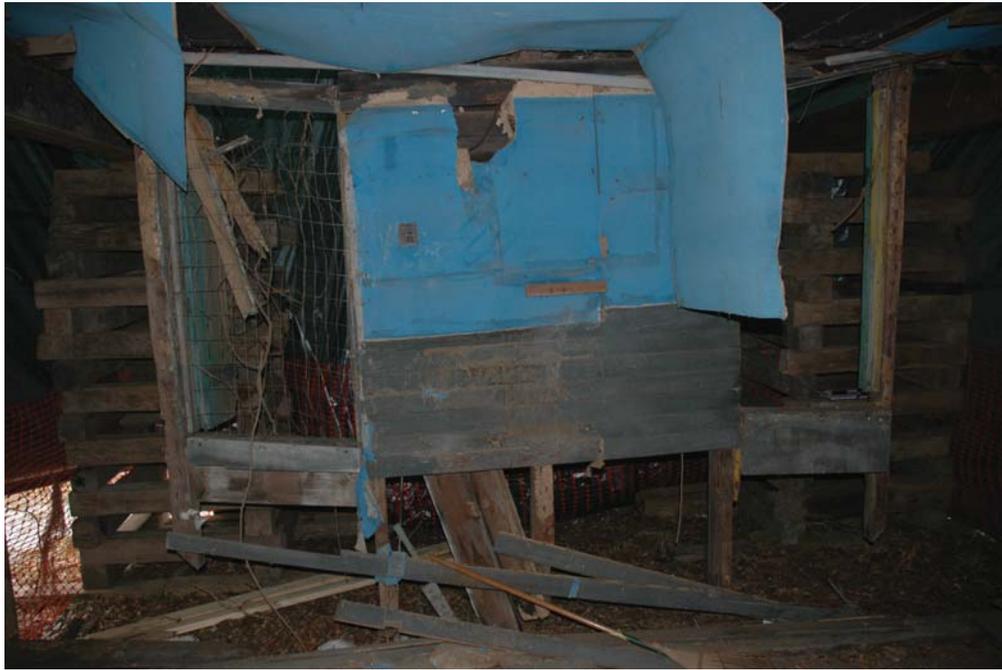
Figure 49: Interior view; First floor window along the East Elevation. Both window openings are in fair to poor condition. Some window trim still exists and will be useful to replicate and restore both windows in the next phase of the project. The existing cardboard attached to the interior wall and ceiling was used as wallpaper some time in the late 1940s to early 1950s. The indigo blue color painted on the cardboard must have made this room very bright.

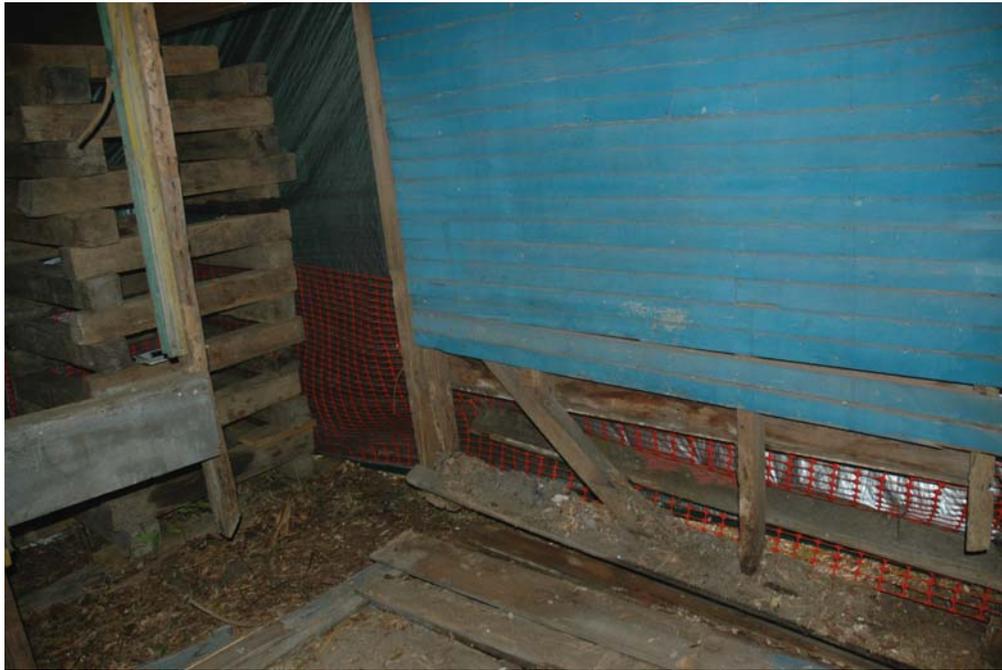
Figure 50: Interior view; First floor looking at the SE corner. Note the indigo blue paint on the interior wall. The horizontal boards appear to have been installed at a later date than the original 1870 construction. The parlor room appears have been modified three to four different times over the last 140 years.

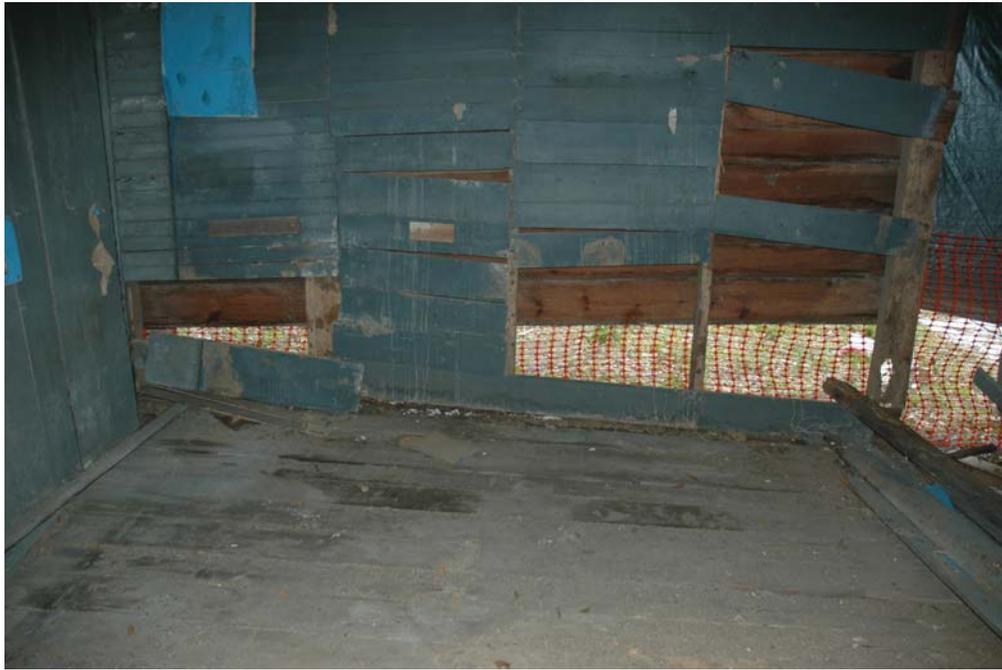
Figure 51: Interior view; North wall of the parlor room. Three different types of horizontal wall boards can be seen on this wall. Also noted are three different paint colors on the same wall. Each paint color indicates a different renovation to the parlor from 1870 to the 1940s.

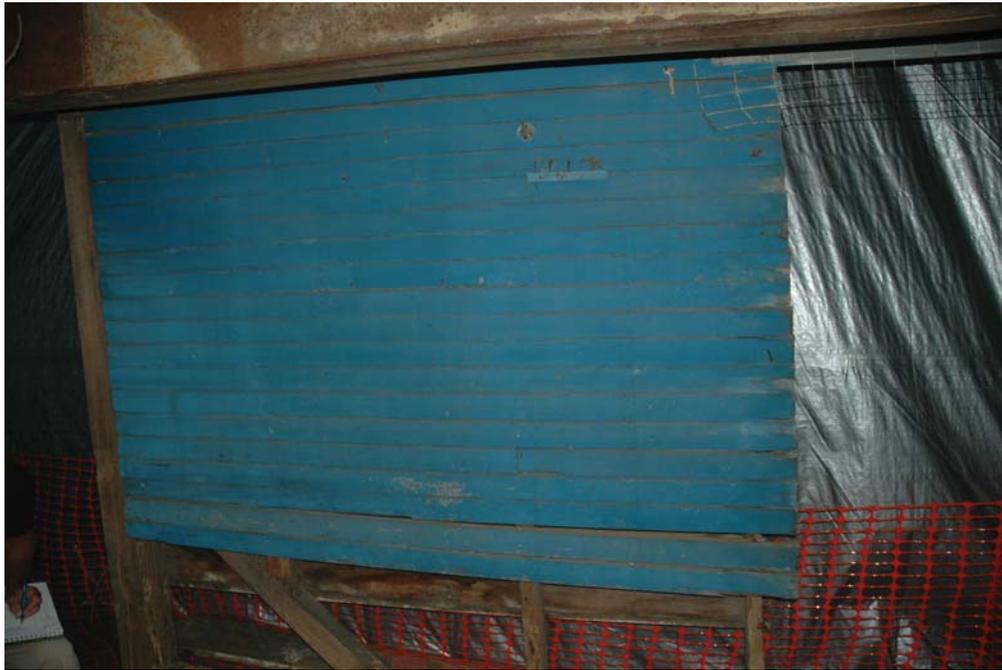
Figure 52: Interior view; Exposed wall timber along the South Elevation; April 2009. Each wall section starts with a 4x6 corner post and cross knee brace to square up each corner of the house. Because each first floor sill is missing due to rot and termite damage, every wall stud and brace will need to be repaired to reattach the wall system to the new floor sill (Reference timber frame examples).
