The Garvin House: A Preservation & Interpretation Plan For An 1870 Freedman's Home

Prepared for the Town of Bluffton, South Carolina
By

July 15, 2009

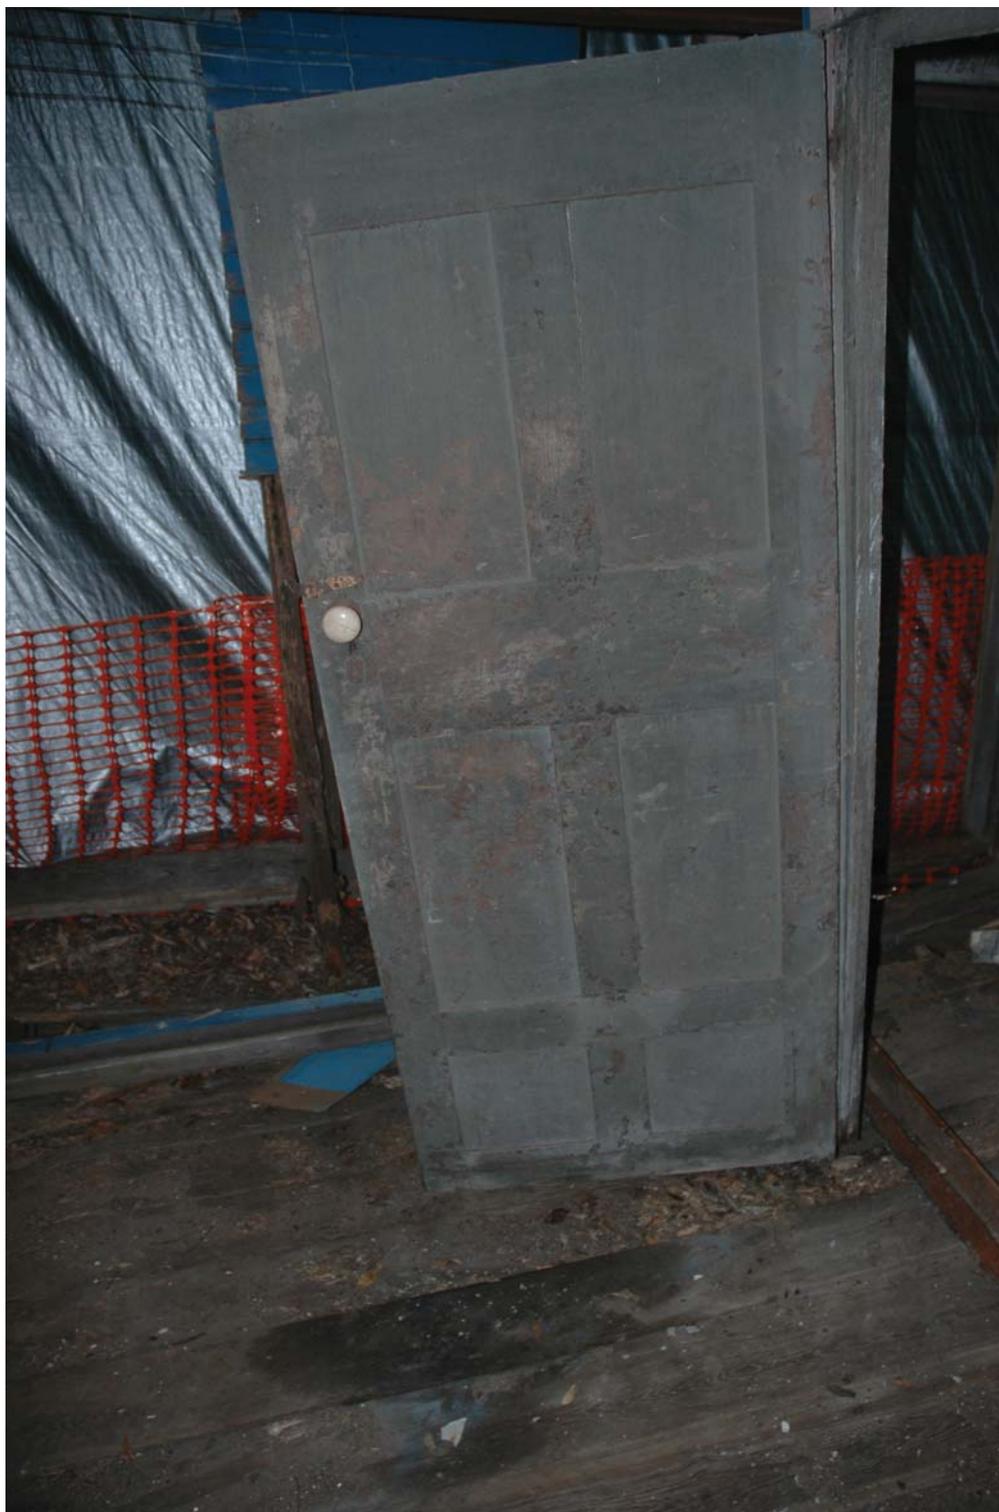
Figure 53: The existing door is located between the first floor hallway and parlor room. This “cross and bible” panel style door is hanging upside down and has a different finish on each side. The door itself is in great condition with the original doorknob and lockbox still attached. During the next phase, this door will need to be turned upright and the existing hinges replaced with a more period appropriate pin hinge (Reference Restoration-Preservation plan).

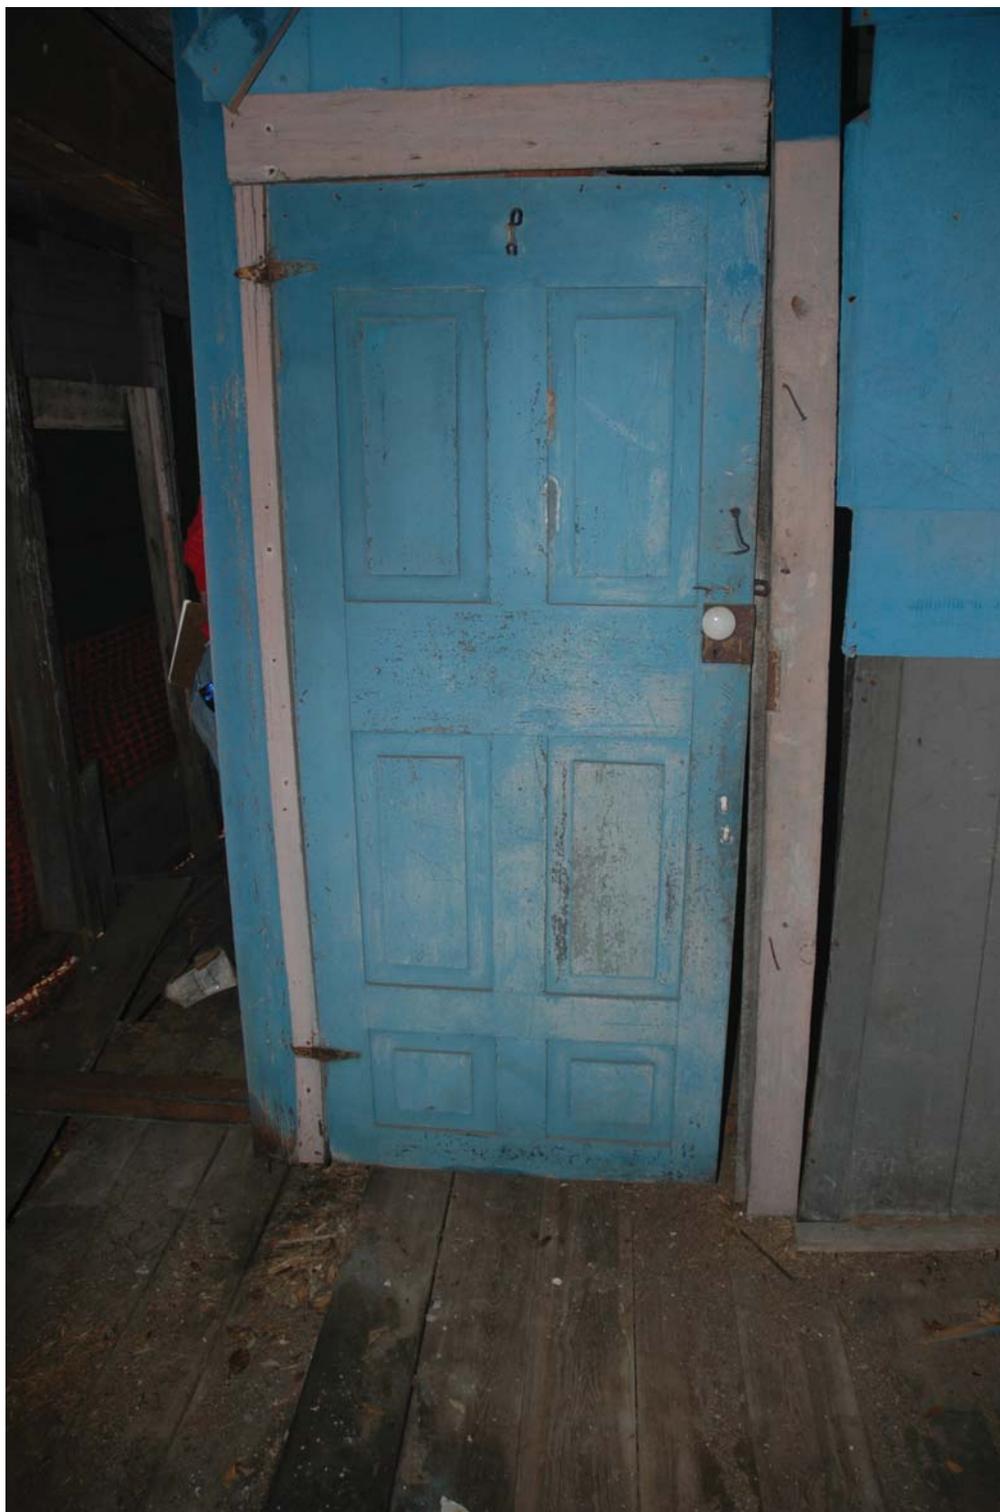
Figure 54: Parlor room elevation of the door shown in Figure 53.

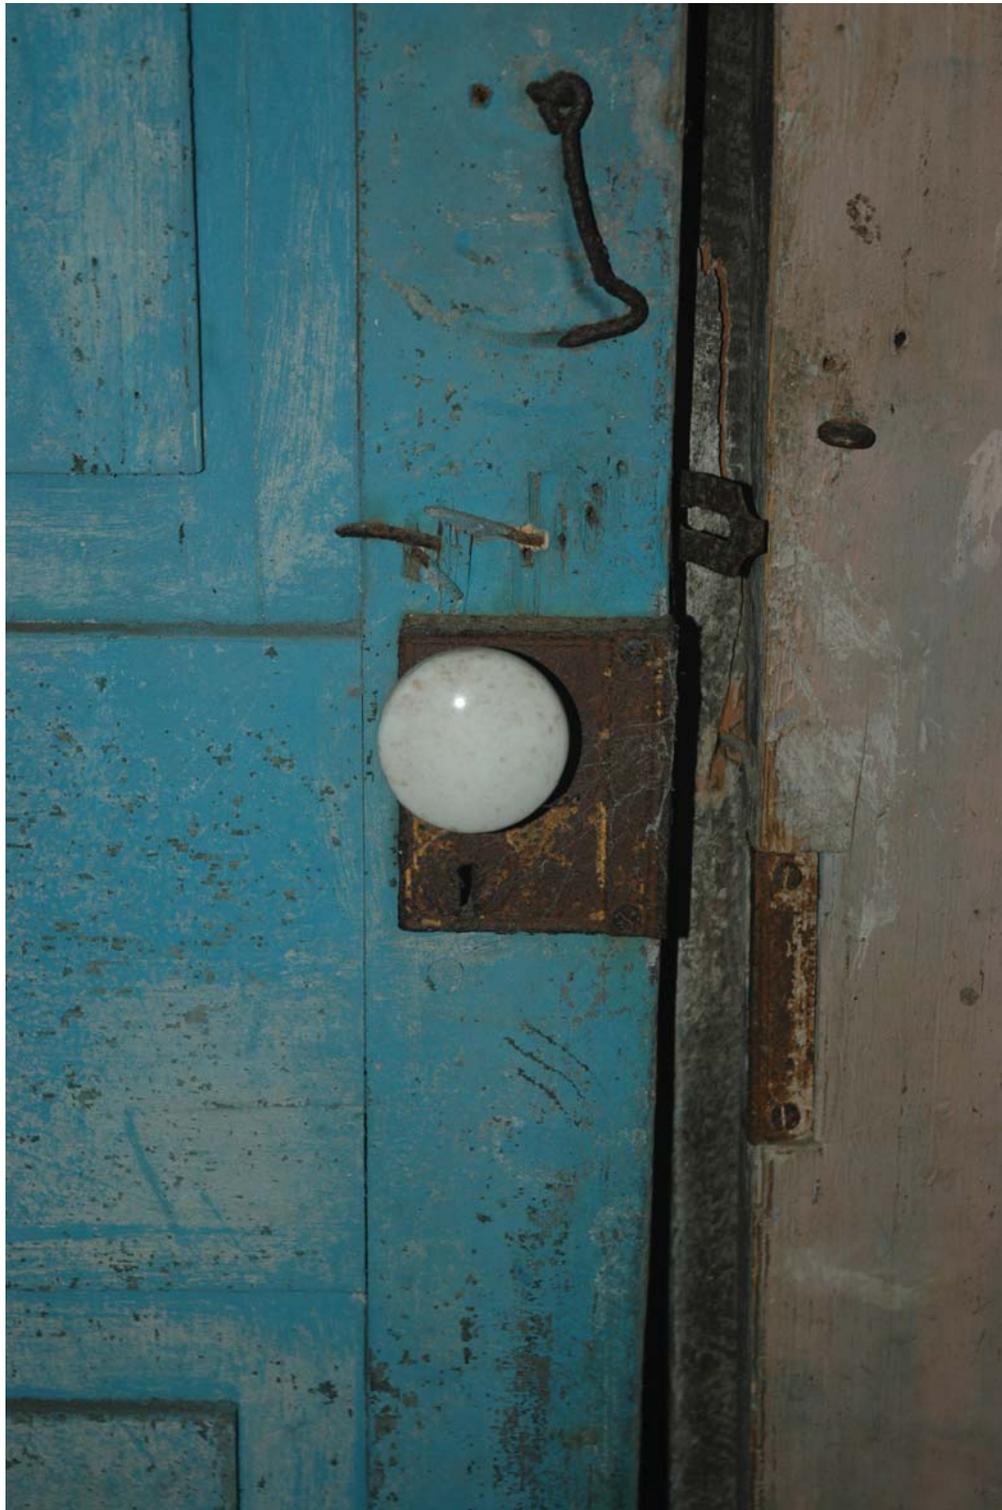
Figure 55: Interior view; First floor door located between the central hallway and parlor. Note the original ceramic door knob and lock box. This type of hardware is very common on doors from the 1870s to 1920s. The existing square pin hinges attached to this door date from the 1900 to present. Two interior pin hinges would have been attached to this style of door in the 1870s (Reference Restoration-Preservation Plan).

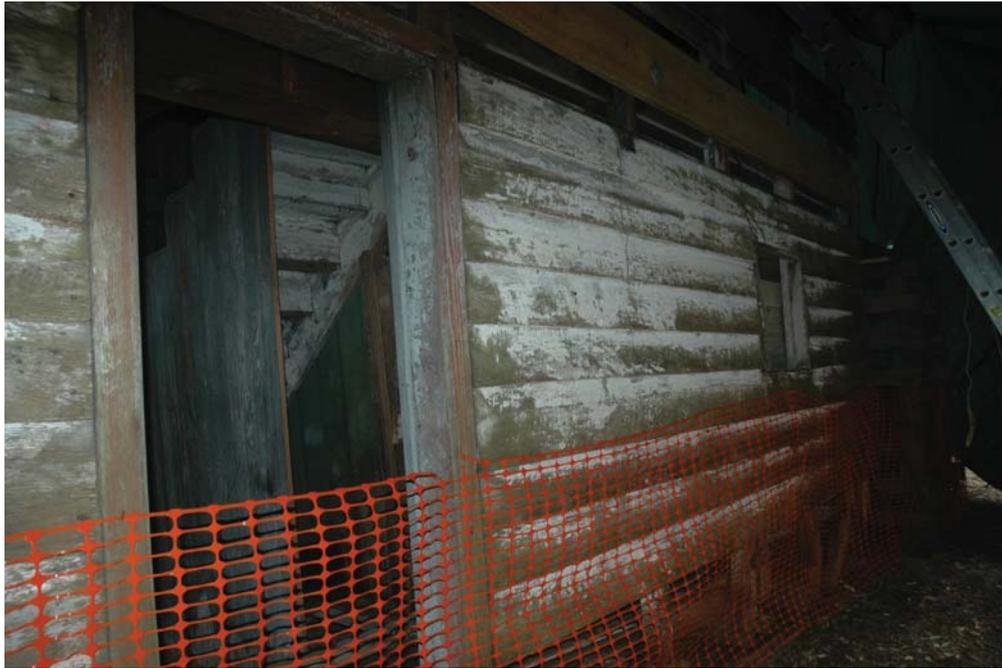
Figure 56: Exterior view; Outside door entrance located on the North Elevation; April 2009. The door frame and trim appear to be in good condition. The threshold is deteriorated and will need to be replicated during the next phase. The existing window near the NW corner (kitchen space) appears to have been added at a later period (neither the window size nor the window framing matches the original wall material). Note the central stairway construction with exposed strings, treads and risers, all whitewashed in the underneath closet space.

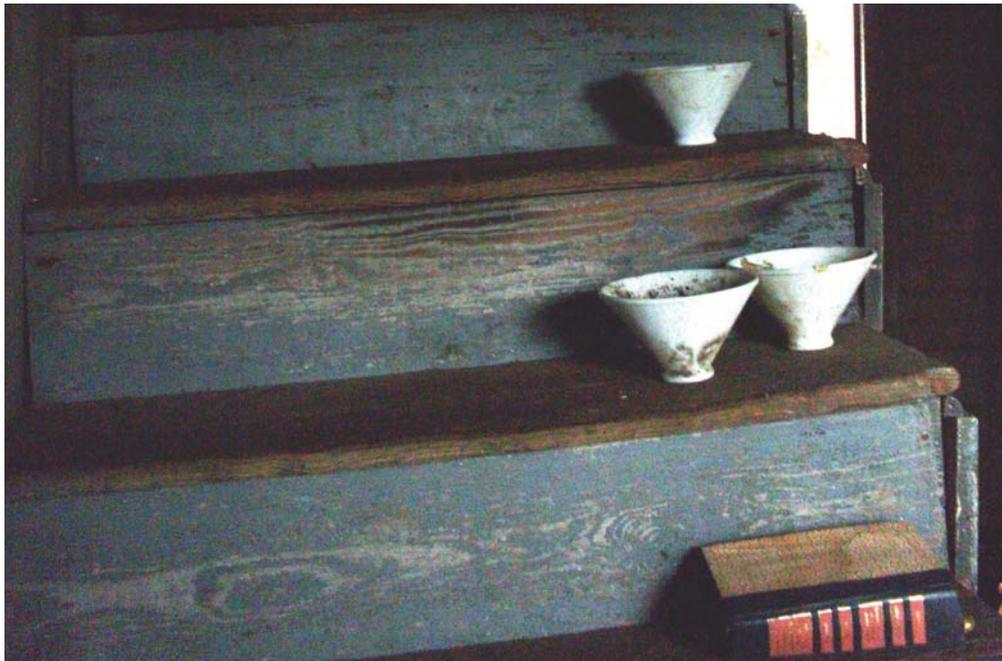
Figure 57: Interior view; Central stairway; December 2008. The staircase has 12 steps from the first to second floor (8 inch risers and 7 inch treads) no existing handrail or newel post on the first floor.

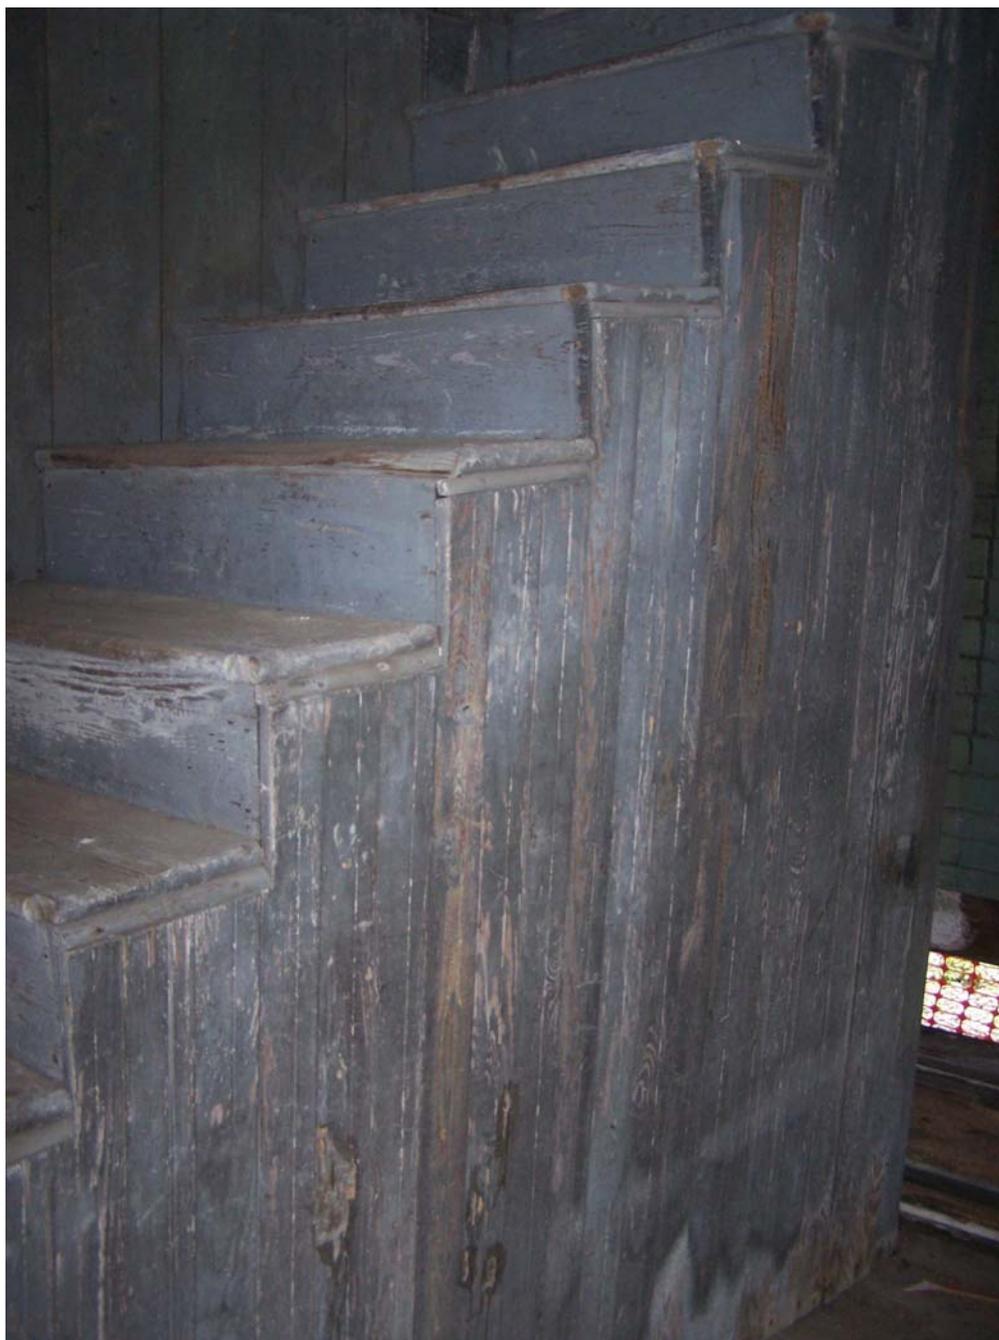
Figure 58: Interior view; Central stairway; December 2008. From the construction method of the stairs, it could be argued that the stairway is original to the 1870 construction date. Other resources on the Garvin House state the stairway was added later and a wide ladder was used earlier to access the second floor (traditional slave cabin construction). From the 1800s framing Post and Girt system of the house, it can be determined that Mr. Garvin was a skilled carpenter or had friends with the skills to complete this house with a central hallway and staircase at the 1870 time period.

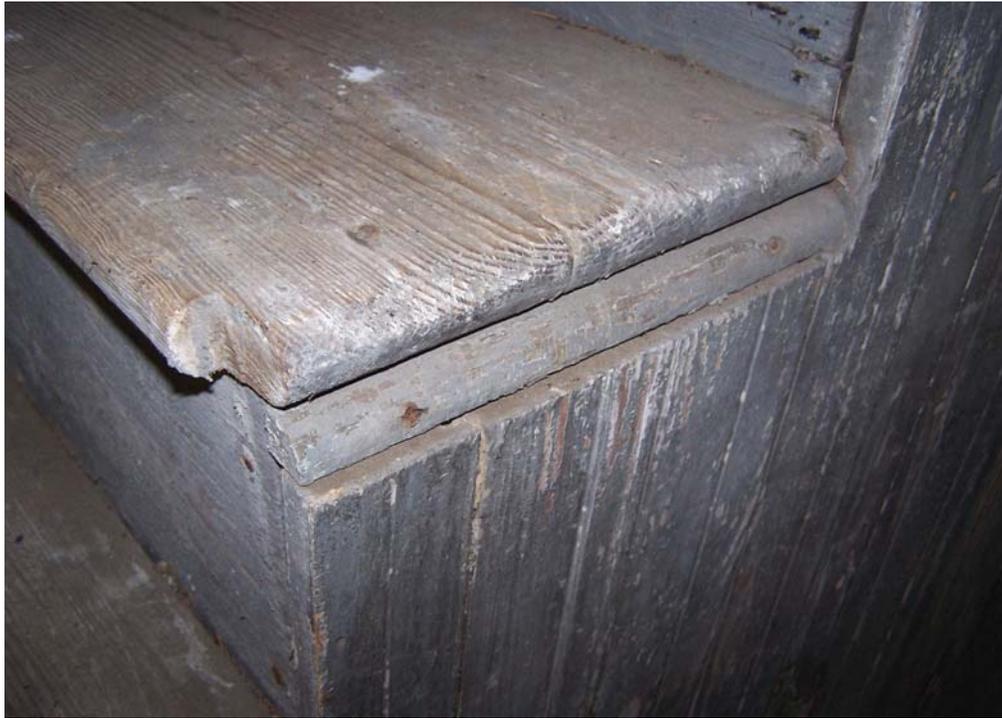
Figure 59: Interior view, first floor stairway, June 2009. Note the 90 degree corner cutout on each stair tread. This indicates the staircase had a simple handrail support with 1x2 pickets (probably pine). Similar style of handrail can be compared to the Historic Bluffton Heyward House central hallway stairs.

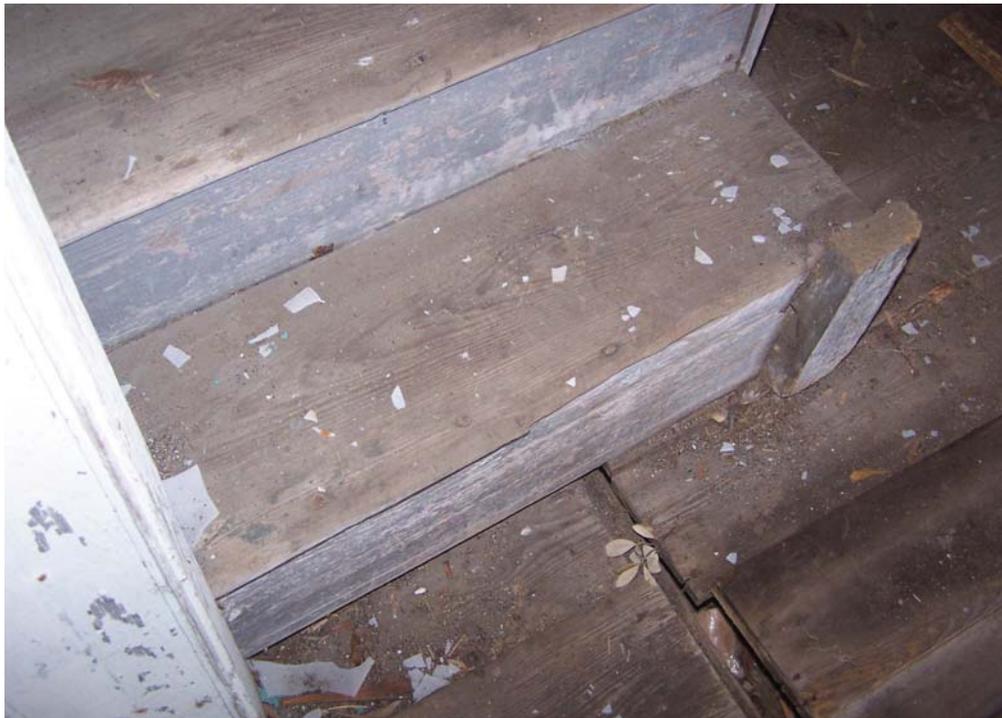
Figure 60: Interior view, first floor stairway, June 2009. Note the remains of the newel post (2x4) at the base of the hallway stairs. Sometime in the last 40 years, the existing handrail system was removed from the Garvin House. Each riser and tread appears to be original to the house (1870s). Three to five colors of white to grey paint have been applied to the stair system over the years.

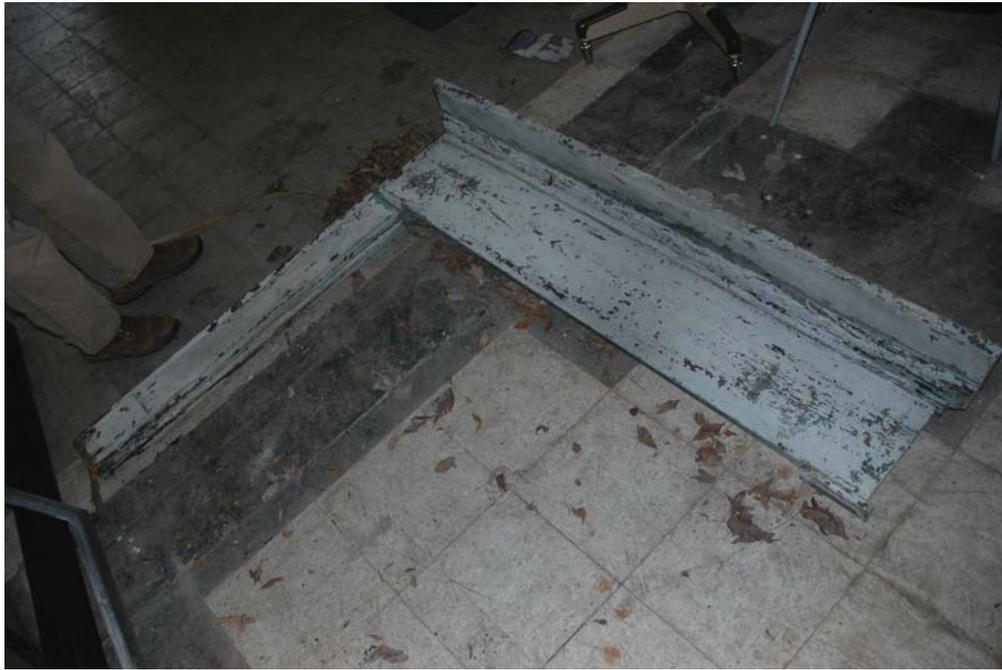
Figure 61: Storage photo of the salvaged mantle from the West Elevation chimney; April 2009. This rustic mantle, constructed of pine, was probably recycled from some other building prior to 1870. The trim profiles do not exist anywhere in the Garvin House except this mantle. The right support leg is missing but the left leg is in good condition and not missing any trim pieces and can be used to replicate the missing right section.

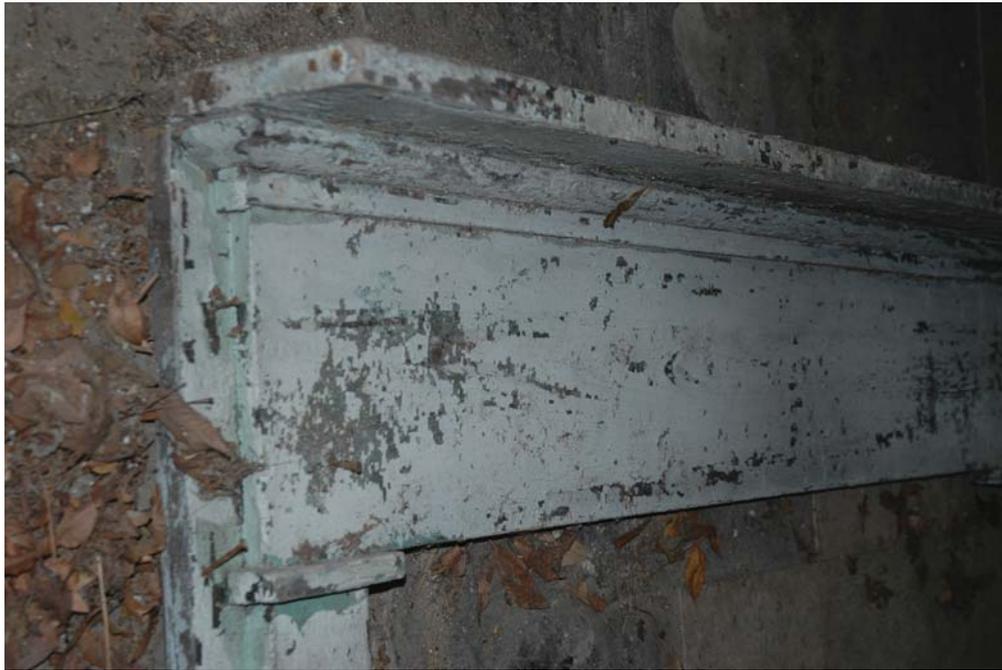
Figure 62: Close-up photo of the original fireplace mantle; April 2009. Note the ogee and square trim band beneath the top shelf section of the mantle. Simple design with three layers of paint beneath the existing topcoat (white color).

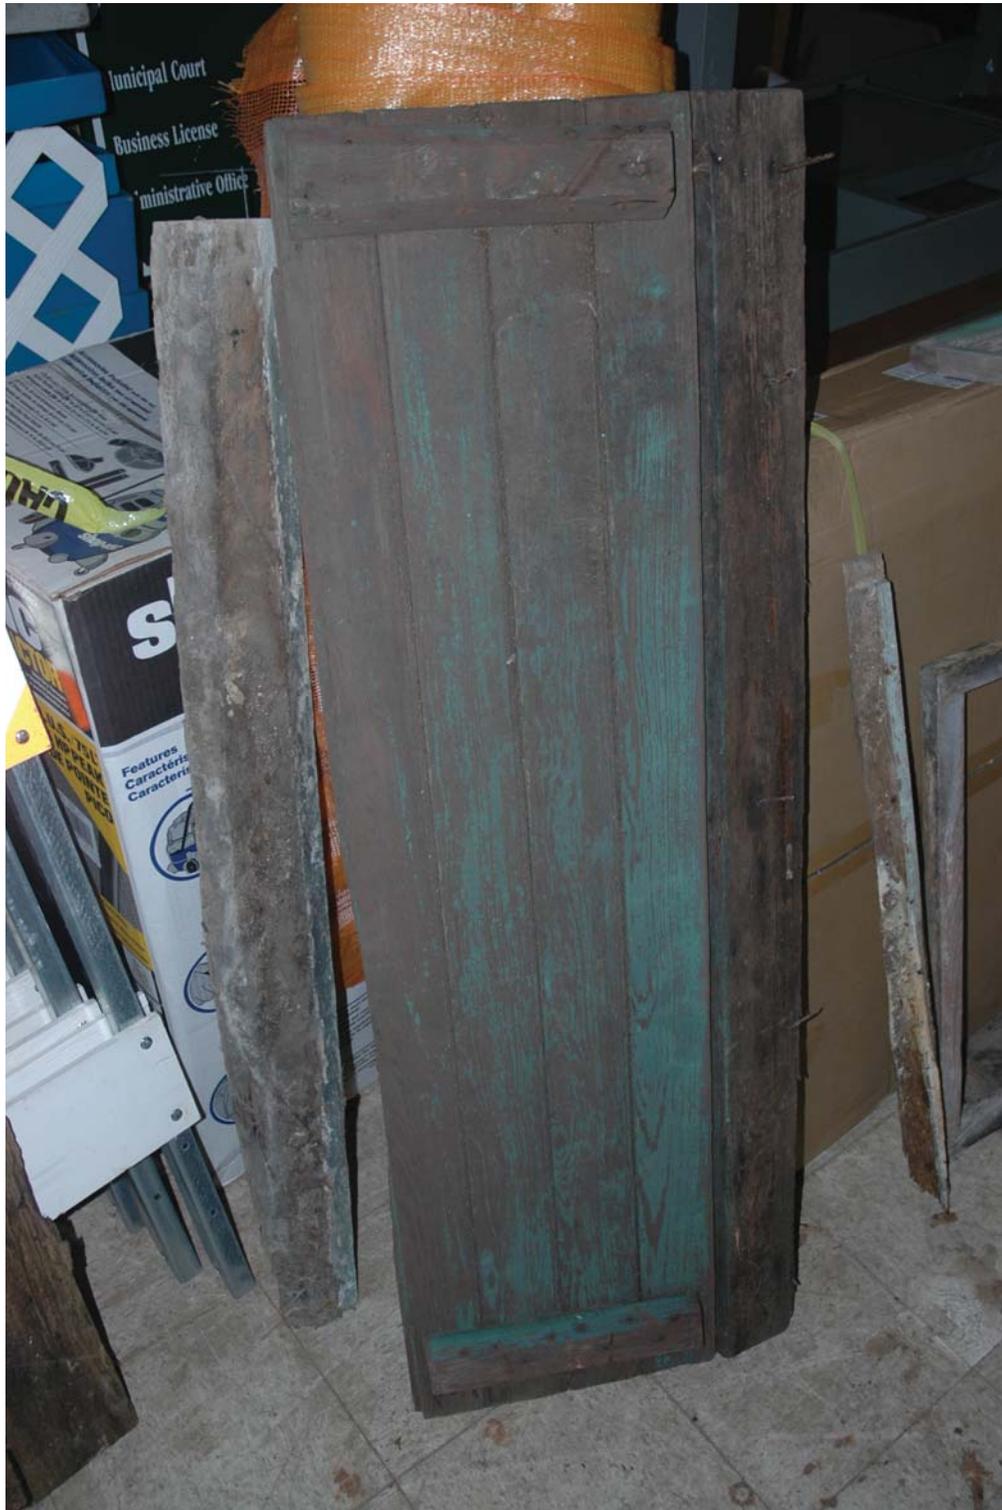
Figure 63: Storage photo of the first floor window shutter from the east elevation. Note the board and batten construction of the shutter. Three other shutters are still attached to the first floor window openings on the Garvin House. The existing shutters are all in good condition with two coats of faded, greenish-blue paint.

All new windows will be six-over-six panes with new replicated sashes for the first and second floor. The first floor shutters on the east elevation will be refurbished and reinstalled on the Garvin House. All other shutters will be replicated to match the east elevation profile. The second floor shutters will be replicated using the board and batten shutter from storage [Figures 64 & 65]. All missing weatherboarding will be 1x8 sawn cut and painted white. All trim and shutters will be painted the greenish-blue color to match the 1870s time period.

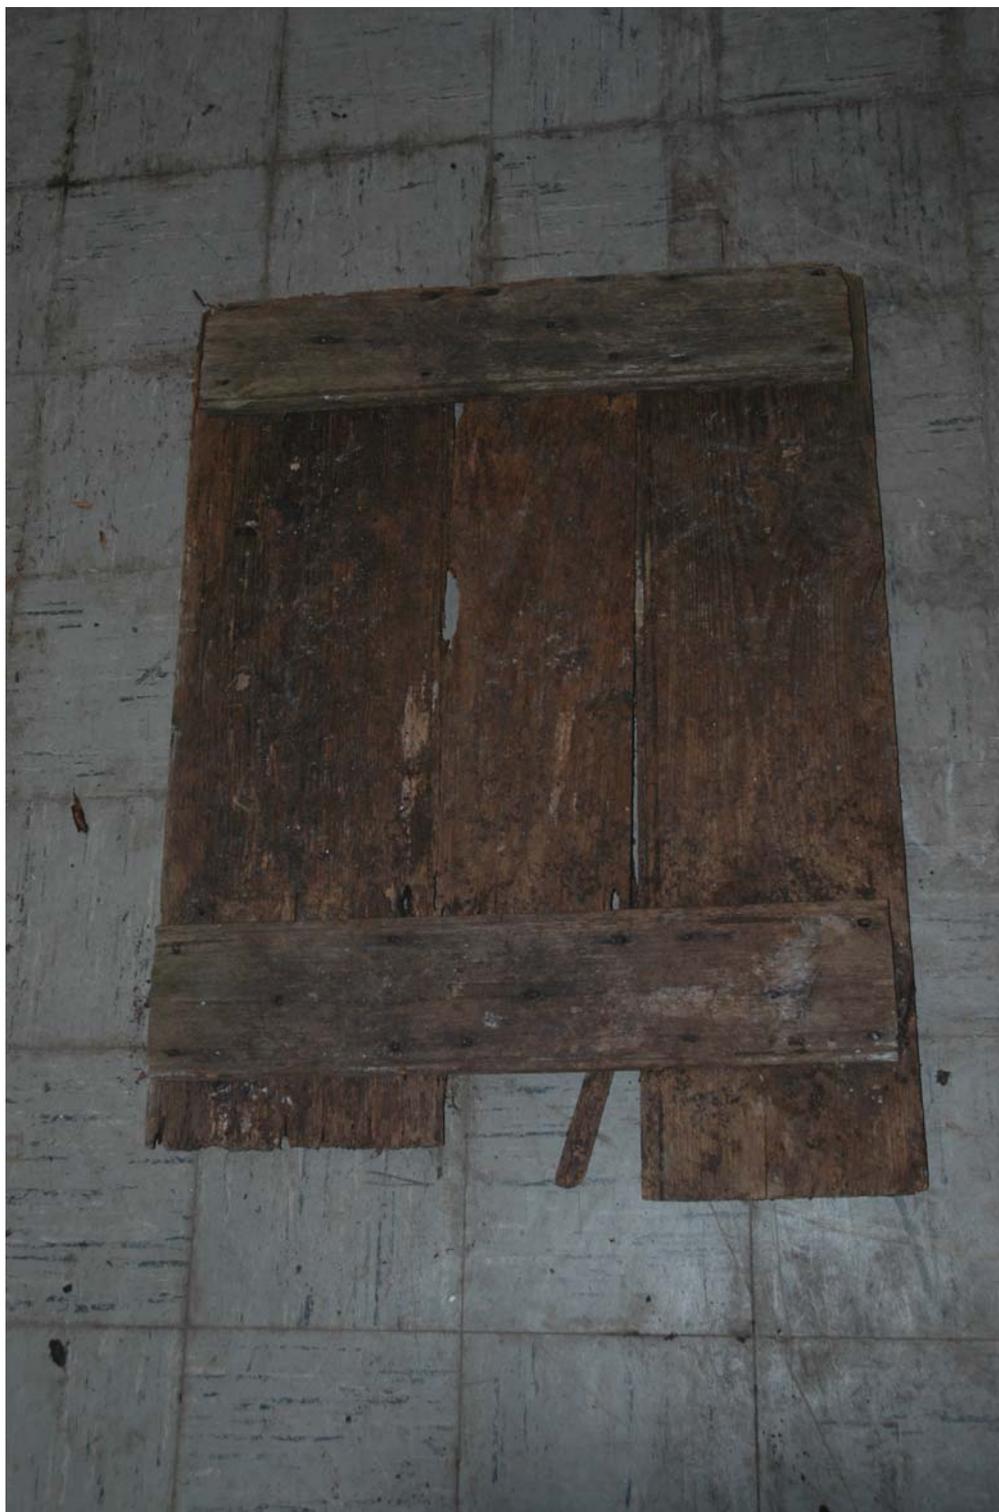
Figure 64: Storage photo of the window shutters from the second floor, East Elevation; April 2009. Note the board and batten construction method. The boards used to fabricate this original shutter are similar to the interior wallboards and trim on the first and second floors. The condition of this shutter is fair. The objective of this study would be to place this shutter in the collection for the Bluffton Historical Preservation Society and replicate a similar shutter to be installed on the second floor of the house.

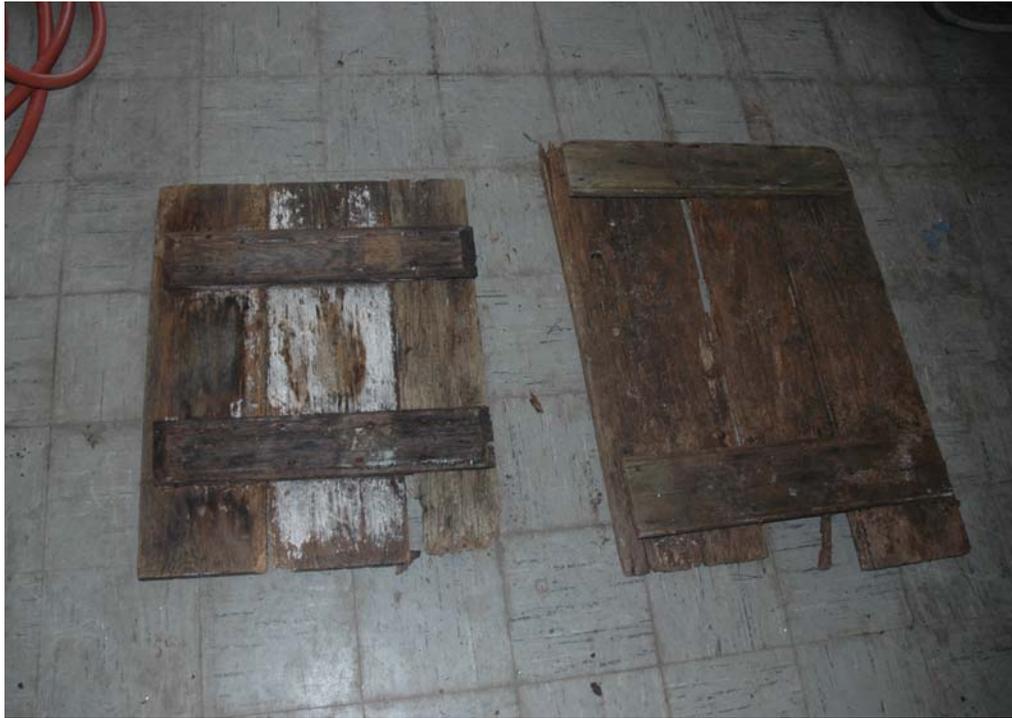
Figure 65: Storage photos of two different size shutters from the second floor, East Elevation. These two shutters are board and batten style of construction. The shutter on the right fits the window opening on the second floor. The left shutter appears to fit the opening for the kitchen window on the North Elevation of the house on the first floor. Both shutters are in poor condition and will need to be replicated upon the Restoration phase of the Garvin House.

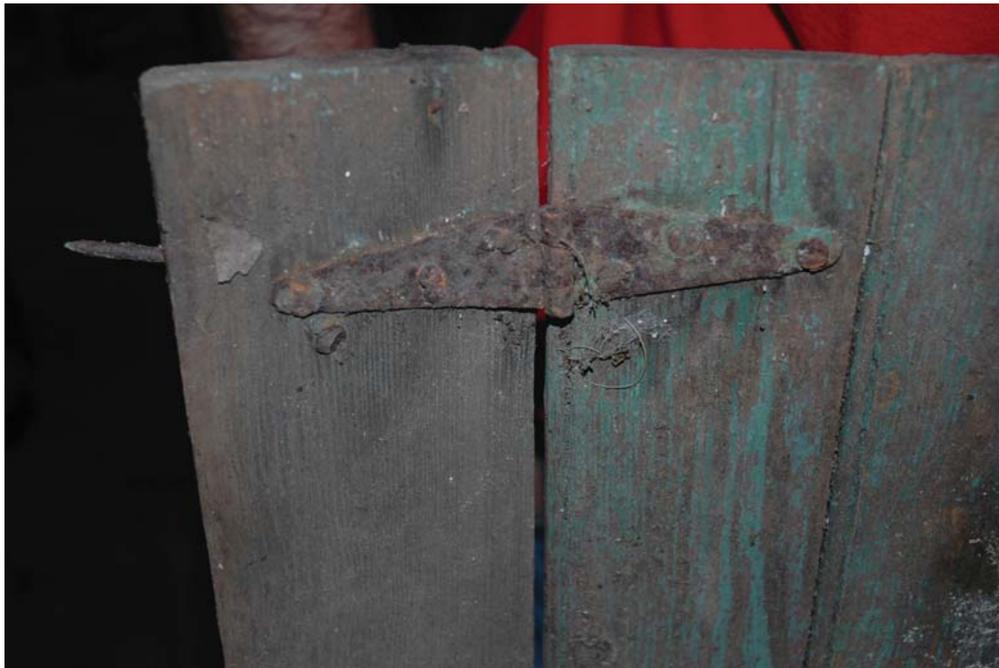
Figure 66: Storage photo of the first floor shutter from the East Elevation. The existing hinge hardware on this shutter is old but not original to the house. This type of pin hinge would not have been available in the South region in the 1870s. A strap hinge would have been used to attach this shutter to the house in 1870. The existing pin hinge was patented in the early to late 1880s. All door and shutter hardware would have had a strap hinge or a very simple pin hinge to hang the interior doors. All the exterior doors would have had a strap hinge.

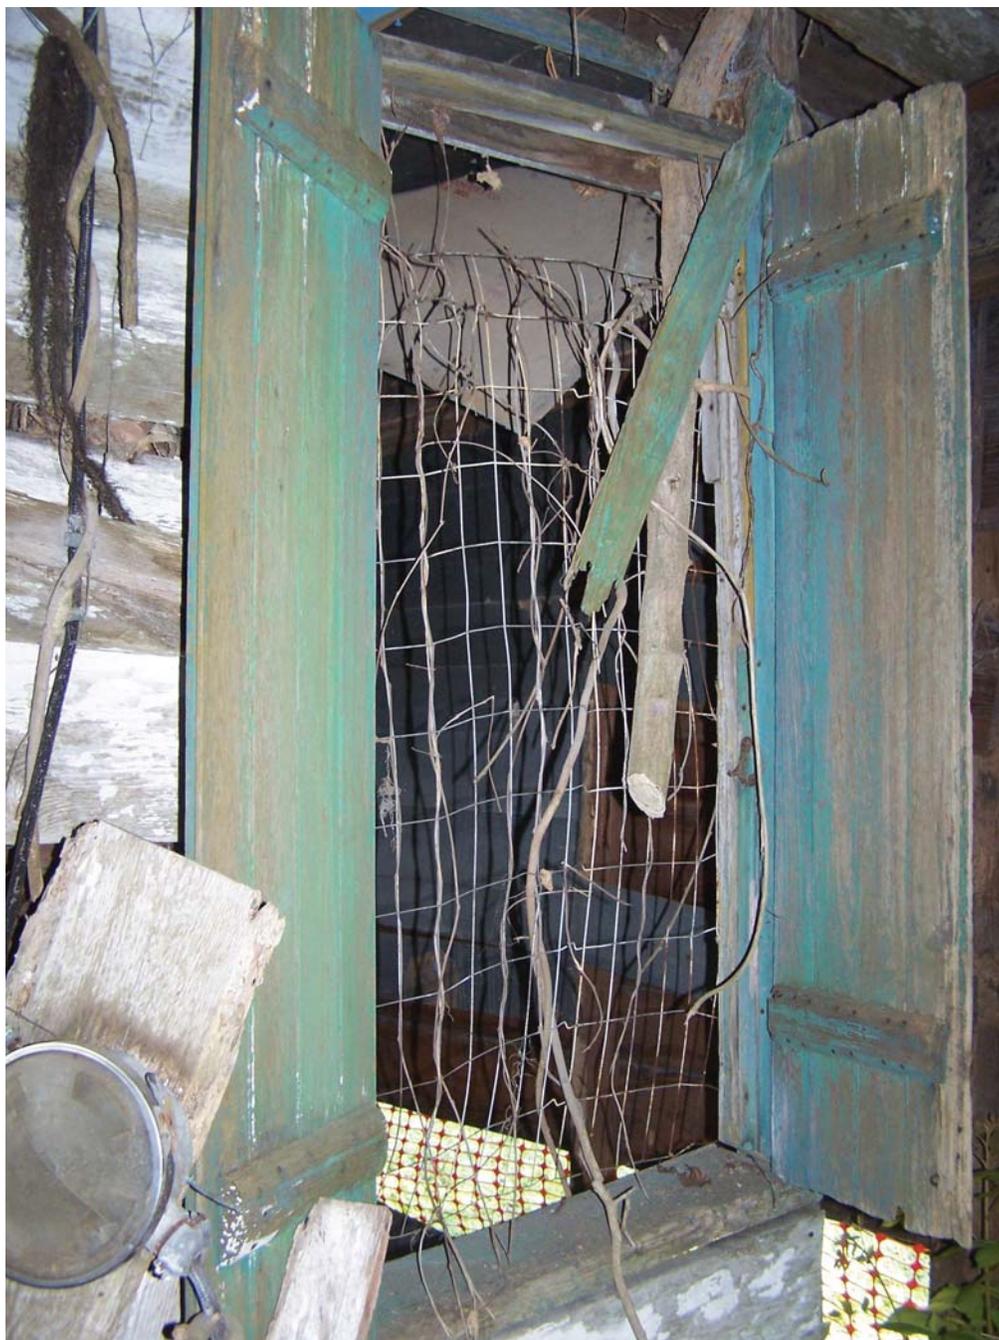
Figure 67: Exterior view, First floor window-East elevation, June 2009. The first floor window shutters on the northeast corner are in good condition. The board and batten construction of these shutters would have had strap hinges. The existing v-wing hinge would have been installed after 1890s to 1900. Most of the existing hardware on the windows or shutters would have been recycled from another site.

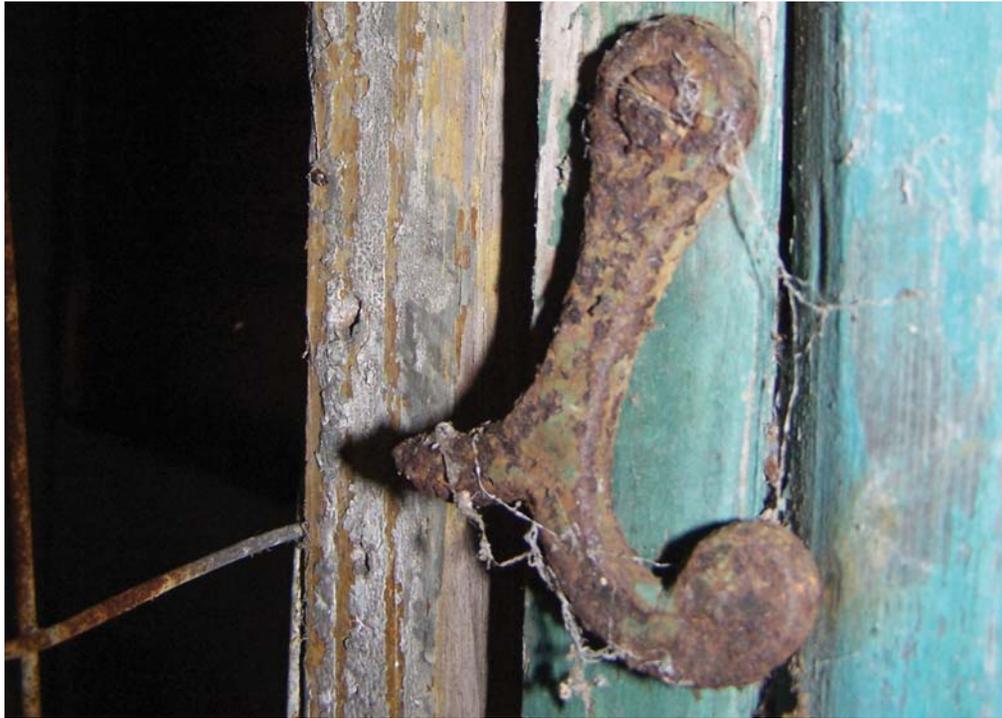
Figure 68: Exterior view, first floor window on east elevation, June 2009. The upper sash stays latch (Victorian style) appears to be original to the 1870 house period. If not, this stays latch would have been used in the 1870s time period. Recommended that all the restored windows have a period appropriate stays latch installed.

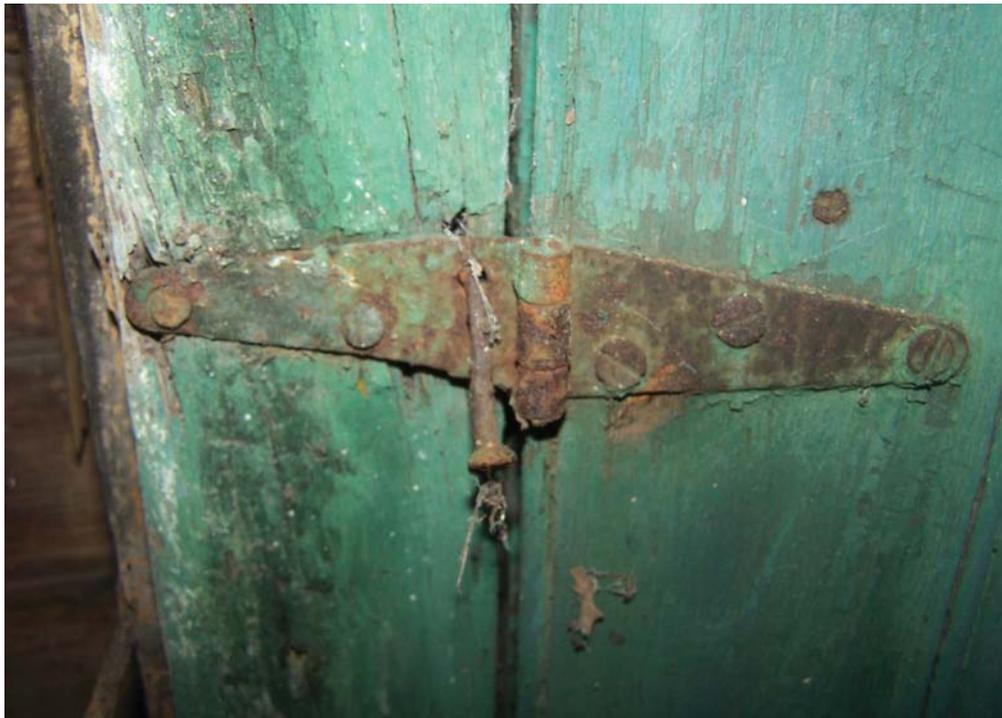
Figure 69: Exterior view, first floor window on east elevation, June 2009. Detail of the existing v-wing hinge.

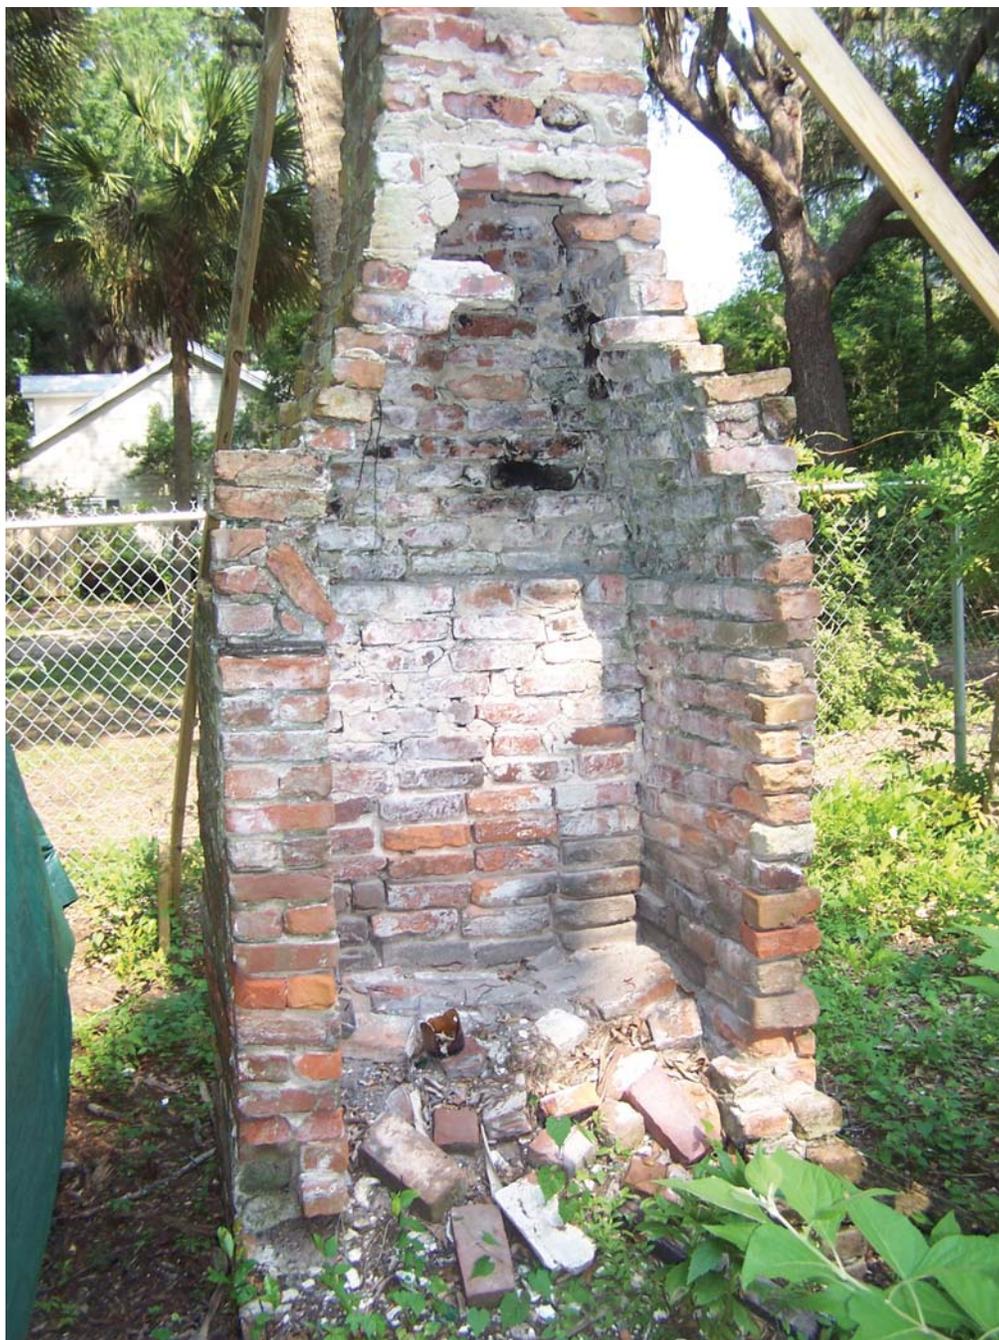
Figure 70: Exterior view, existing north 1930s chimney structure. The chimney base and stack are in critical condition. The existing chimney will have to be dismantled because of its deteriorate state. As noted in Restoration option plans for the Garvin House, the bricks from this chimney structure can be reused in the new foundation support piers beneath the house.

The existing free-standing chimney/firebox can be utilized one of two ways. Both of the two proposed options indicate that the existing chimney will have to be dismantled because of the deteriorated state of both the firebox and individual brick units. It is proposed that these bricks be recycled to help reconstruct the brick support piers beneath the main Garvin House. This way, the old and newly replicated bricks will blend together and be incorporated with the restored building for the next 100 years.

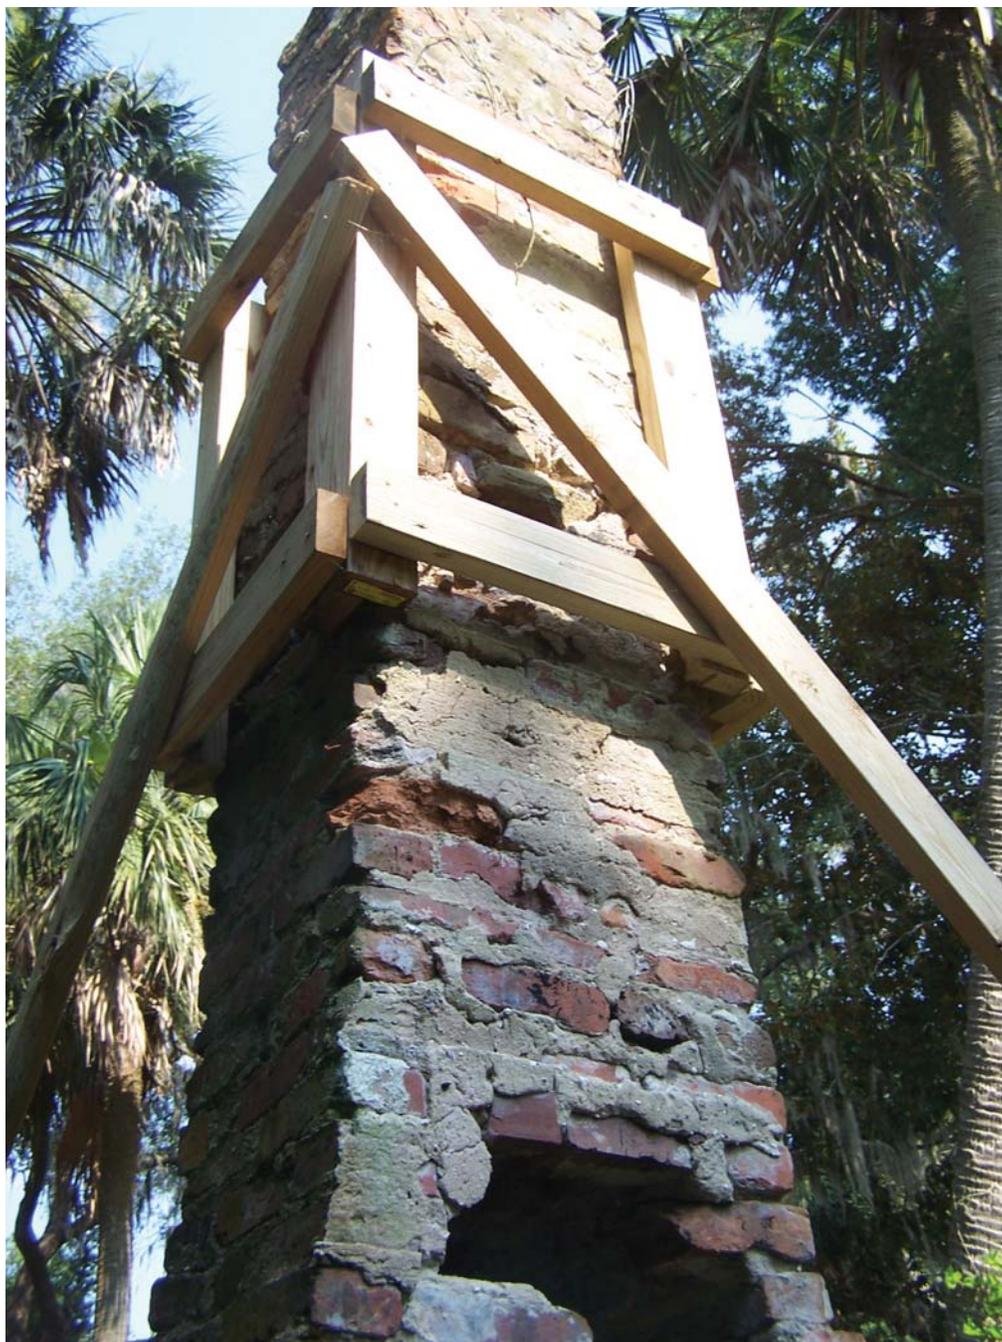
Figure 71: Exterior view, existing north 1930s chimney structure. Detail view of the support framing for the existing chimney.

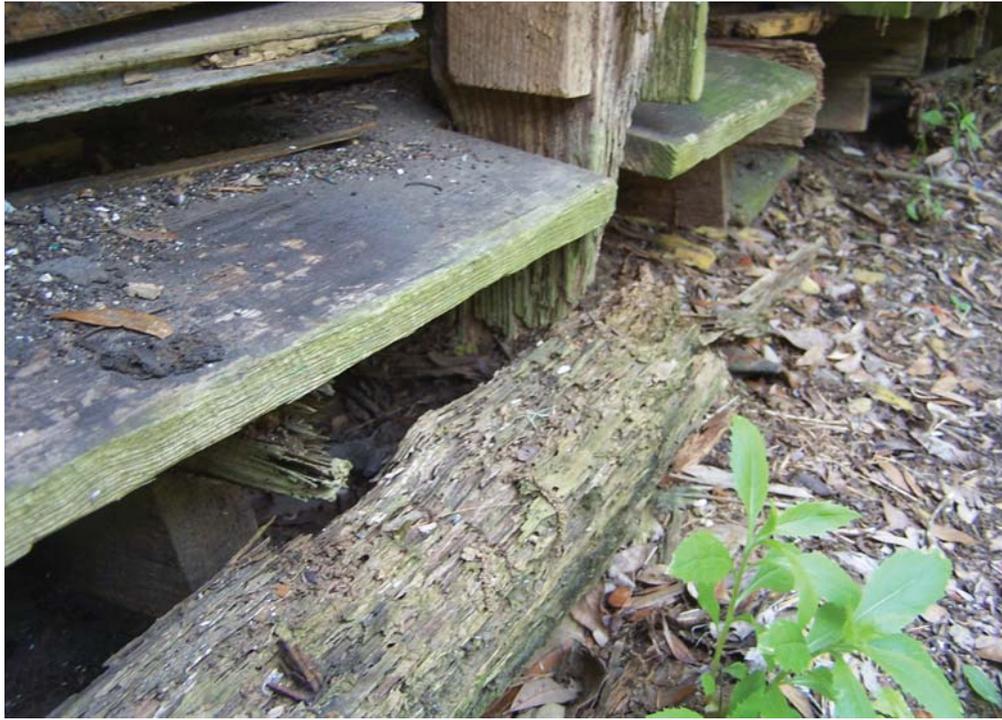
Figure 72: Exterior Foundation view, South elevation, June 2009. Note the remains of the original 6x6 floor sill. The existing 2x8 floor joists were notched out 4" upon the floor sill. Termite damage is obvious from all floor elevations of the building. The current floor joist will need to be inspected when the building is raised 3 feet off the ground to dig out the new footing system for the house. Extensive insect damage to the floor sills and bottom wall studs.

The existing floor system will need to be lifted up an additional 3 feet to dig out new concrete footers and allow the general contractor to build new brick piers to match the old Savannah brick type (4 inches wide, 3 inches high and 9 inches long). Each new footer will be 2 feet wide and 18 inches deep with #5 rebar. All new first floor sills (on all four elevations) will be treated 4x8 wood. All new brick piers must have foundation strap to meet renovation standards associated with the IBC (international building code) 2006.
