The Garvin House: A Preservation & Interpretation Plan For An 1870 Freedman's Home

Prepared for the Town of Bluffton, South Carolina
By

July 15, 2009

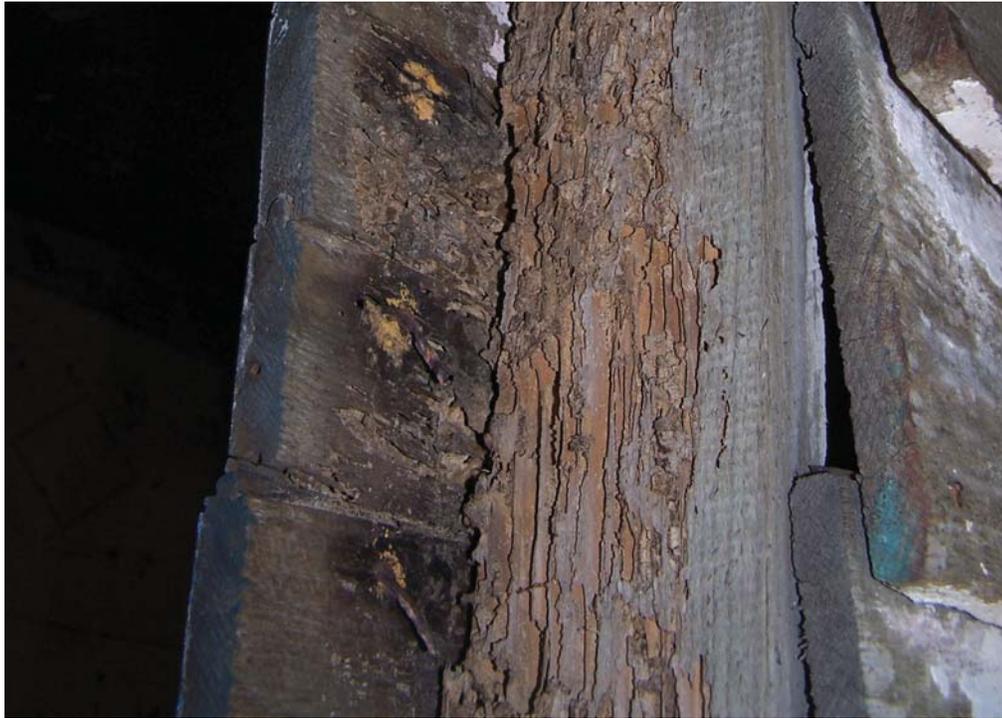
Figure 73: Exterior view, South elevation wall, June 2009. Note the extreme termite-insect damage to the walls studs and window frame. Each stud or wall member will have to have Dutchman repair or be replaced to stabilize the south wall.

Upon repairing each corner post (4x6), each wall stud will need to be Dutchman together to remove the rot and termite damage from the first floor section of each stud 2x4 or 4x4. Each repair will require 8 to 12 inches of timber to remove the damaged wood section. Each corner post and cross brace will need to be fastened together using hidden screws to stabilize and straighten or square up the building. After the building's foundation and first floor system have been repaired, the support steel inserted during the stabilization phase can be lowered down and removed.

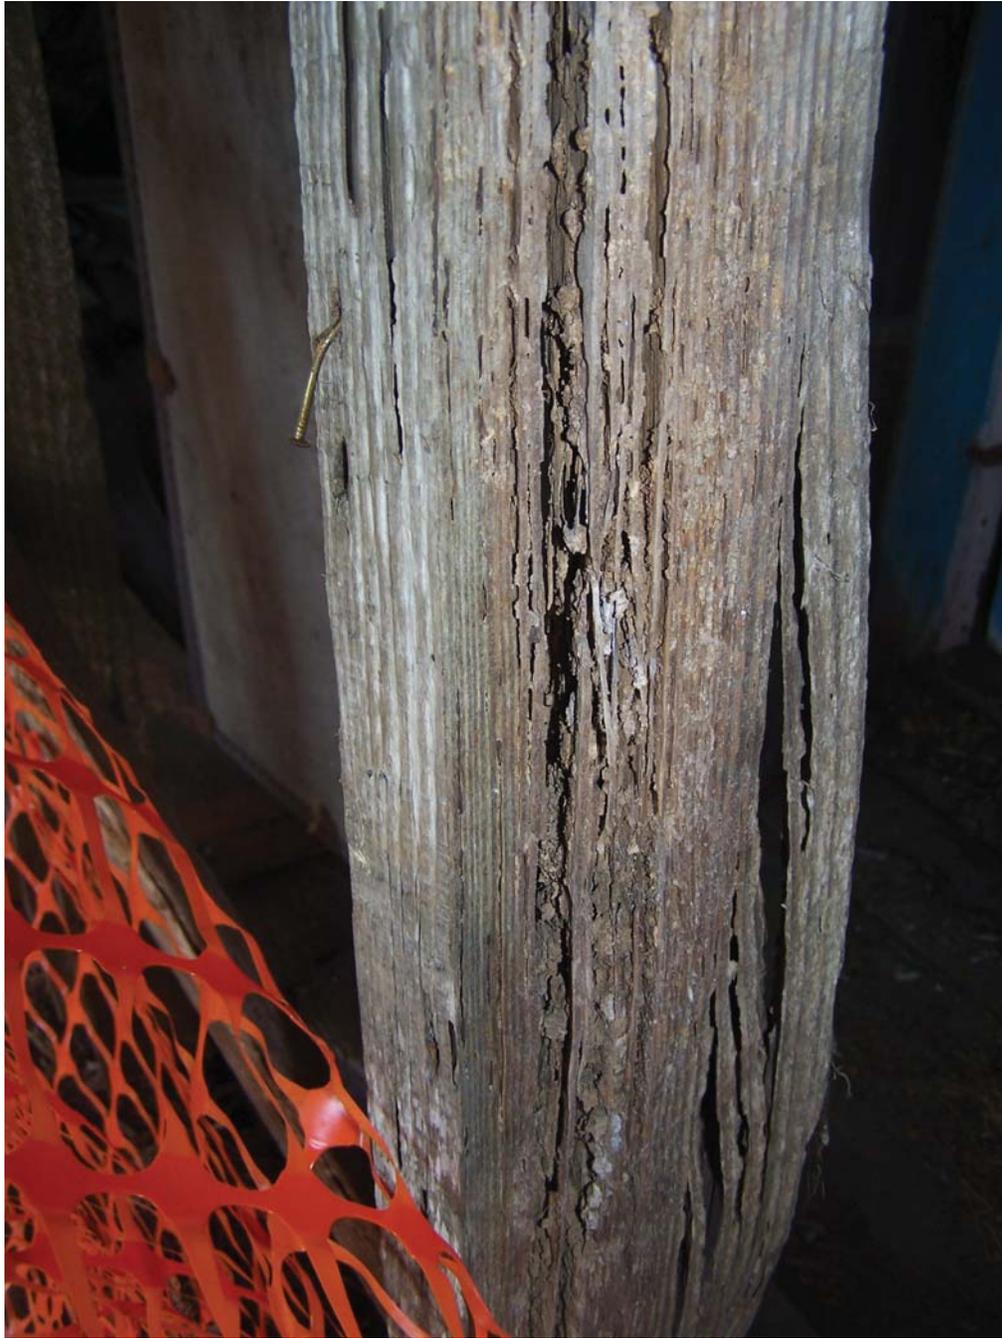
Figure 74: Exterior view, South elevation wall, June 2009. Additional view of the termite damage to the existing wood framing. Each stud or wall member will have to have Dutchman repair or be replaced to stabilize the south wall.

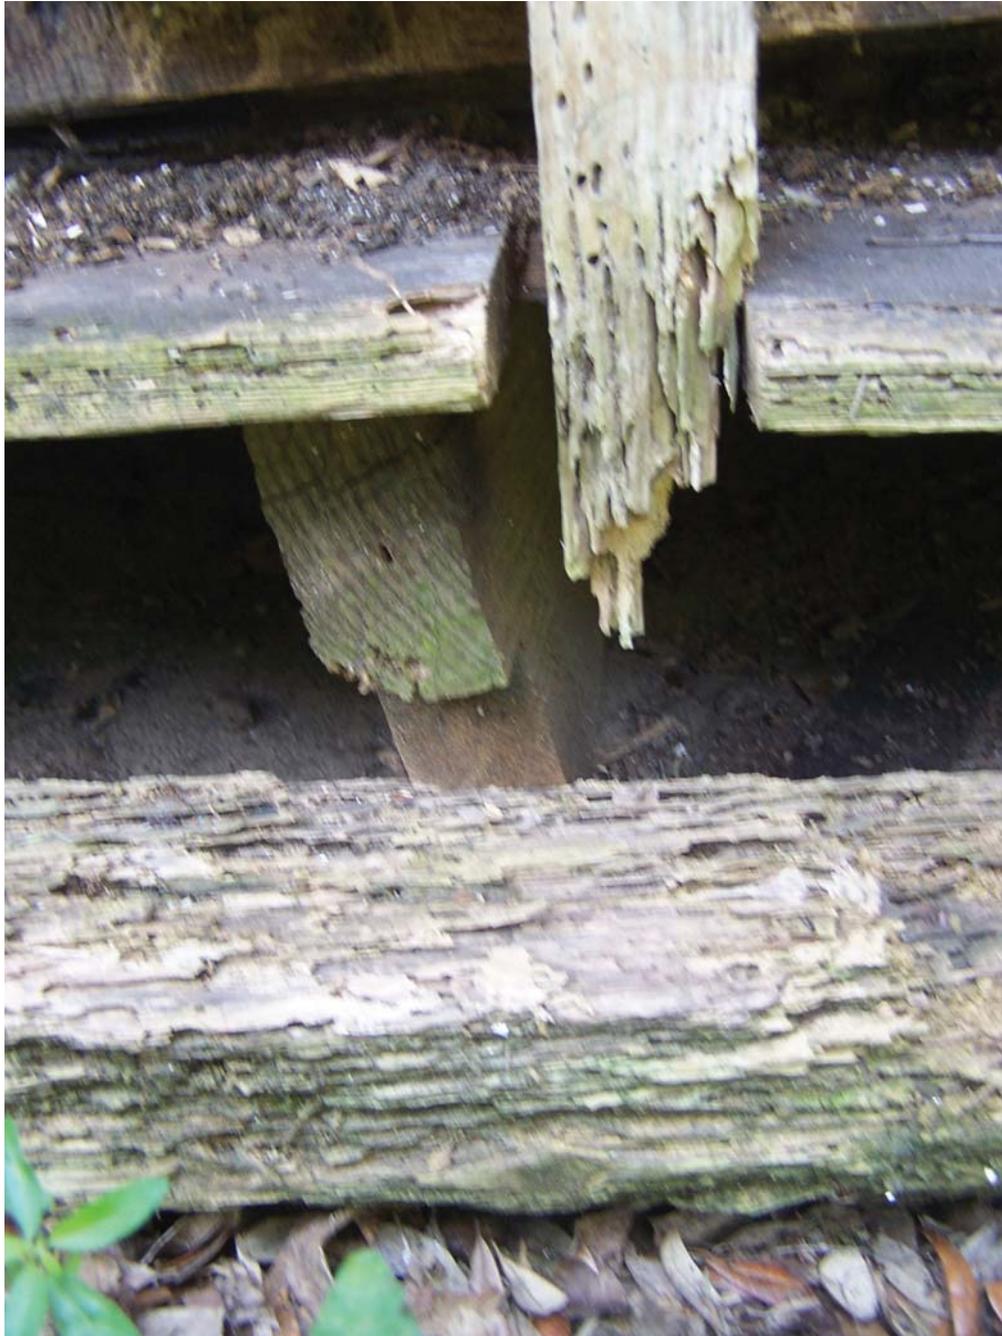
Figure 75: Exterior view, South elevation floor-wall, June 2009. Each wall stud as noted will need to be repaired. New floor sill will be installed on all four elevations. The wall studs all appear to have been toe nailed to the top of the floor sill.

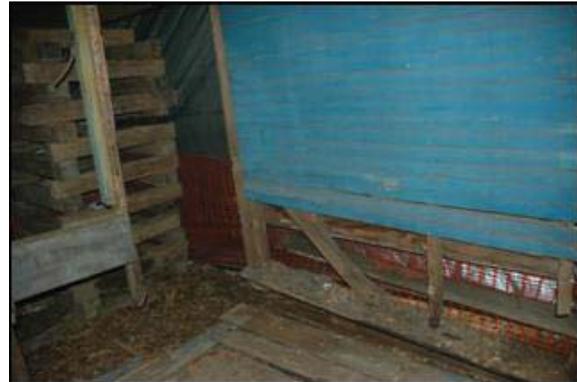
Figure 77: view of the SE corner post and wall structure.

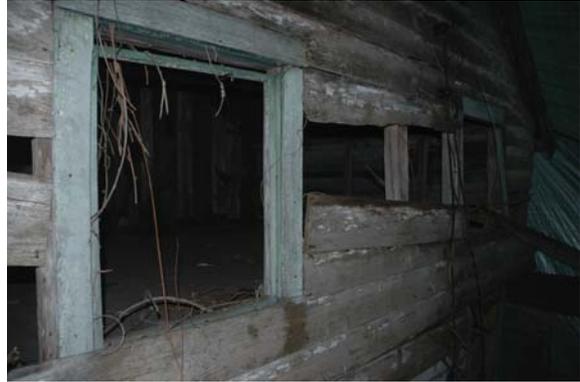
Figure 78: Exterior view of the second floor window opening – East elevation.

Two existing window openings on the second floor should be dismantled, all window trim replicated, repaired, primed and reinstalled (east elevation). Upon reconstruction of the west wall, two new window openings will need to be replicated using the size and dimensions from the east elevation, second floor.

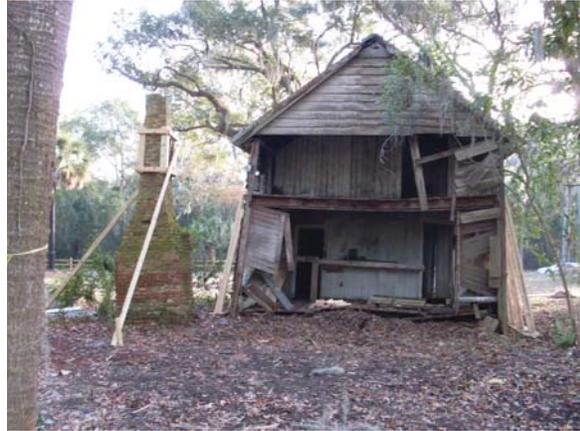
Figure 79: Exterior view of west elevation of Garvin House 2008.

After all four elevation walls have been stabilized and all wall components repaired, the west elevation chimney needs to be reconstructed. Note that the new chimney can be constructed so that it can be used in interpretive programs with real cooking fires, or the chimney can be reconstructed only as a static structure for appearance only. In reconstructing the west end chimney, any standard size brick can be used to rebuild the interior sections of the chimney from the foundation to the chimney stack. A Savannah-style brick, similar to that used in the original chimney, should be used on the exterior veneer to ensure an authentic 1870s appearance. A consultation with the local Fire Marshall will need to occur prior to beginning this component of the Garvin House restoration.

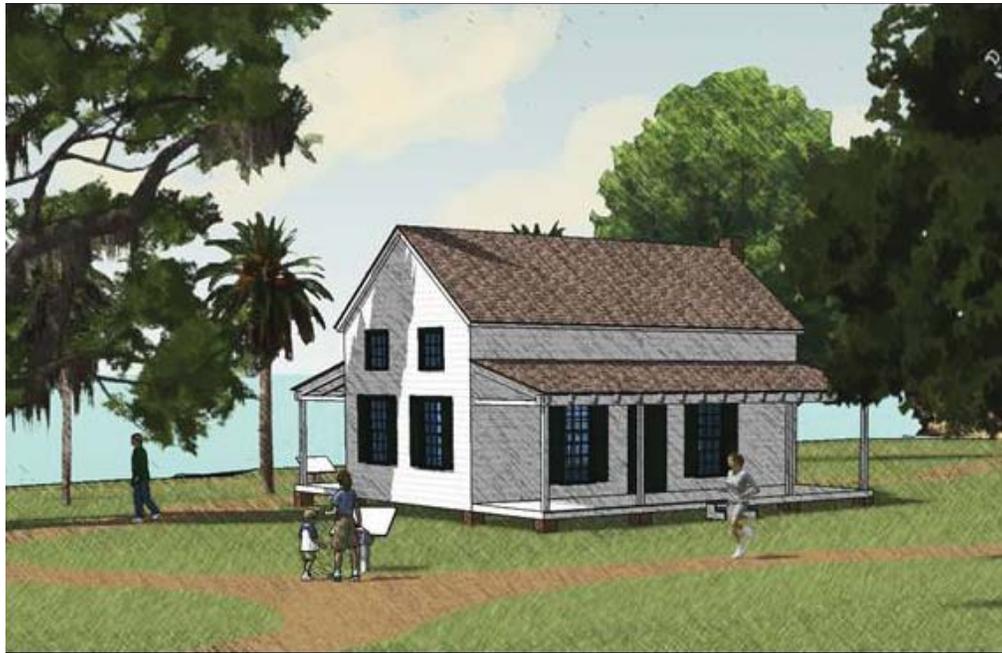
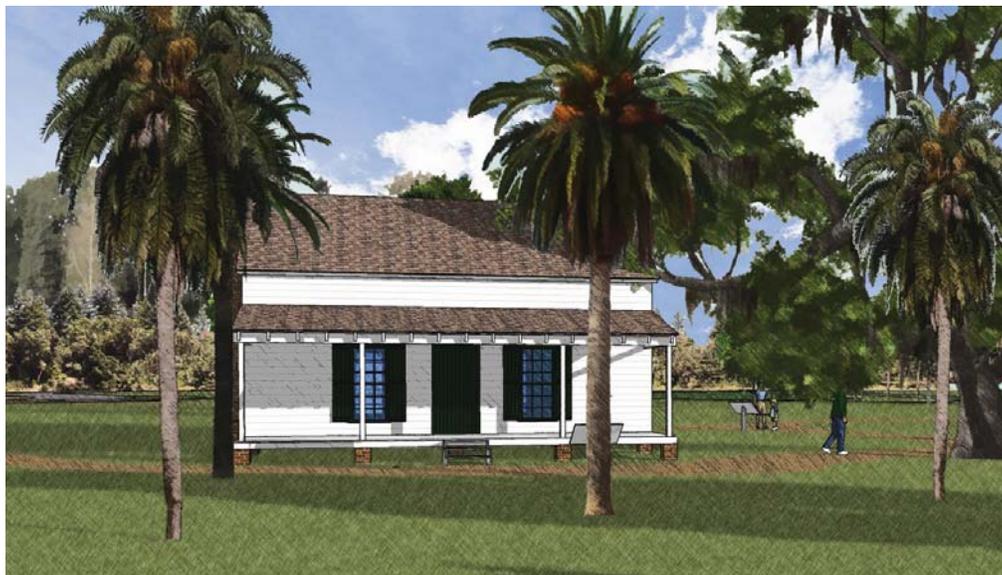
Figure 81: Computer-generated model of the restored Garvin House.

Figure 82: Another perspective of the Computer-generated model of the restored Garvin House.

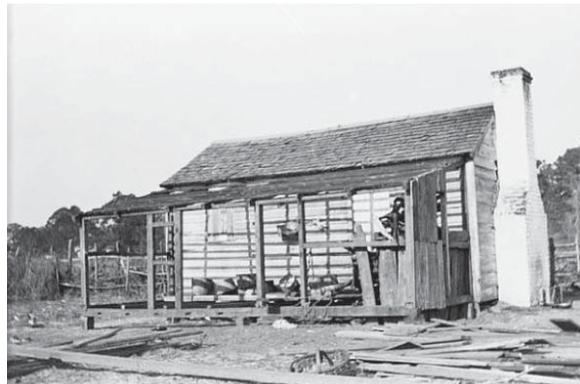
Figure 83: This photo, taken ca. 1905, shows the renovation of a former slave cabin in progress. Note the use of whitewash paint on the siding and chimney as well as the use of wood blocks to provide foundation support for the rear rooms.

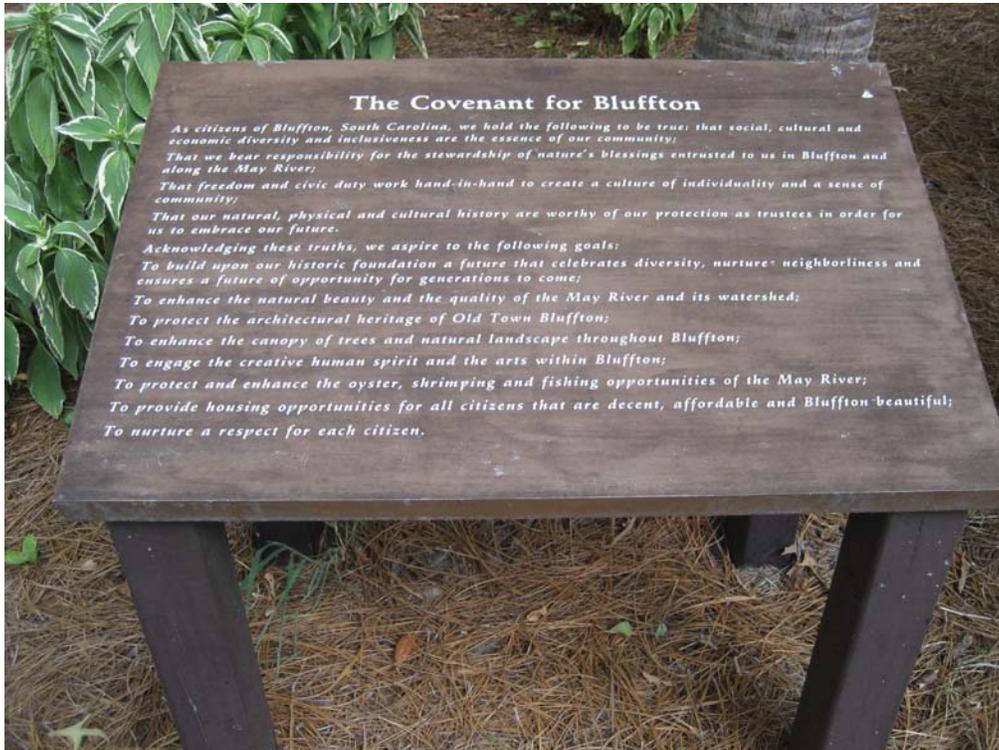
Figure 84: An example of outdoor interpretive wood sign that follows current codes for Bluffton.

- Wood sign
- Interpretive panel surface to be no more than five-foot square in diameter (two-and-a-half-feet by two-and-a-half-feet)
- Five feet in total height
- No more than two signs on one parcel of land

With those limitations we have come up with two styles of signs. Both follow the above regulations. Wood Signage One would be plain with painted text, much like the one illustrated in Figure 84. Wood Signage Two would have color and one photograph or graphic painted directly onto the surface.

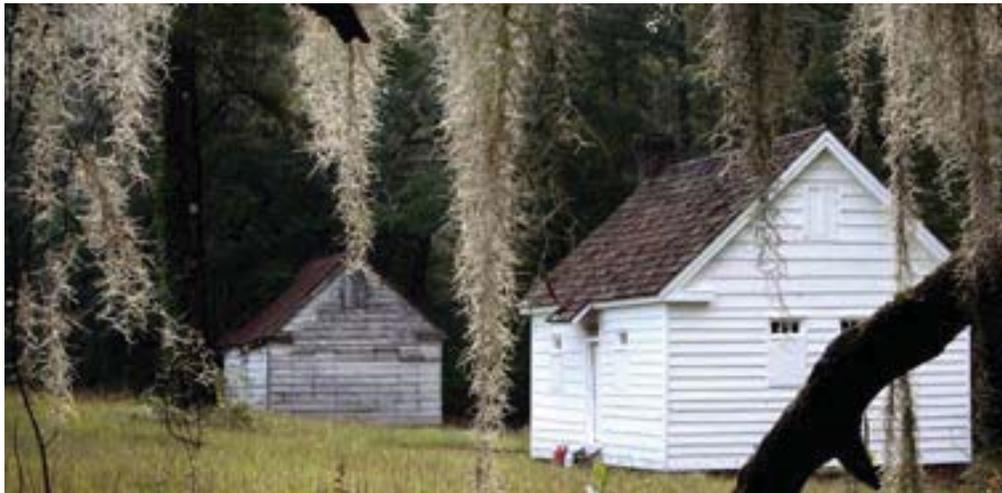
Slave cabins still stand at the Friendfield Plantation in Georgetown, South Carolina. The whitewashed, wooden structures on Slave Street, a sandy track at the back of the plantation owner's house, were once crammed with captive African labourers. No more than sheds really, the cabins have no heating, no glass windows and no indoor plumbing, and are propped up on brick pillars to keep out flood water and visiting snakes.

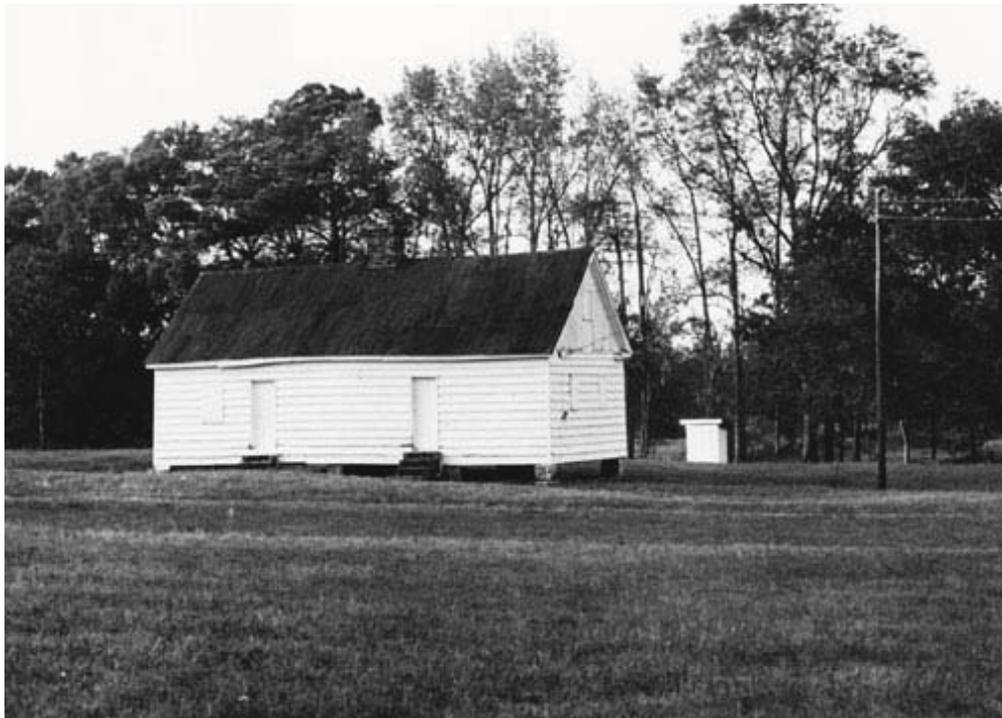
A Slave-Freedman cabin at Friendfield Plantation near Georgetown. Note the 16 x 30 size of the structure. Very common layout and architectural style for an African-American servant House.

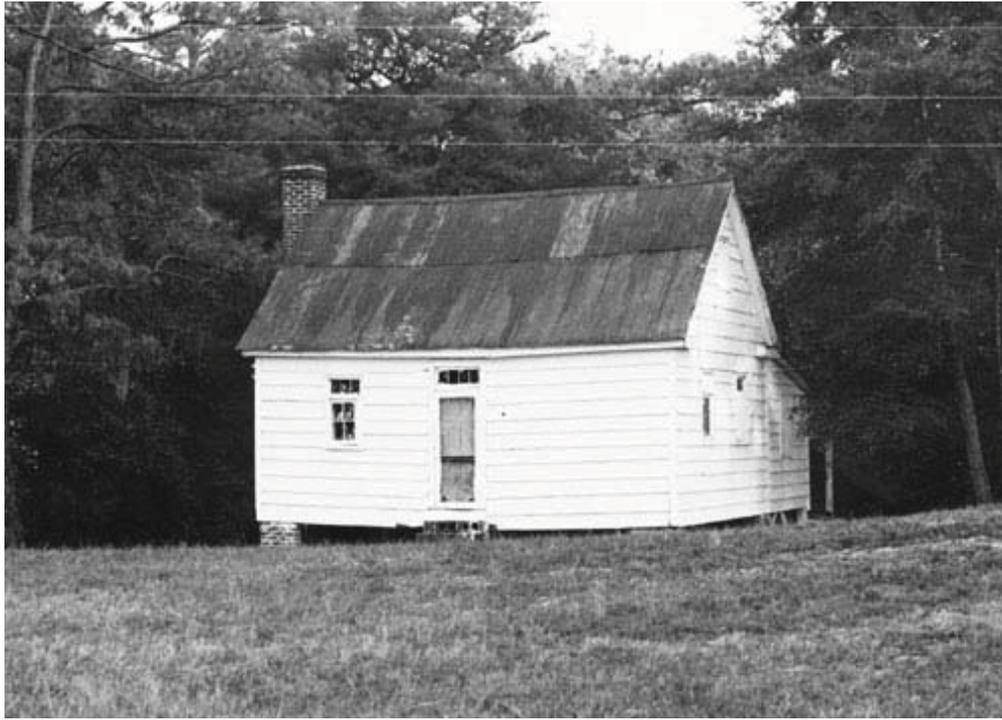
A Slave-Freedman cabin at Friendfield Plantation. Note the location of the windows and front door entrance (overhead 4-light transom is a very uncommon architectural element for a Freedman structure). Also recognize the back room addition similar to the Garvin House in Bluffton from a later renovation to the slave cabin before 1900.

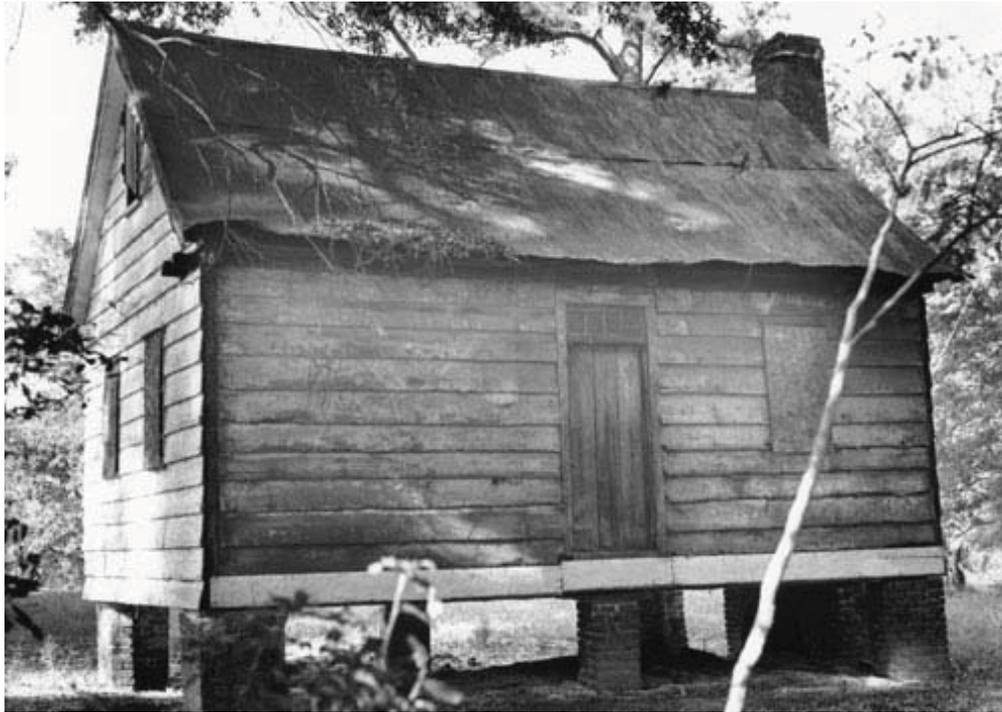
A Slave-Freedman cabin on Hobcaw property related to the Friendfield Plantation. Note the center door with two windows on the gable ends, similar to the Garvin House. Metal corrugated roof was installed after 1920s to replace the wood shingle material.

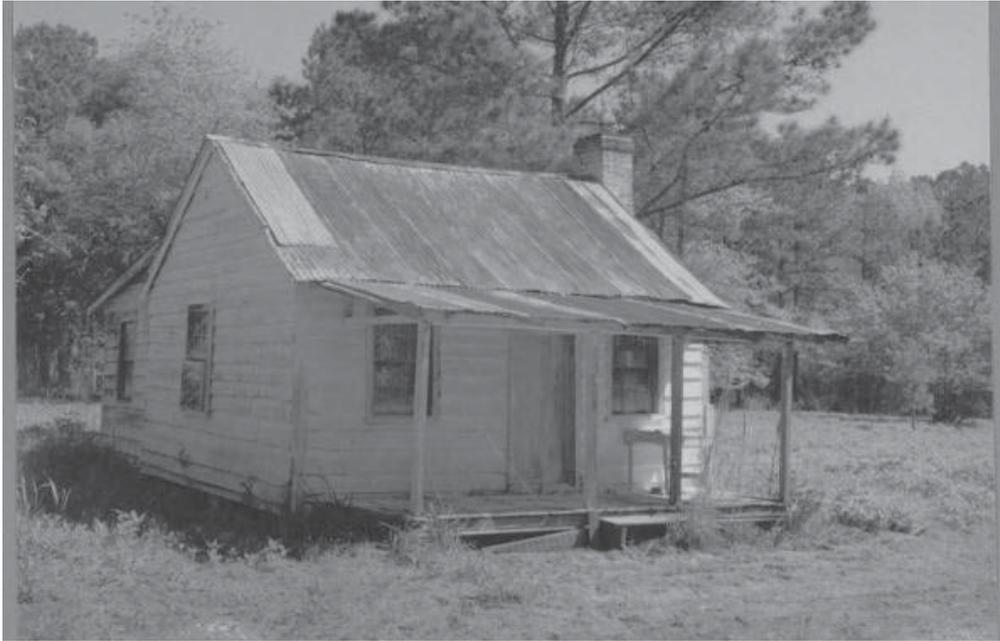
A.3 Former Slave Cabins with Additions

One of seven extant structures in Friendfield Village, this ca. 1850 cabin stands in the north middle row of cabins. Slave cabins had no porches, glass windows or rear additions; this cabin shows modifications made in the mid-1930s, including a rear addition and front porch. Corrugated tin has been placed over cypress shingles. The cabin was last lived in ca. 1950. (photo taken in 1975)

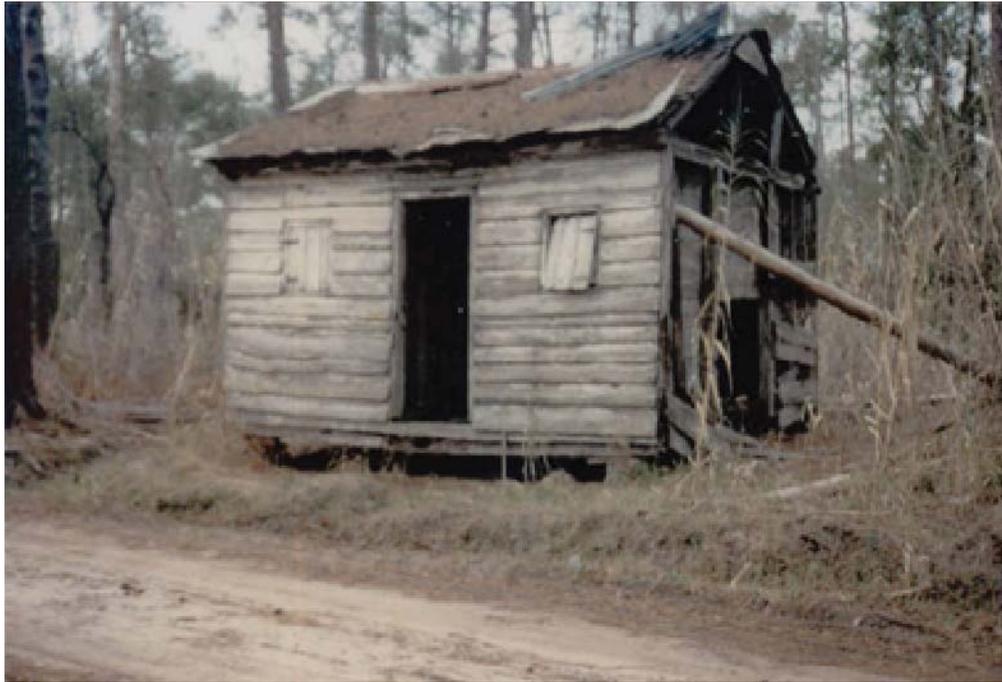
A.5 Slave Cabin in Friendfield Village

The slave cabin on Hobcaw Barony is shown here after barely surviving Hurricane Hugo (September 1989). The cabin features two rooms, shuttered windows, wood shingles, and wide boards. These were conserved and a chimney was rebuilt later that decade. The original slave cabin, located on the northwest end of the street, is one of seven extant structures in the village.

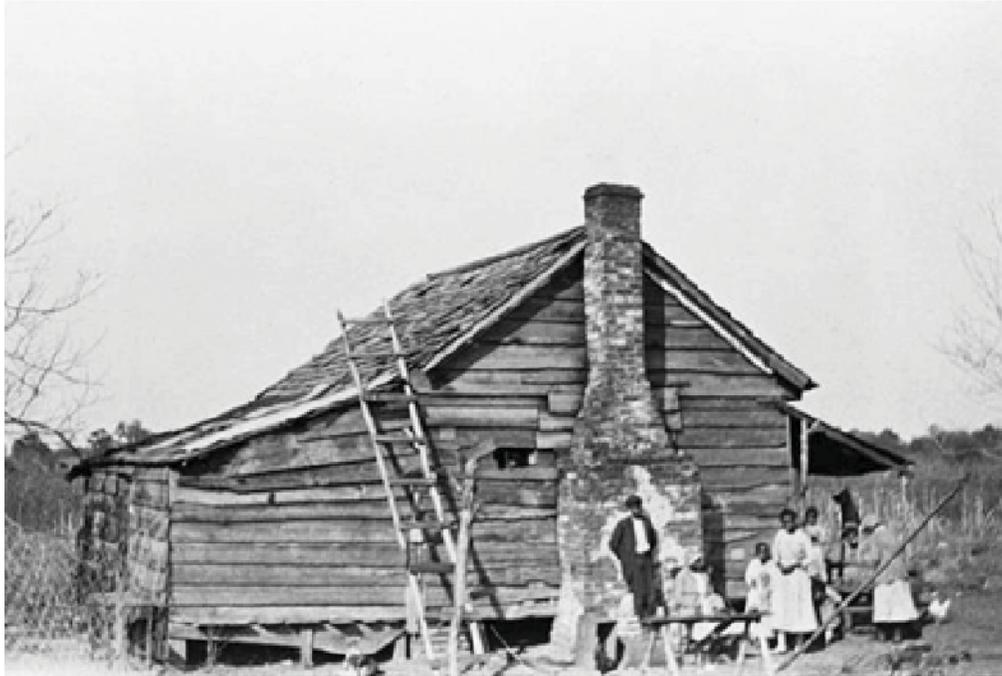
A.6 Slave Cabin with Addition

Pictured here in a ca. 1905 photograph, this former slave cabin includes additions made to enlarge the living space. Two rooms were added at the rear as well as a front porch. The cabin was built of heart pine lumber above the ground on brick piers (note the length of many of the boards). The chimney was constructed of plantation-made bricks and tabby. The roof is composed of cypress shingles overlaid with sheets of tin. Also of note in the photo are the table at the back door, the fishing net and sharpening stone. There are seven African Americans pictured.

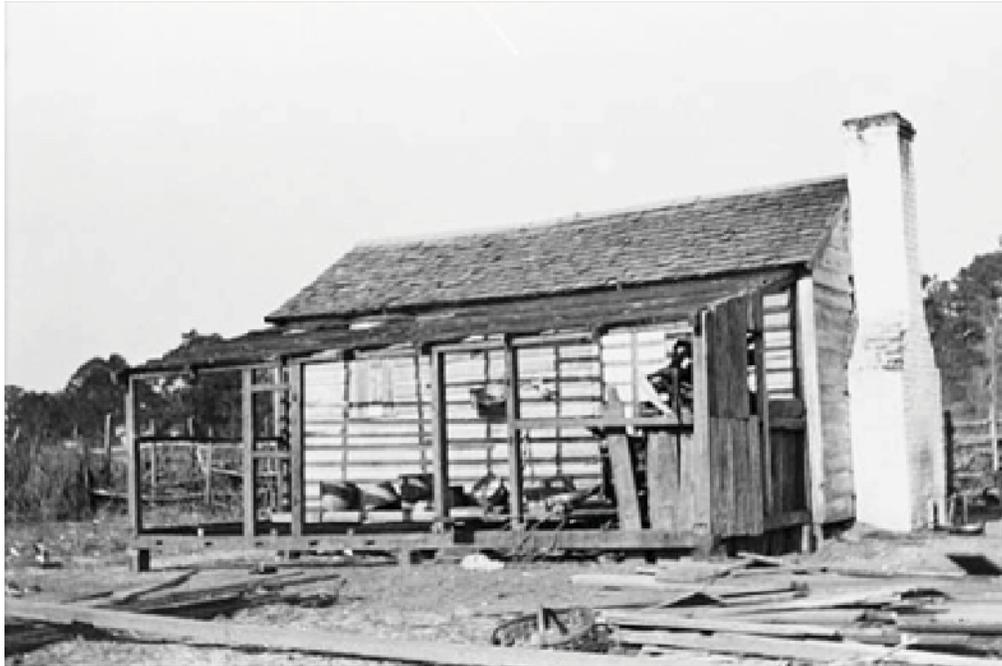
A.8 Former Slave Cabin under Renovation

This photo, taken ca. 1905, shows the renovation of a former slave cabin in progress. Note the use of whitewash paint on the siding and chimney as well as the use of wood blocks to provide foundation support for the rear rooms.

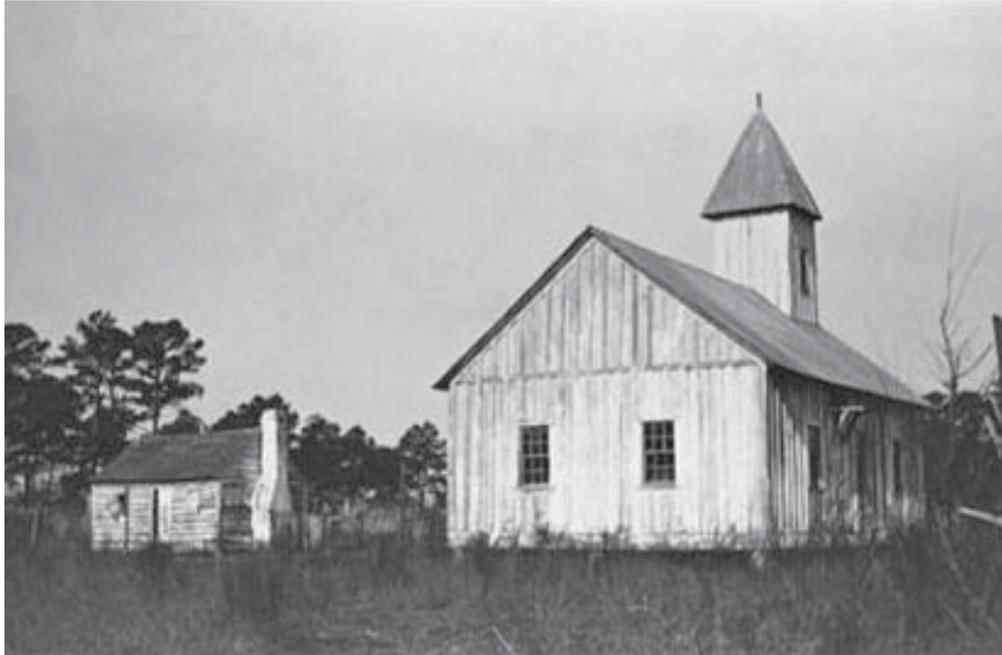
A.9 Friendfield Church

The Friendfield Church, which was built between 1890 and 1900, is a rectangular building with board-and-batten siding, a gabled metal roof, and a pyramidal spire. This was remodeled under the direction of Bernard Baruch. It is typically of South Carolina Lowcountry, freedmen's chapels. The church, erected by All Saints, Waccamaw Parish, Episcopal Church in 1890 replaced a slave chapel. This structure serves as a reference point for the Worship House in Bluffton, demonstrating similar building styles that were common to African American builders in the late 19th century.

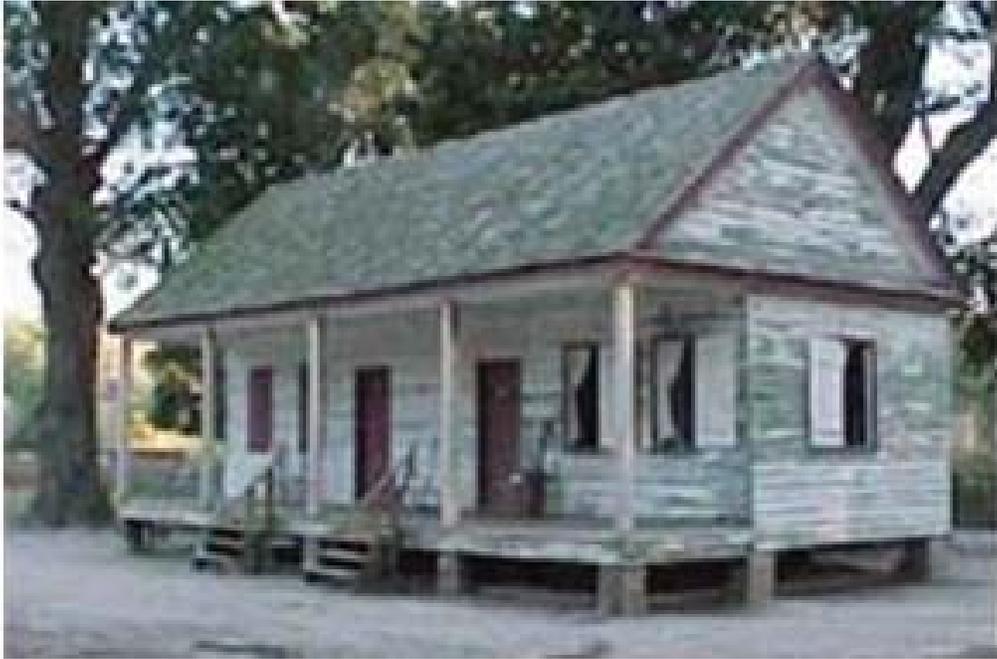
A.10 Eliza's House - Middleton Place Plantation

Eliza's House (c. 1870) was once occupied by former Middleton slaves. This two-family duplex was constructed of mill-sawn weatherboard with a central, double (back-to-back) fireplace, and the interior and exterior walls were whitewashed. There was no connecting access between the two units, but occupants of each half had equal use of the porch and the loft. It is known as "Eliza's House" in memory of Eliza Leach, a South Carolina African-American born in 1891, and the last person to live in the building. She died in 1986, at age 94, and almost to the last continued to live in the house much as her predecessors would have done: raking the bare "swept yard" clear of leaves and twigs, chopping wood for her fire, and toting water from the Spring House -- even though modern conveniences had long since been installed. Eliza also worked over 40 years at Middleton Place, performing a variety of duties, from sweeping and raking in the Gardens to collecting tickets and distributing brochures to visitors.

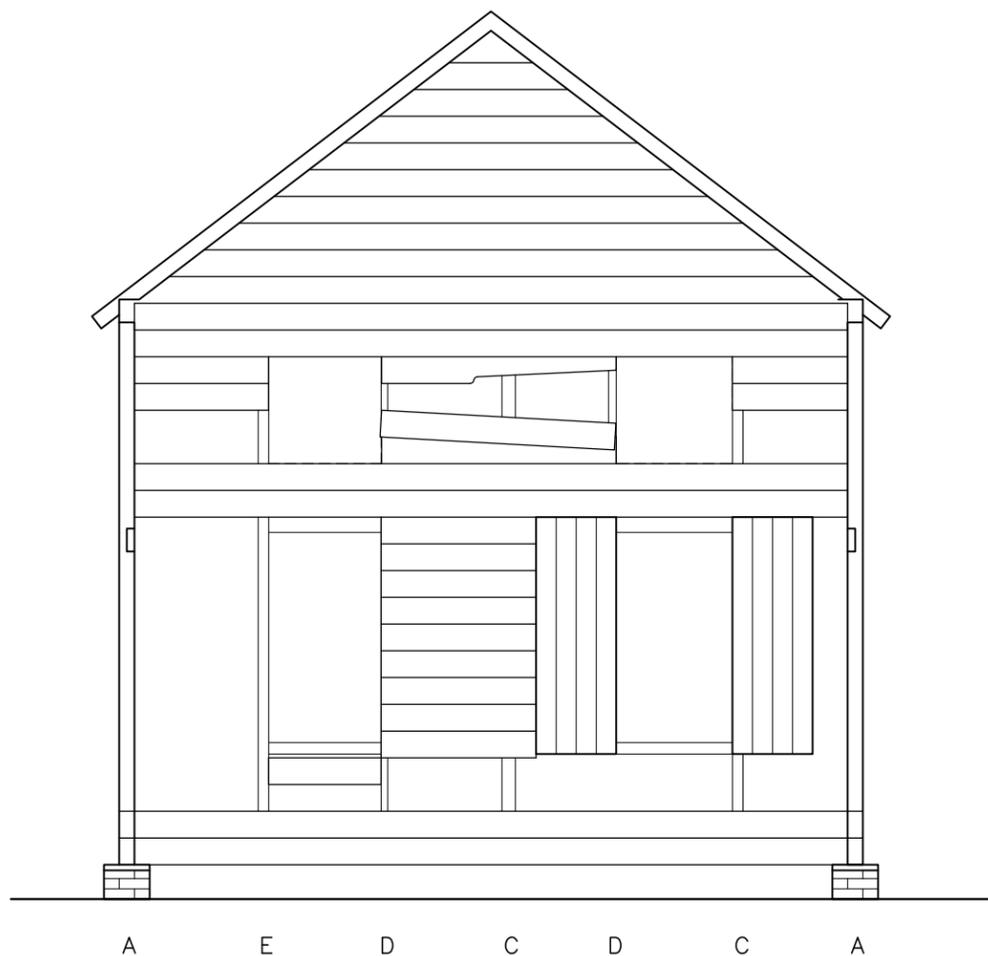
1 EXISTING EAST ELEVATION
 1/4" = 1'-0"

STUD KEY
 A - 4 x 6 ACTUAL
 B - 2 x 4 NOMINAL
 C - 3.5 x 4 ACTUAL
 D - 2 x 4 ACTUAL
 E - 2.75 x 4 ACTUAL
